Project Background Information

Salmon Creek Reconnection Design – Project area map
Landowner: Clark County
Project sponsor: Cowlitz Indian Tribe
SRFB # 23-1151

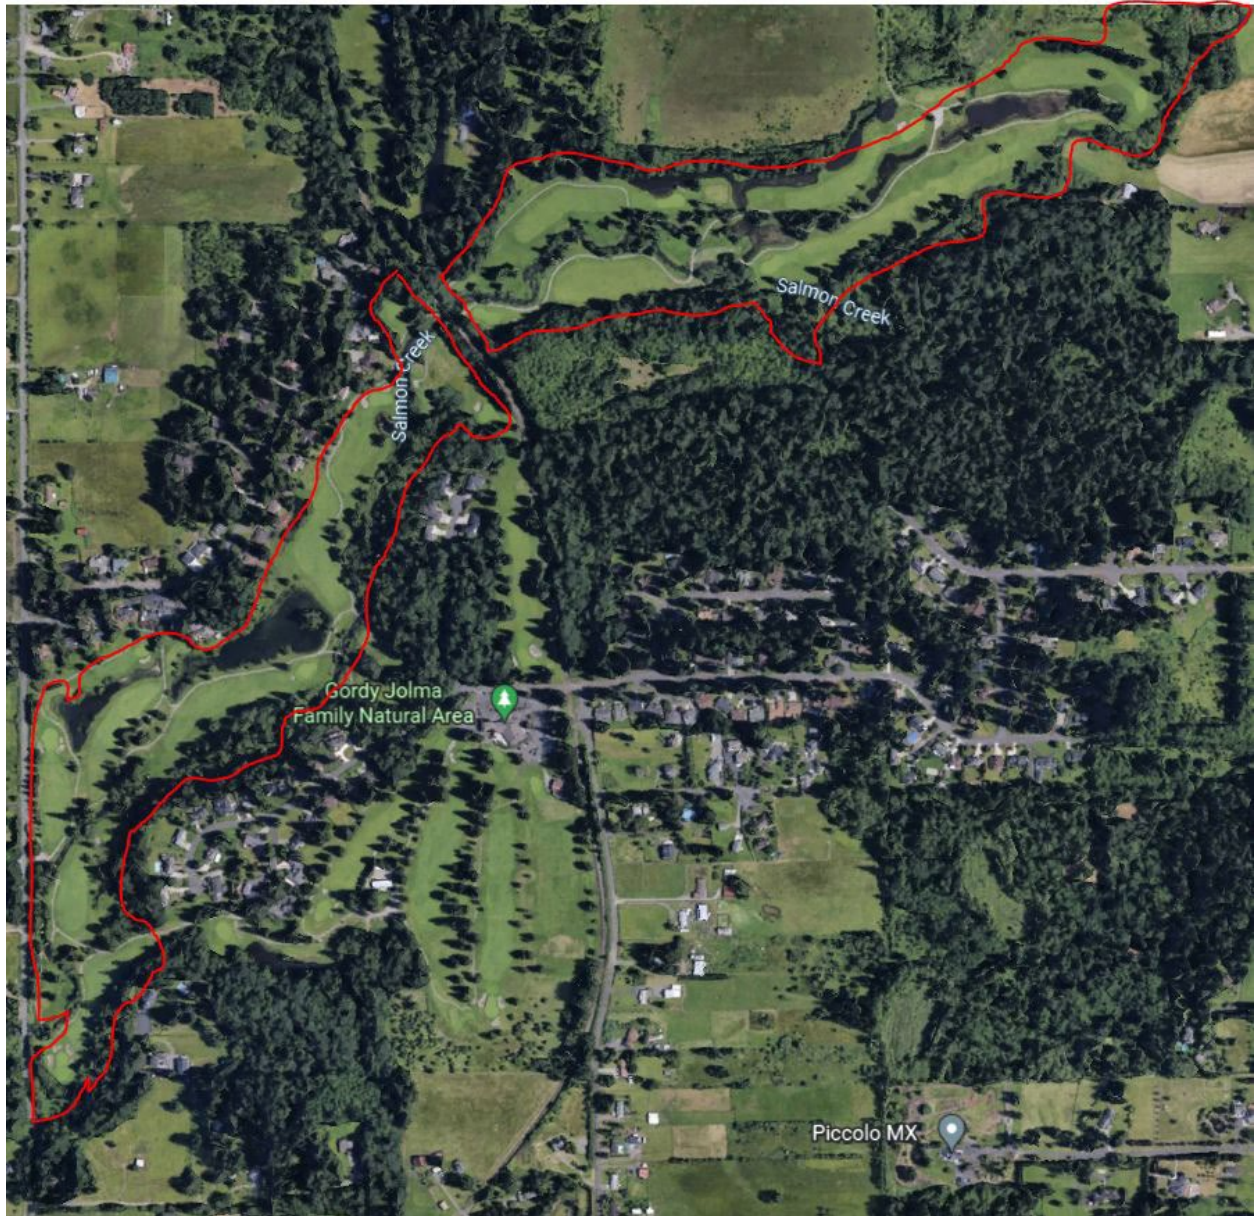
Legacy Lands: Cedars Golf Course Acquisition

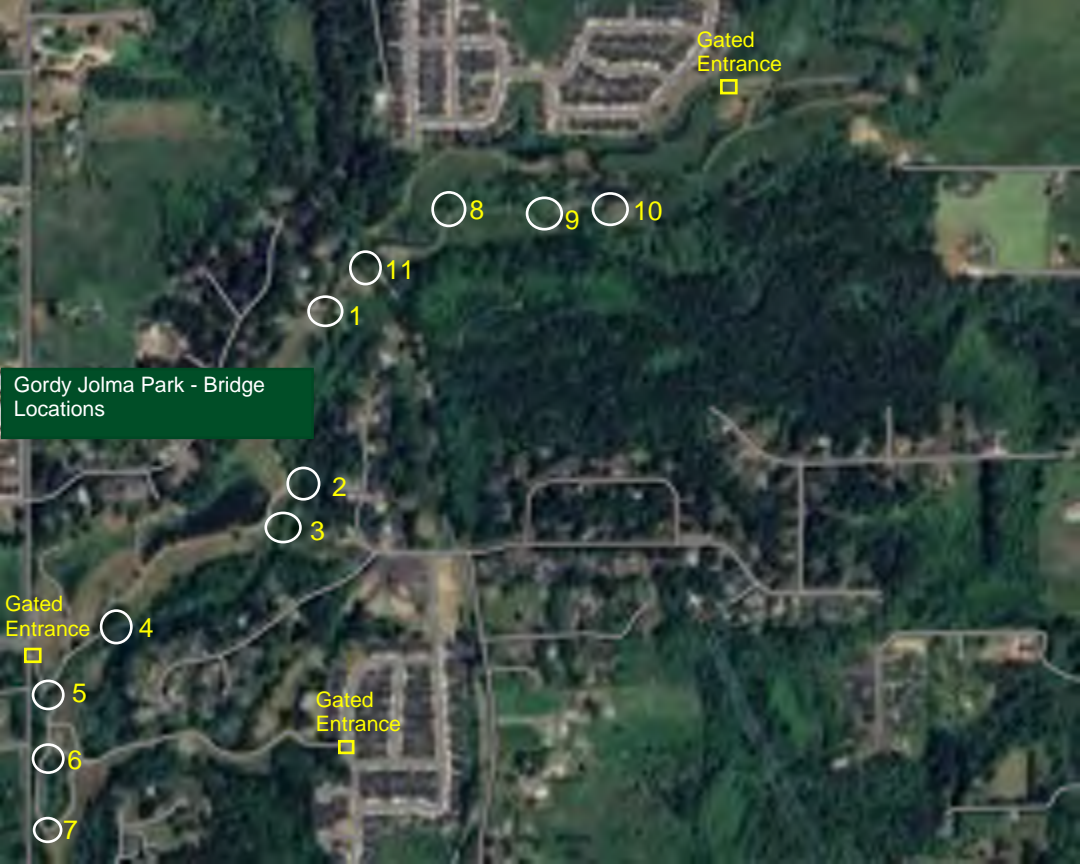
A map showing the location and bridge numbers and the detailed inspection reports are attached.

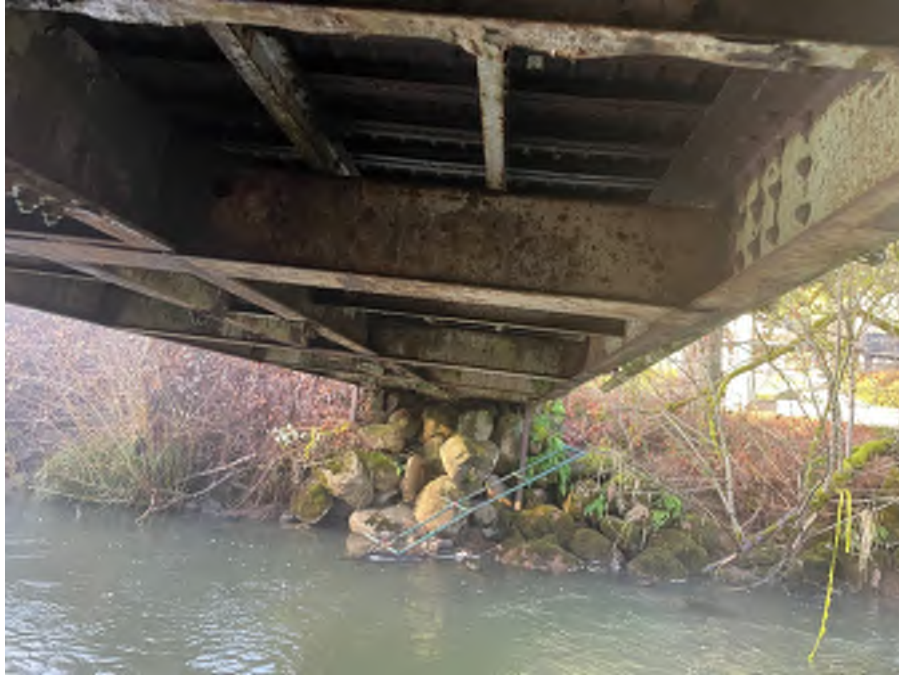
Photo 3 – Gordy Jolma No 1 Abutment with loose rip rap

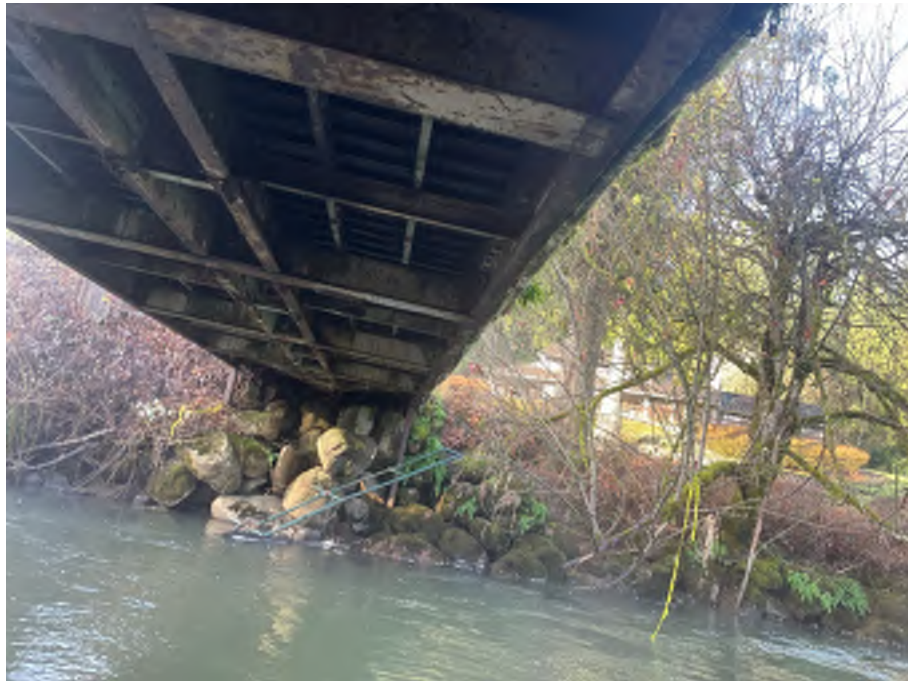
Photo 4 – Gordy Jolma No 1 Loss of paint and surface corrosion on rail car.

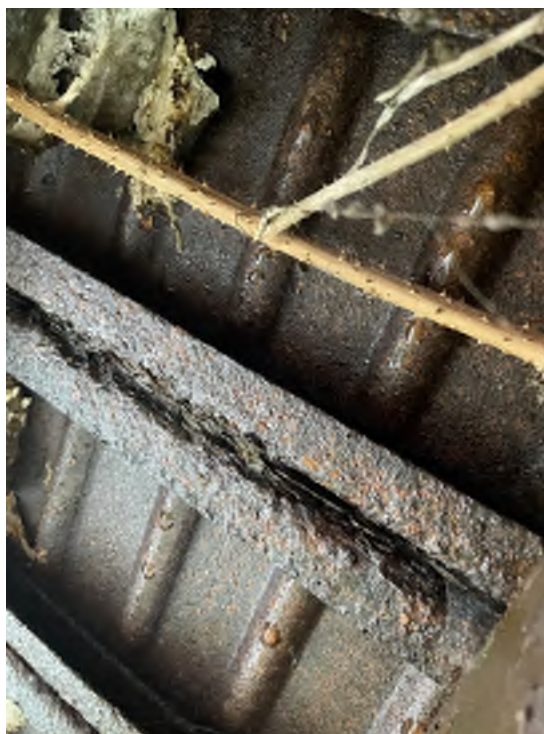
Photo 5 – Gordy Jolma No 1 Severe corrosion on deck plate and deck ribs.

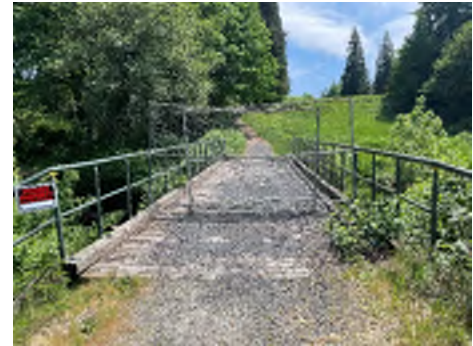
Bridge No. GJ-2
Bridge Name: Gordy Jolma No 2 over
Salmon Creek
Location: Gordy Jolma County Park
Drainage: Salmon Creek
Bridge Type: Railroad Car – Peds/Bikes
Span Length: 30 feet

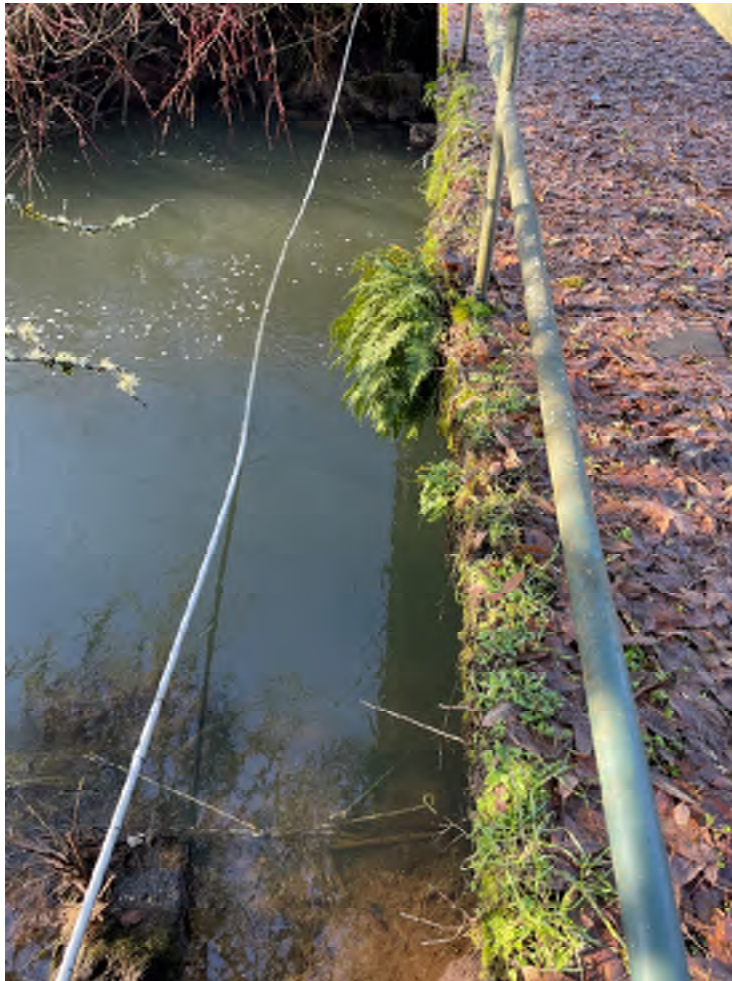
Photo 3 – Gordy Jolma No 3 view of failed 2” conduit in the stream.

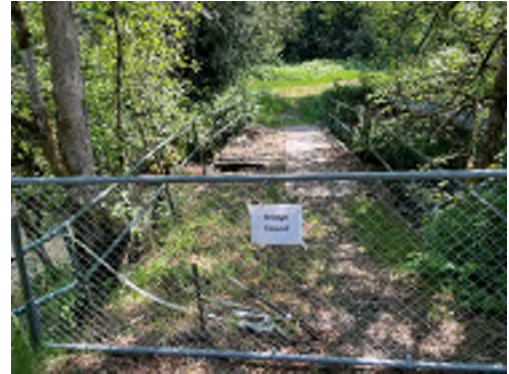
Bridge No. GJ-4
Bridge Name: Gordy Jolma Trail over
Salmon Creek No 4
Location: Gordy Jolma County Park
Drainage: Salmon Creek
Bridge Type: Railroad Car
Span Length: 46' feet

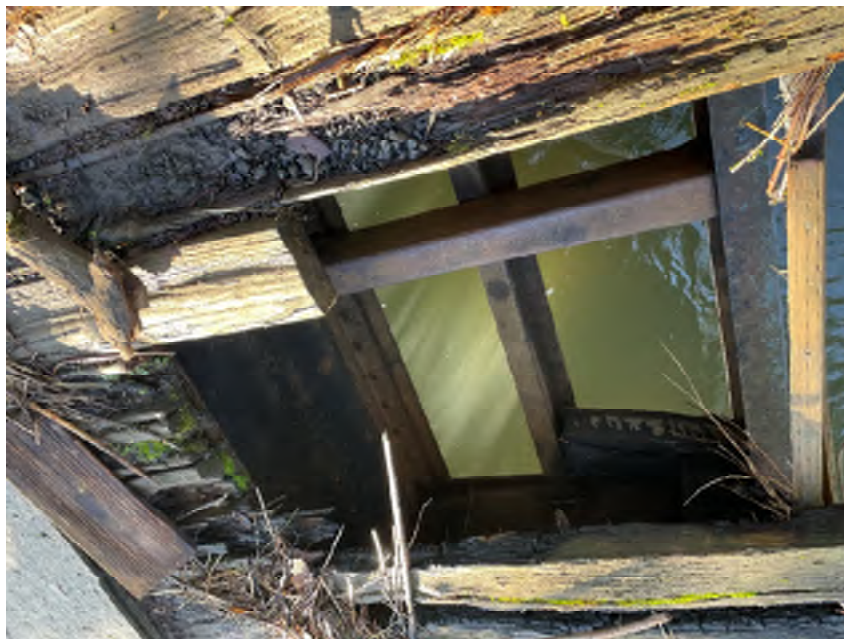
Photo 3 – Gordy Jolma No 4 Hole in Deck due to timber plank failure.

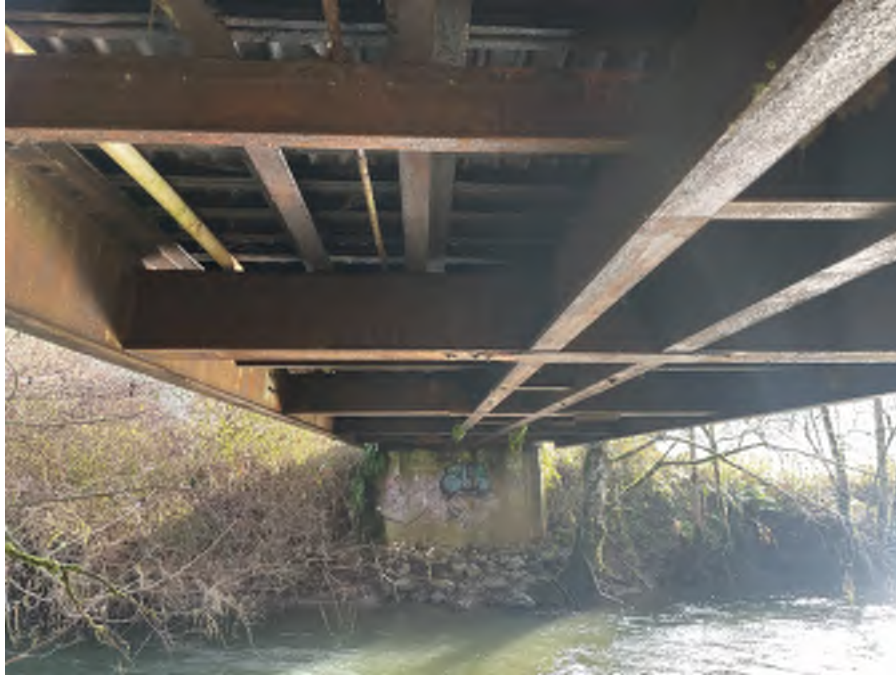
Photo 3 – Gordy Jolma No 5 Abutment with loose rip rap

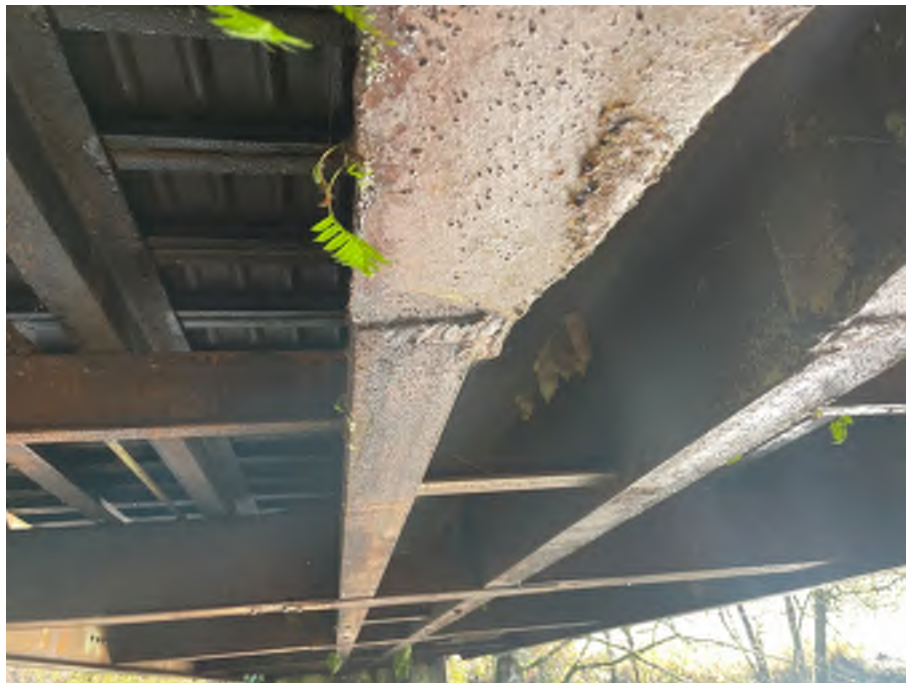
Photo 4 – Gordy Jolma No 5 Loss of paint, surface corrosion, and fatigue-prone weld on rail car.

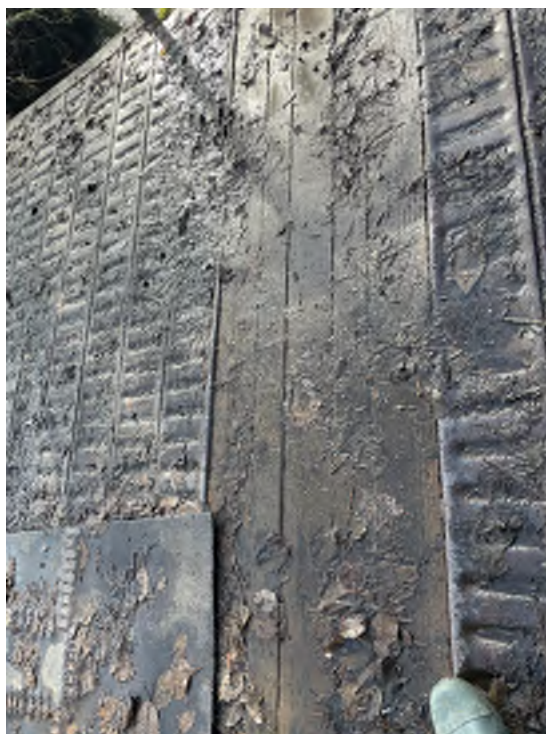
Photo 5 – Gordy Jolma No 5 Corrosion/damage on steel deck plate and timber deck plank section.

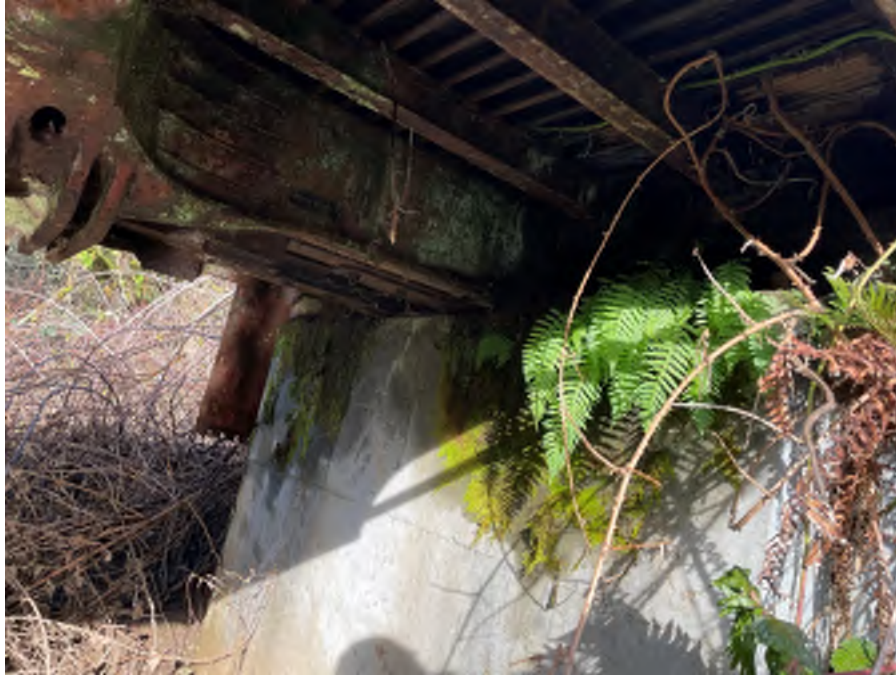
Photo 3 – Gordy Jolma No 6 Abutment with loose rip rap

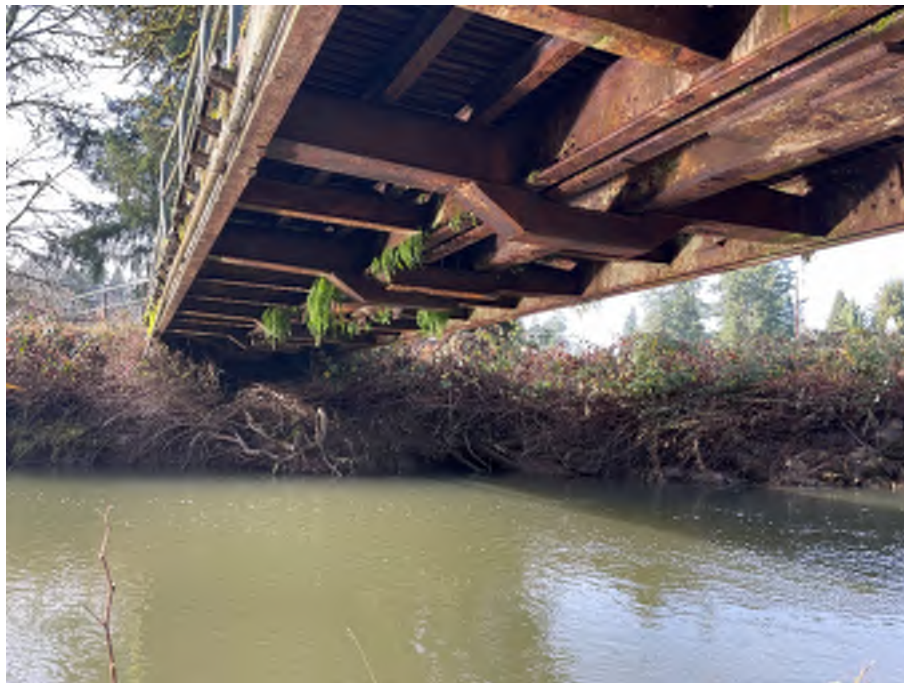
Photo 4 – Gordy Jolma No 6 Loss of paint, surface corrosion, and fatigue-prone weld on rail car.

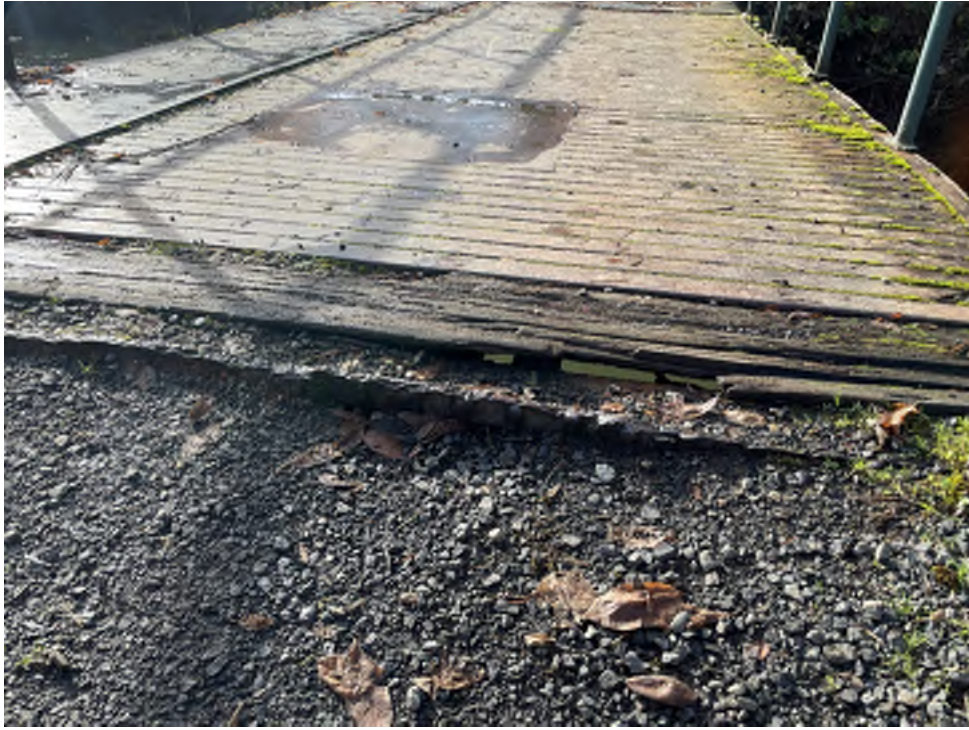
Photo 5 – Gordy Jolma No 6 Corrosion/damage on steel deck plate and erosion and drop off at abutment.

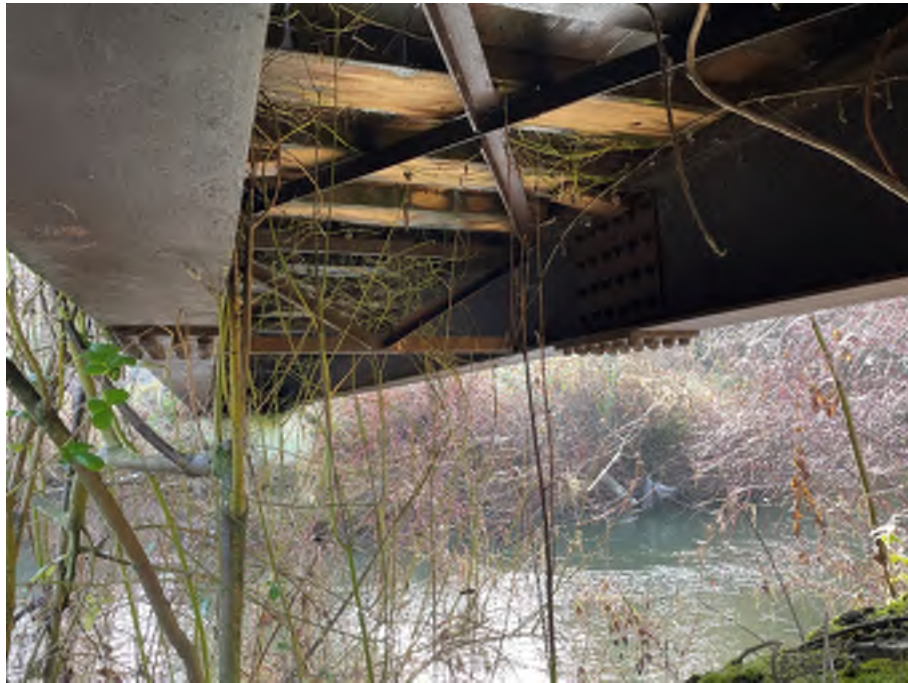
Photo 4 – Gordy Jolma No 7 Light patina on steel surfaces, beginning of crevice corrosion, and fatigue-prone details.

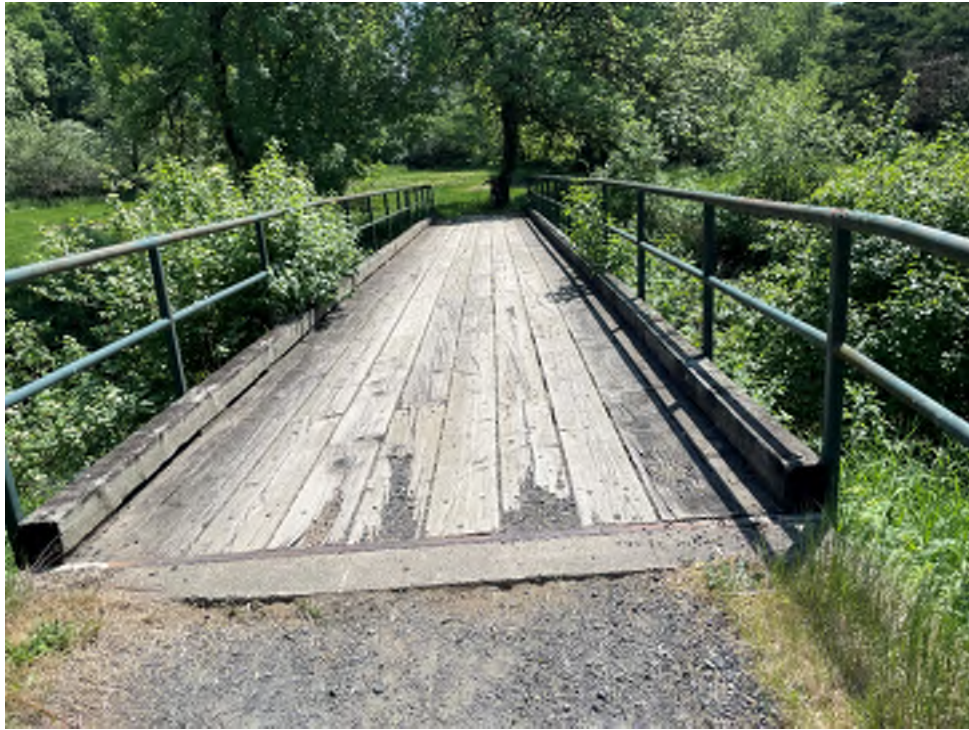
Photo 5 – Gordy Jolma No 7 Erosion and drop off at west abutment.

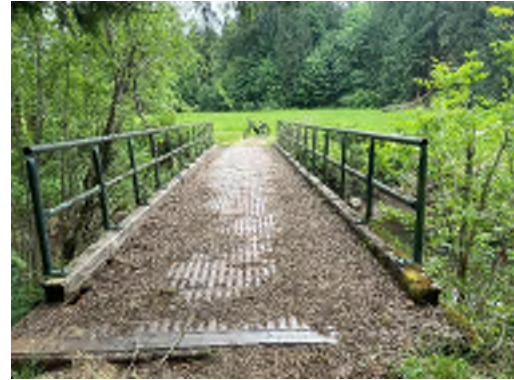
Bridge No. GJ8
Bridge Name: Gordy Jolma Trail over
Salmon Creek No 8
Location: Gordy Jolma County Park
Drainage: Salmon Creek
Bridge Type: Railroad Car
Span Length: 42.0 feet

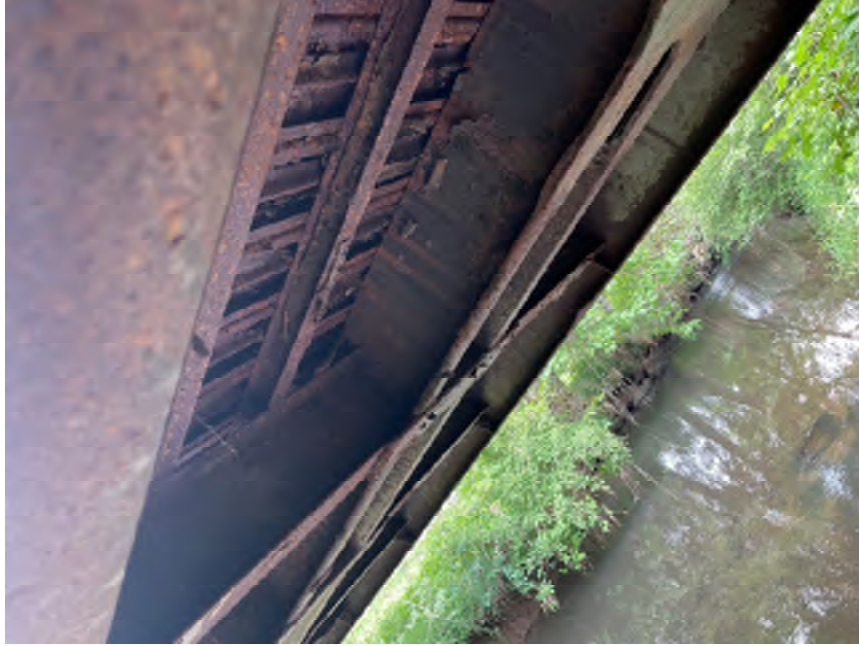
Photo 3 – Gordy Jolma No 8 Severe Corrosion and loss of section steel stringers and bottom of deck surface, crevice corrosion, and fatigue-prone details.

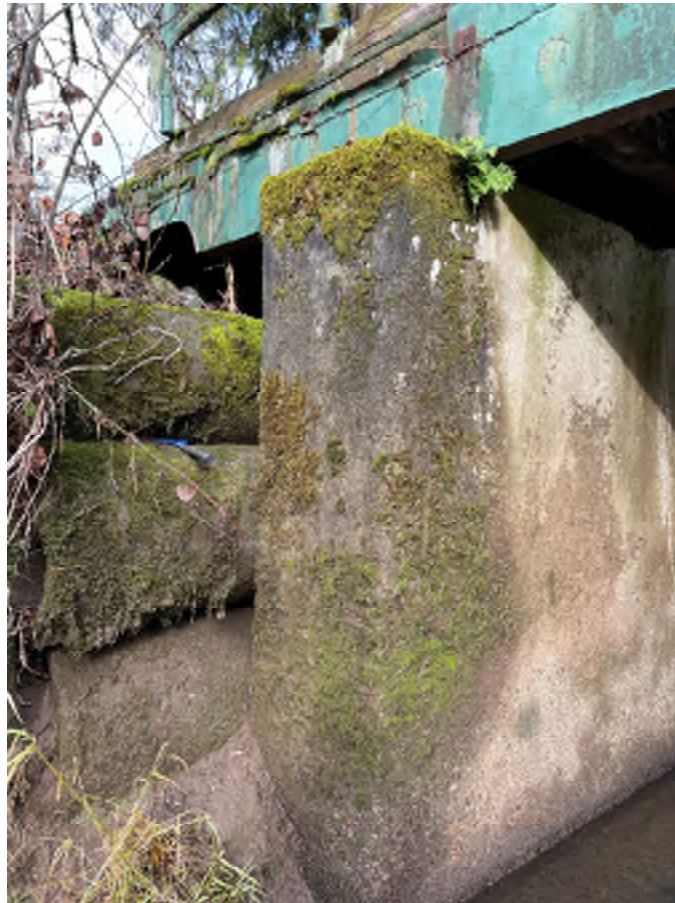
Photo 4 – Gordy Jolma No 8 Abutment and Cantilever Railcar section

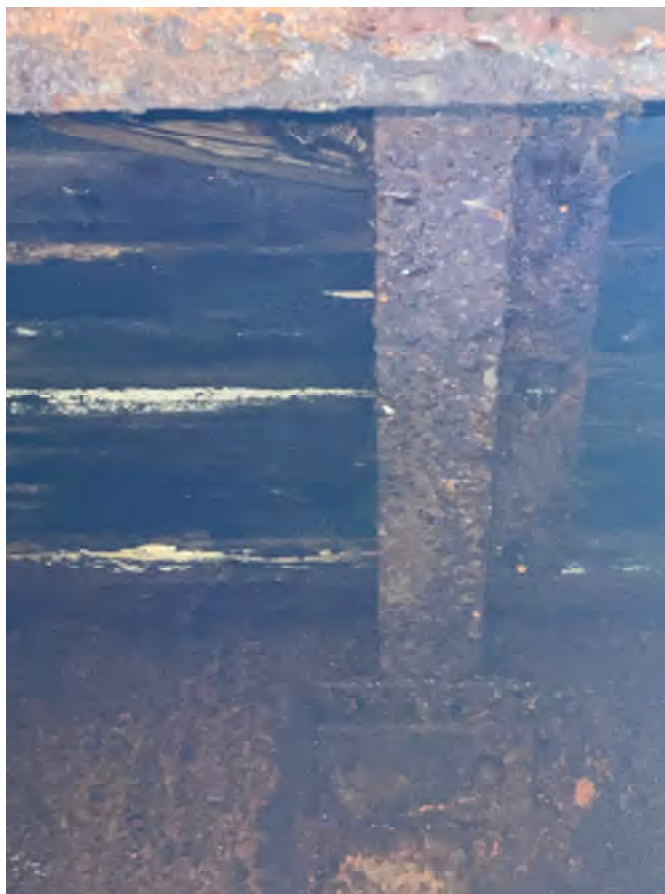
Photo 5 – Gordy Jolma No 9 Railcar beam and cross beam severe corrosion and deep pitting

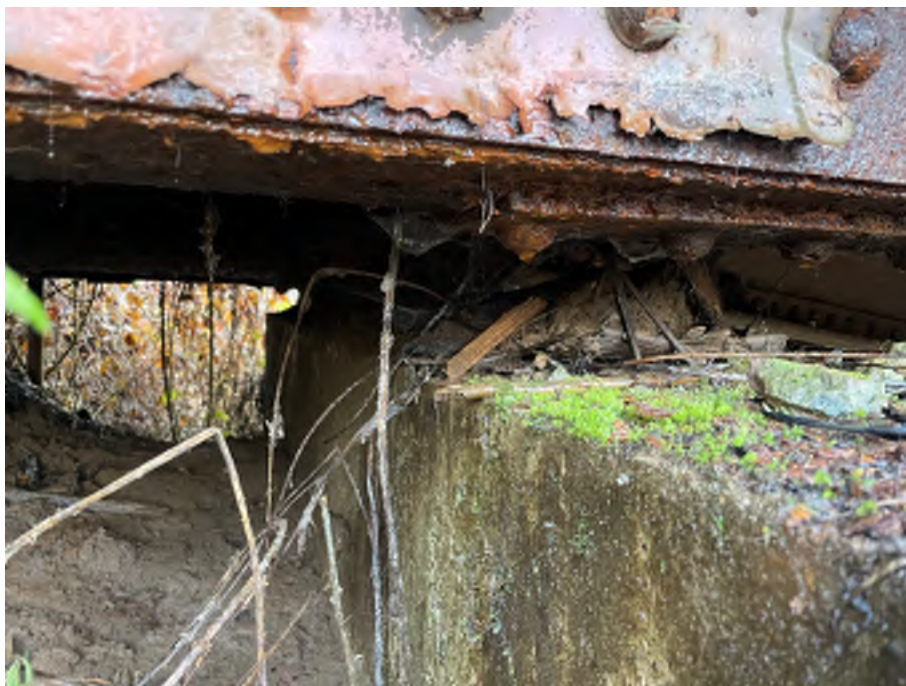
Photo 6 – Gordy Jolma No 9 Railcar main beam severe corrosion and deep pitting

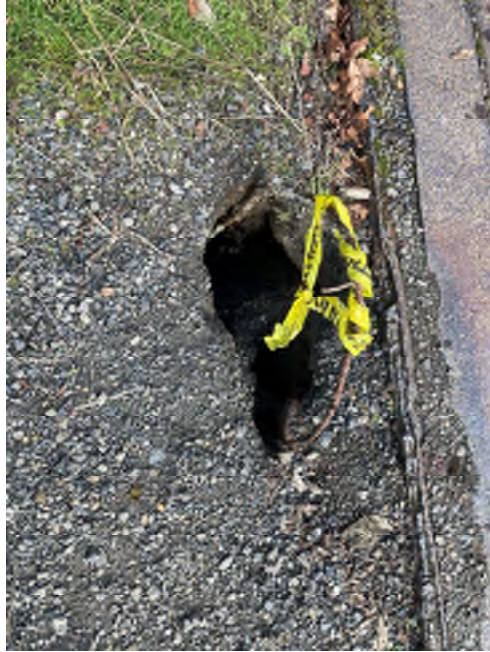
Photo 7 – Gordy Jolma No 9 Approach settlement and hole at north end, tripping hazard

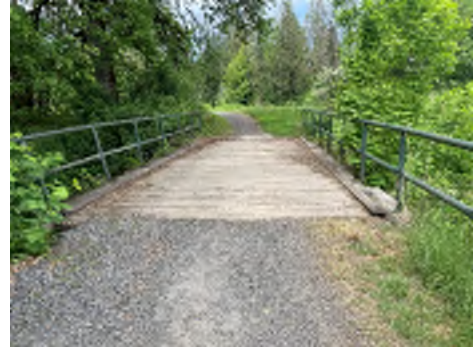
Bridge No. GJ-10
Bridge Name: Gordy Jolma No. 10 over dam
Location: Gordy Jolma County Park
Drainage: Salmon Creek
Bridge Type: Railroad Car
Span Length: 26 feet

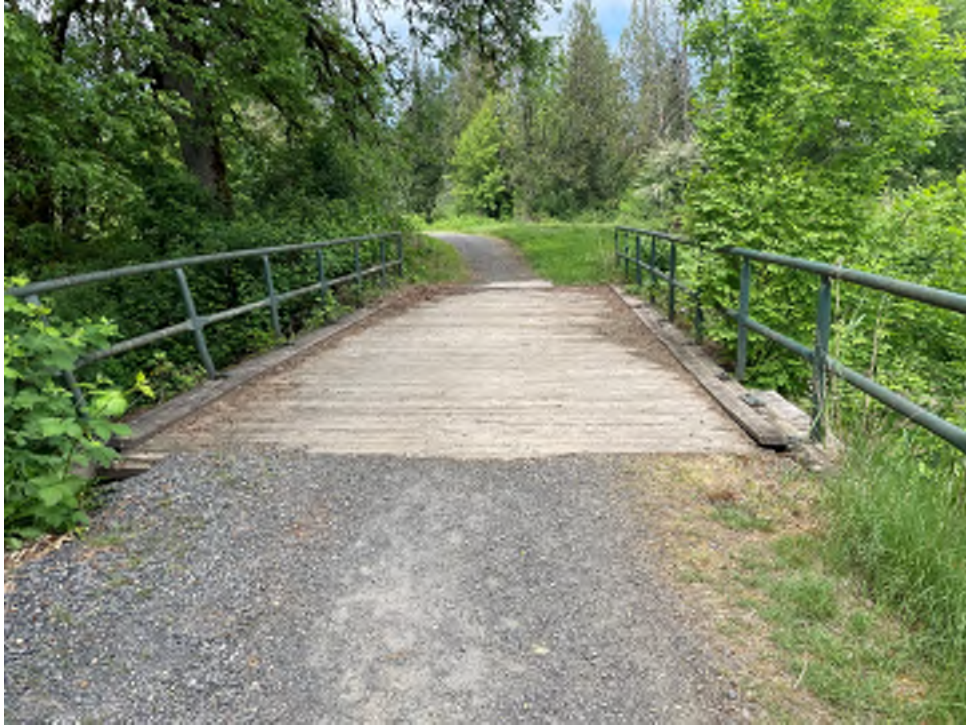
Photo 1 – Gordy Jolma No 10 Approach and Deck view.

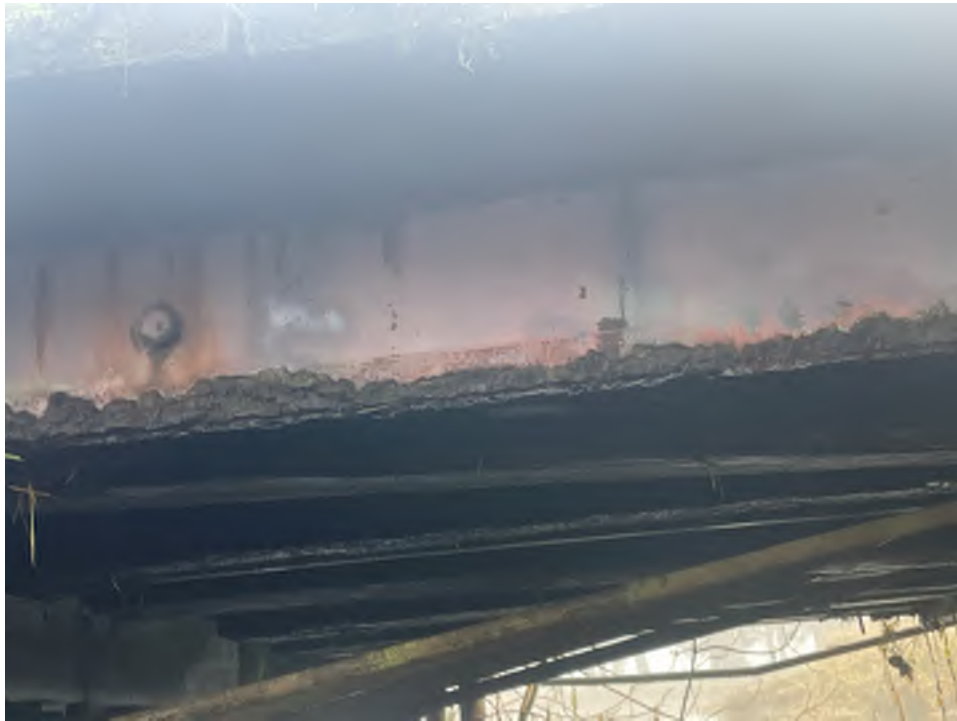
Photo 3 – Gordy Jolma No 10 Severe railcar corrosion and section loss and loose tie rods

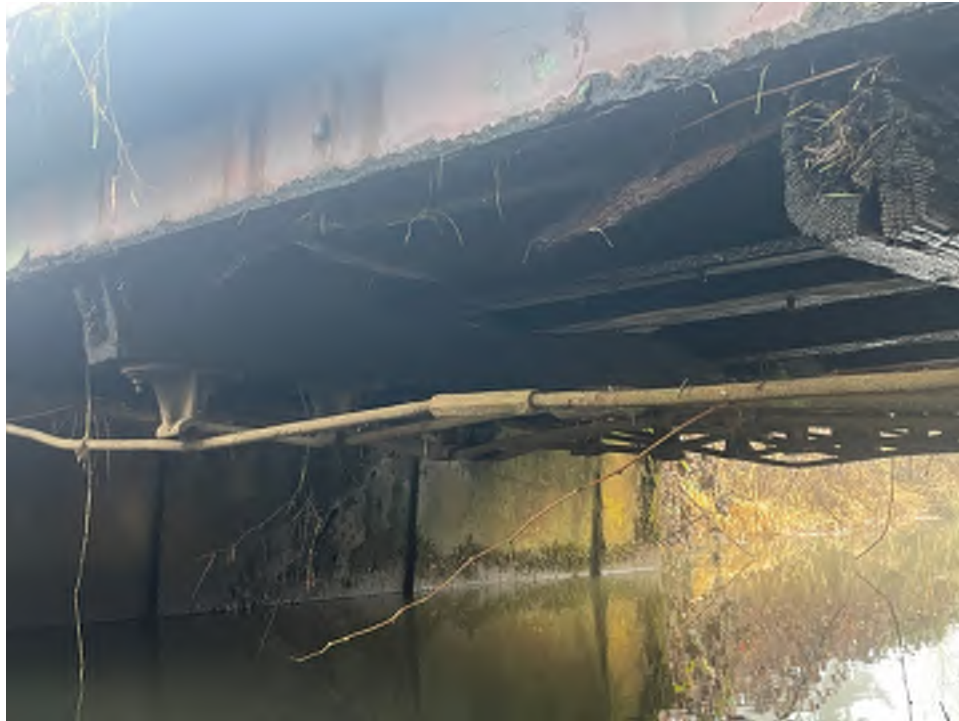
Photo 4 – Gordy Jolma No 10 Rotten timber floorbeams and loose tie rods

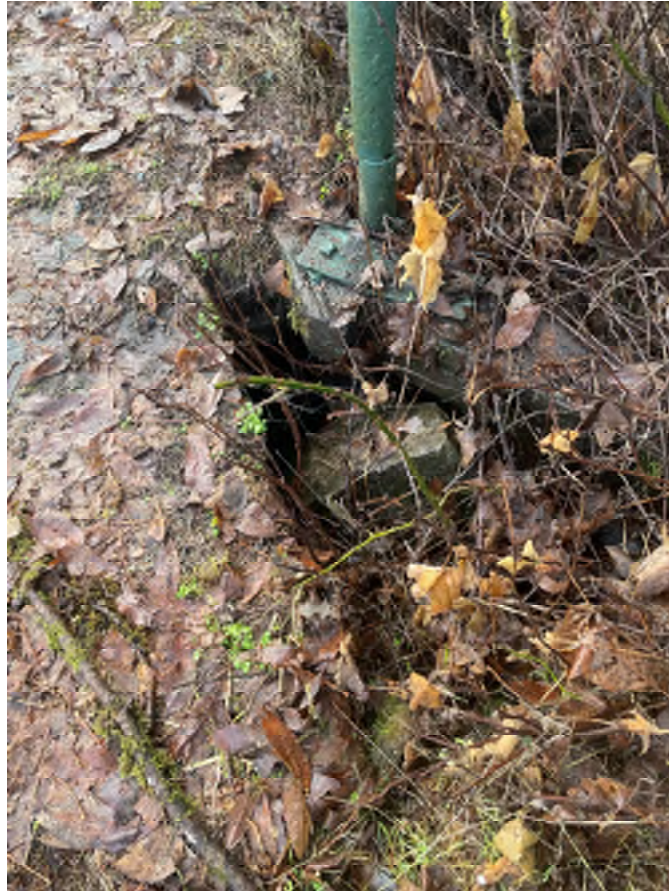
Photo 5 – Gordy Jolma No 10 Approach sloughing and hole at northwest corner

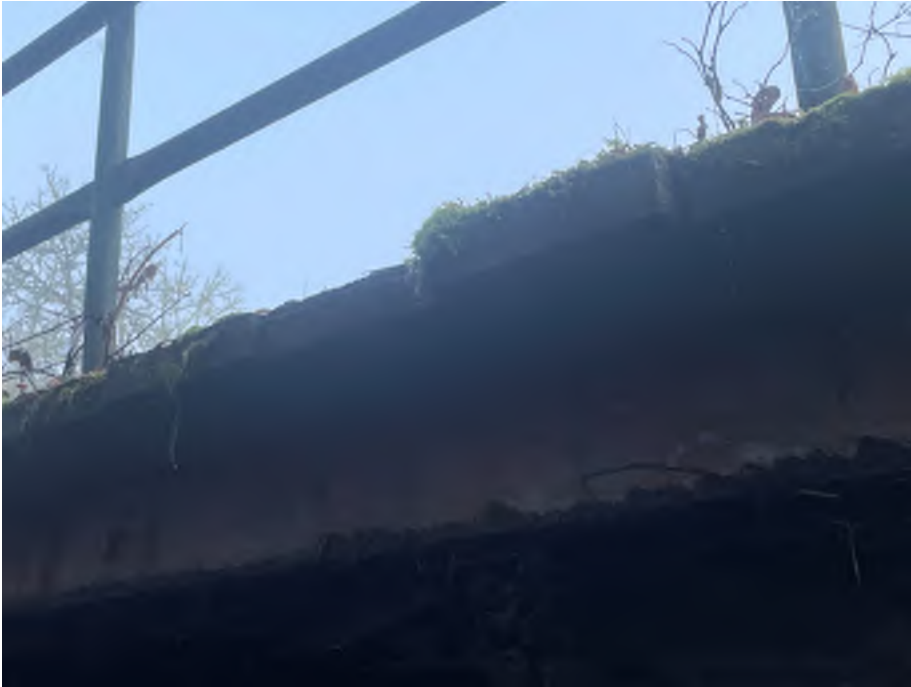
Photo 7 – Gordy Jolma No 10 Railcar steel section loss and timber deck rot and decay

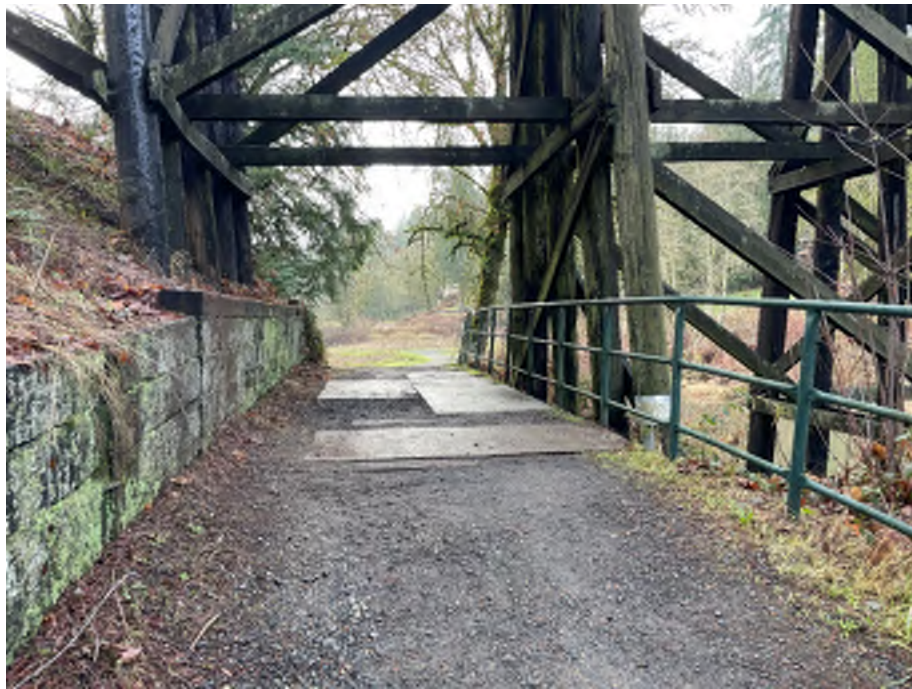
Photo 1 – Gordy Jolma No 11 Approach and Deck view.

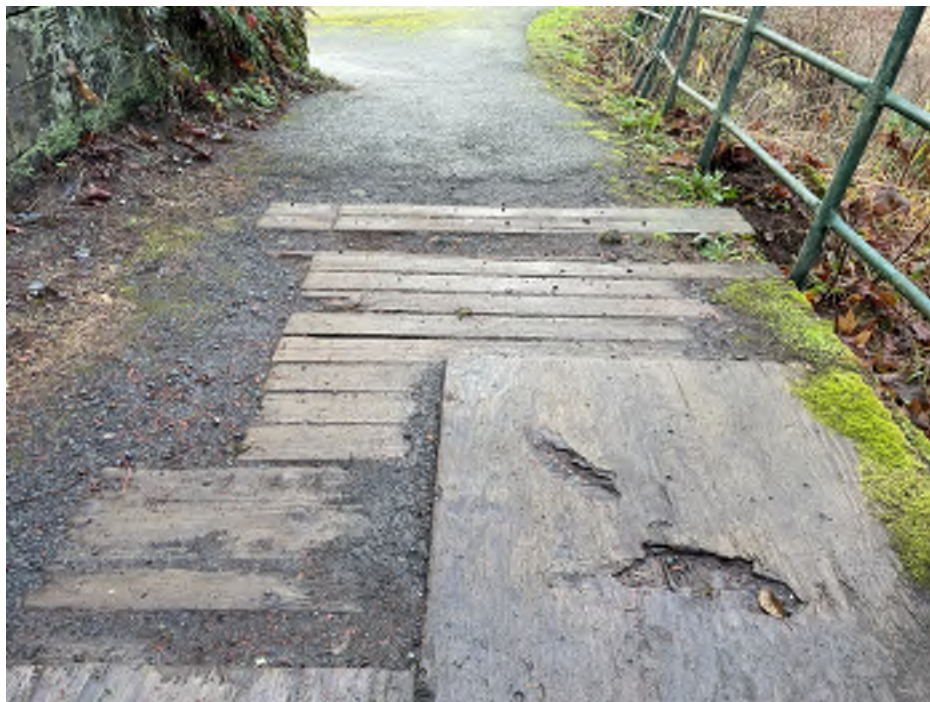
Photo 2 – Gordy Jolma No 11 Deck damage, patching and uneven surface.

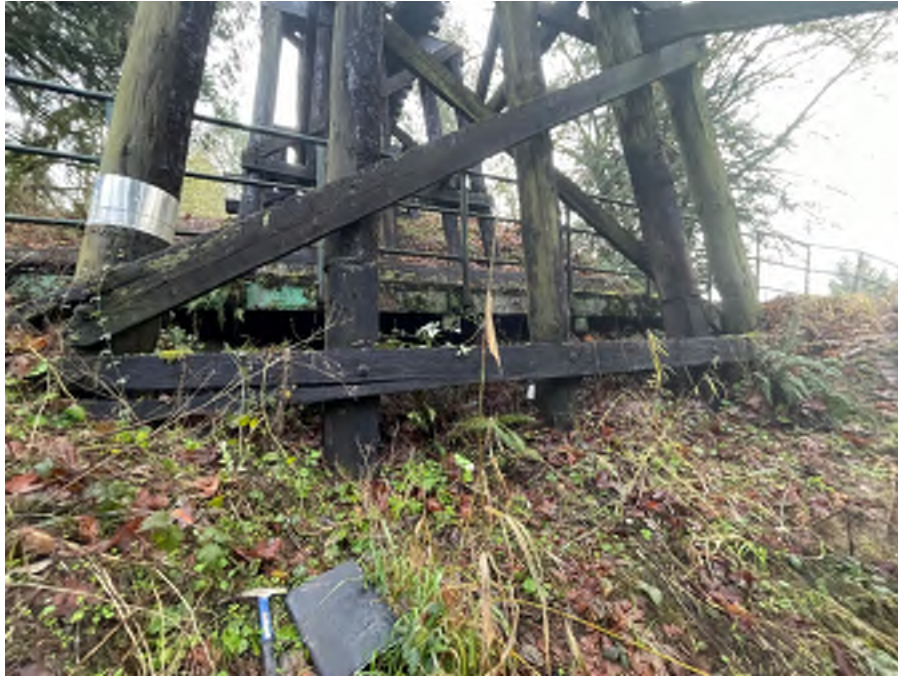
Photo 3 – Gordy Jolma No 11 Elevation View and RR Bridge timber pile bent along north side.

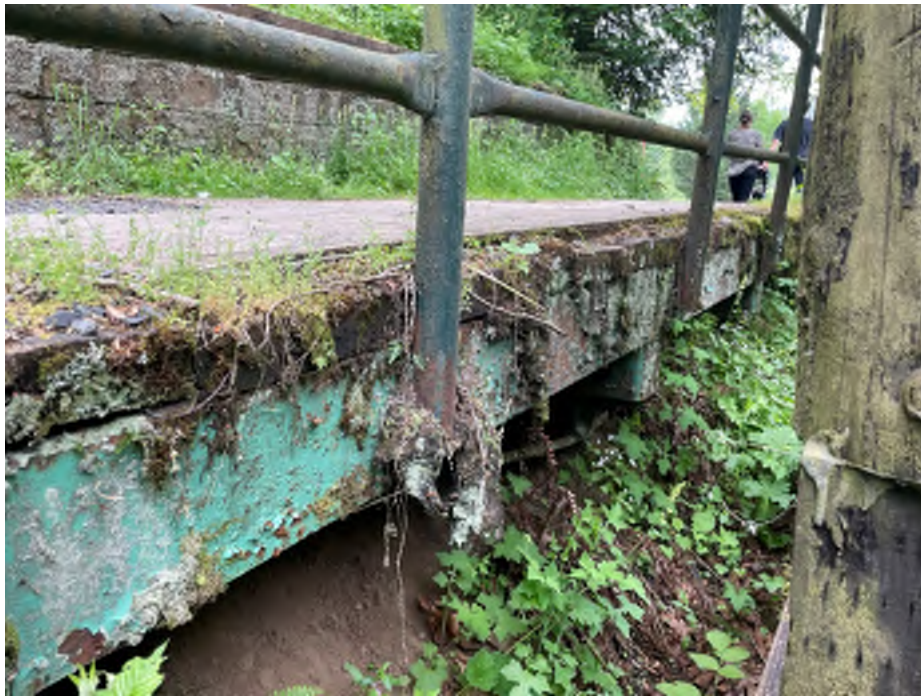
Photo 4 – Gordy Jolma No 11 Side Beam corrosion and loose tie rod.

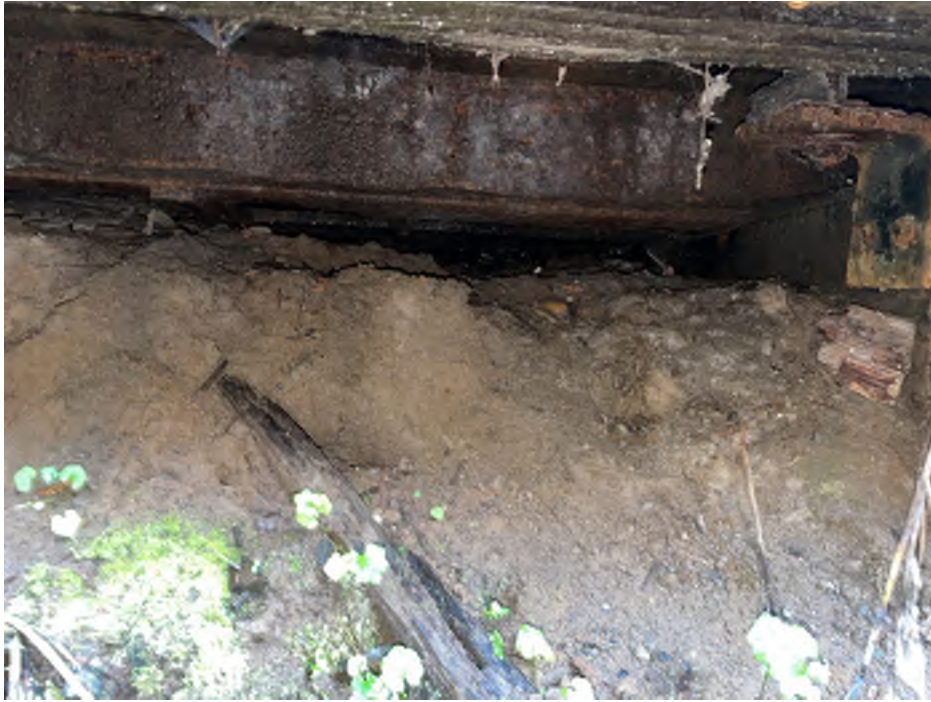
Photo 5 – Gordy Jolma No 11 Interior beam severe corrosion, pitting and loss of section.

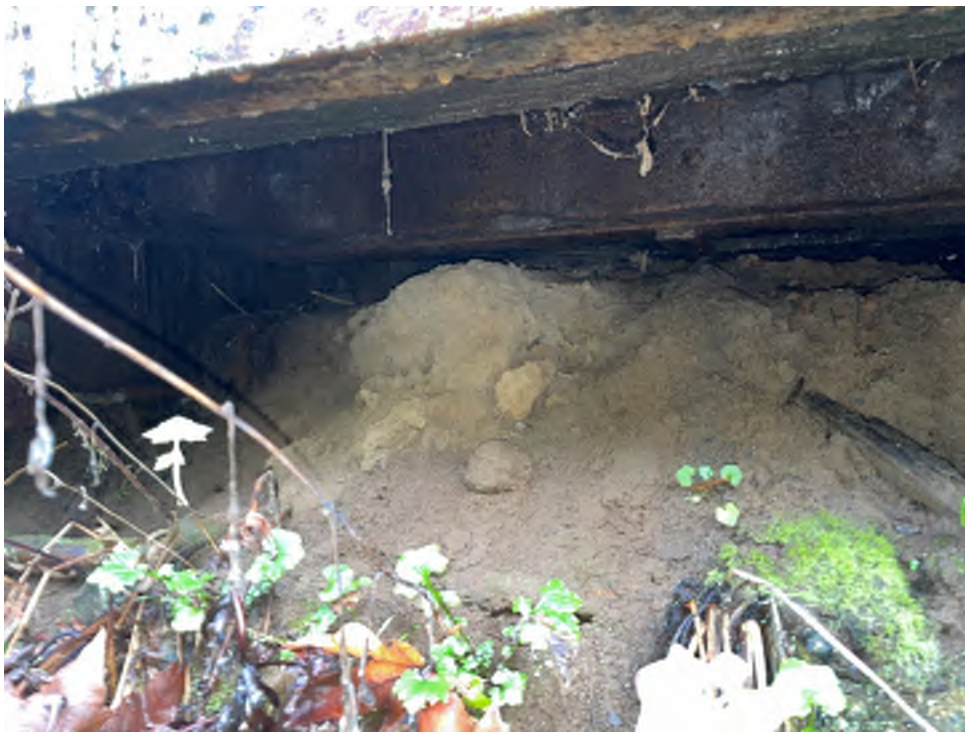
Photo 6 – Gordy Jolma No 11 Interior beam severe corrosion, pitting and loss of section.
