Project Background Information

Salmon Creek Reconnection Design – Project area map
Landowner: Clark County
Project sponsor: Cowlitz Indian Tribe
SRFB # 23-1151

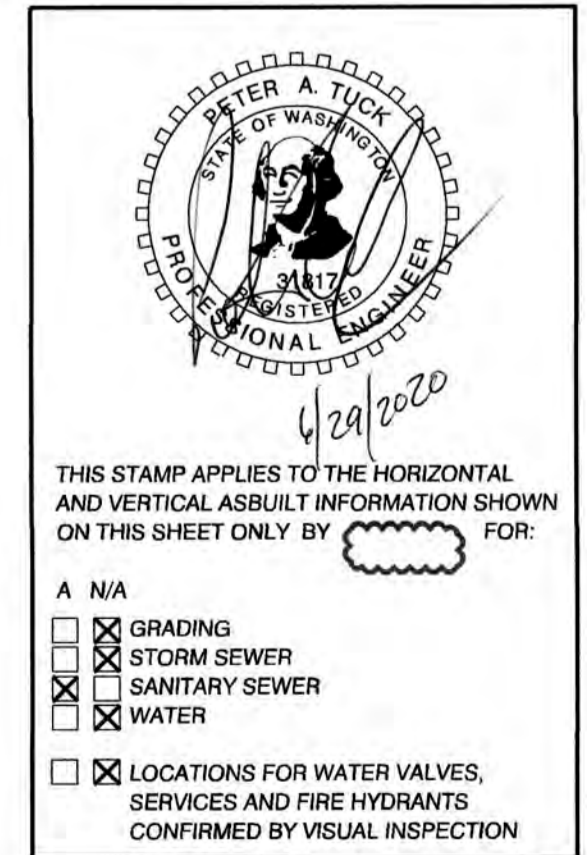
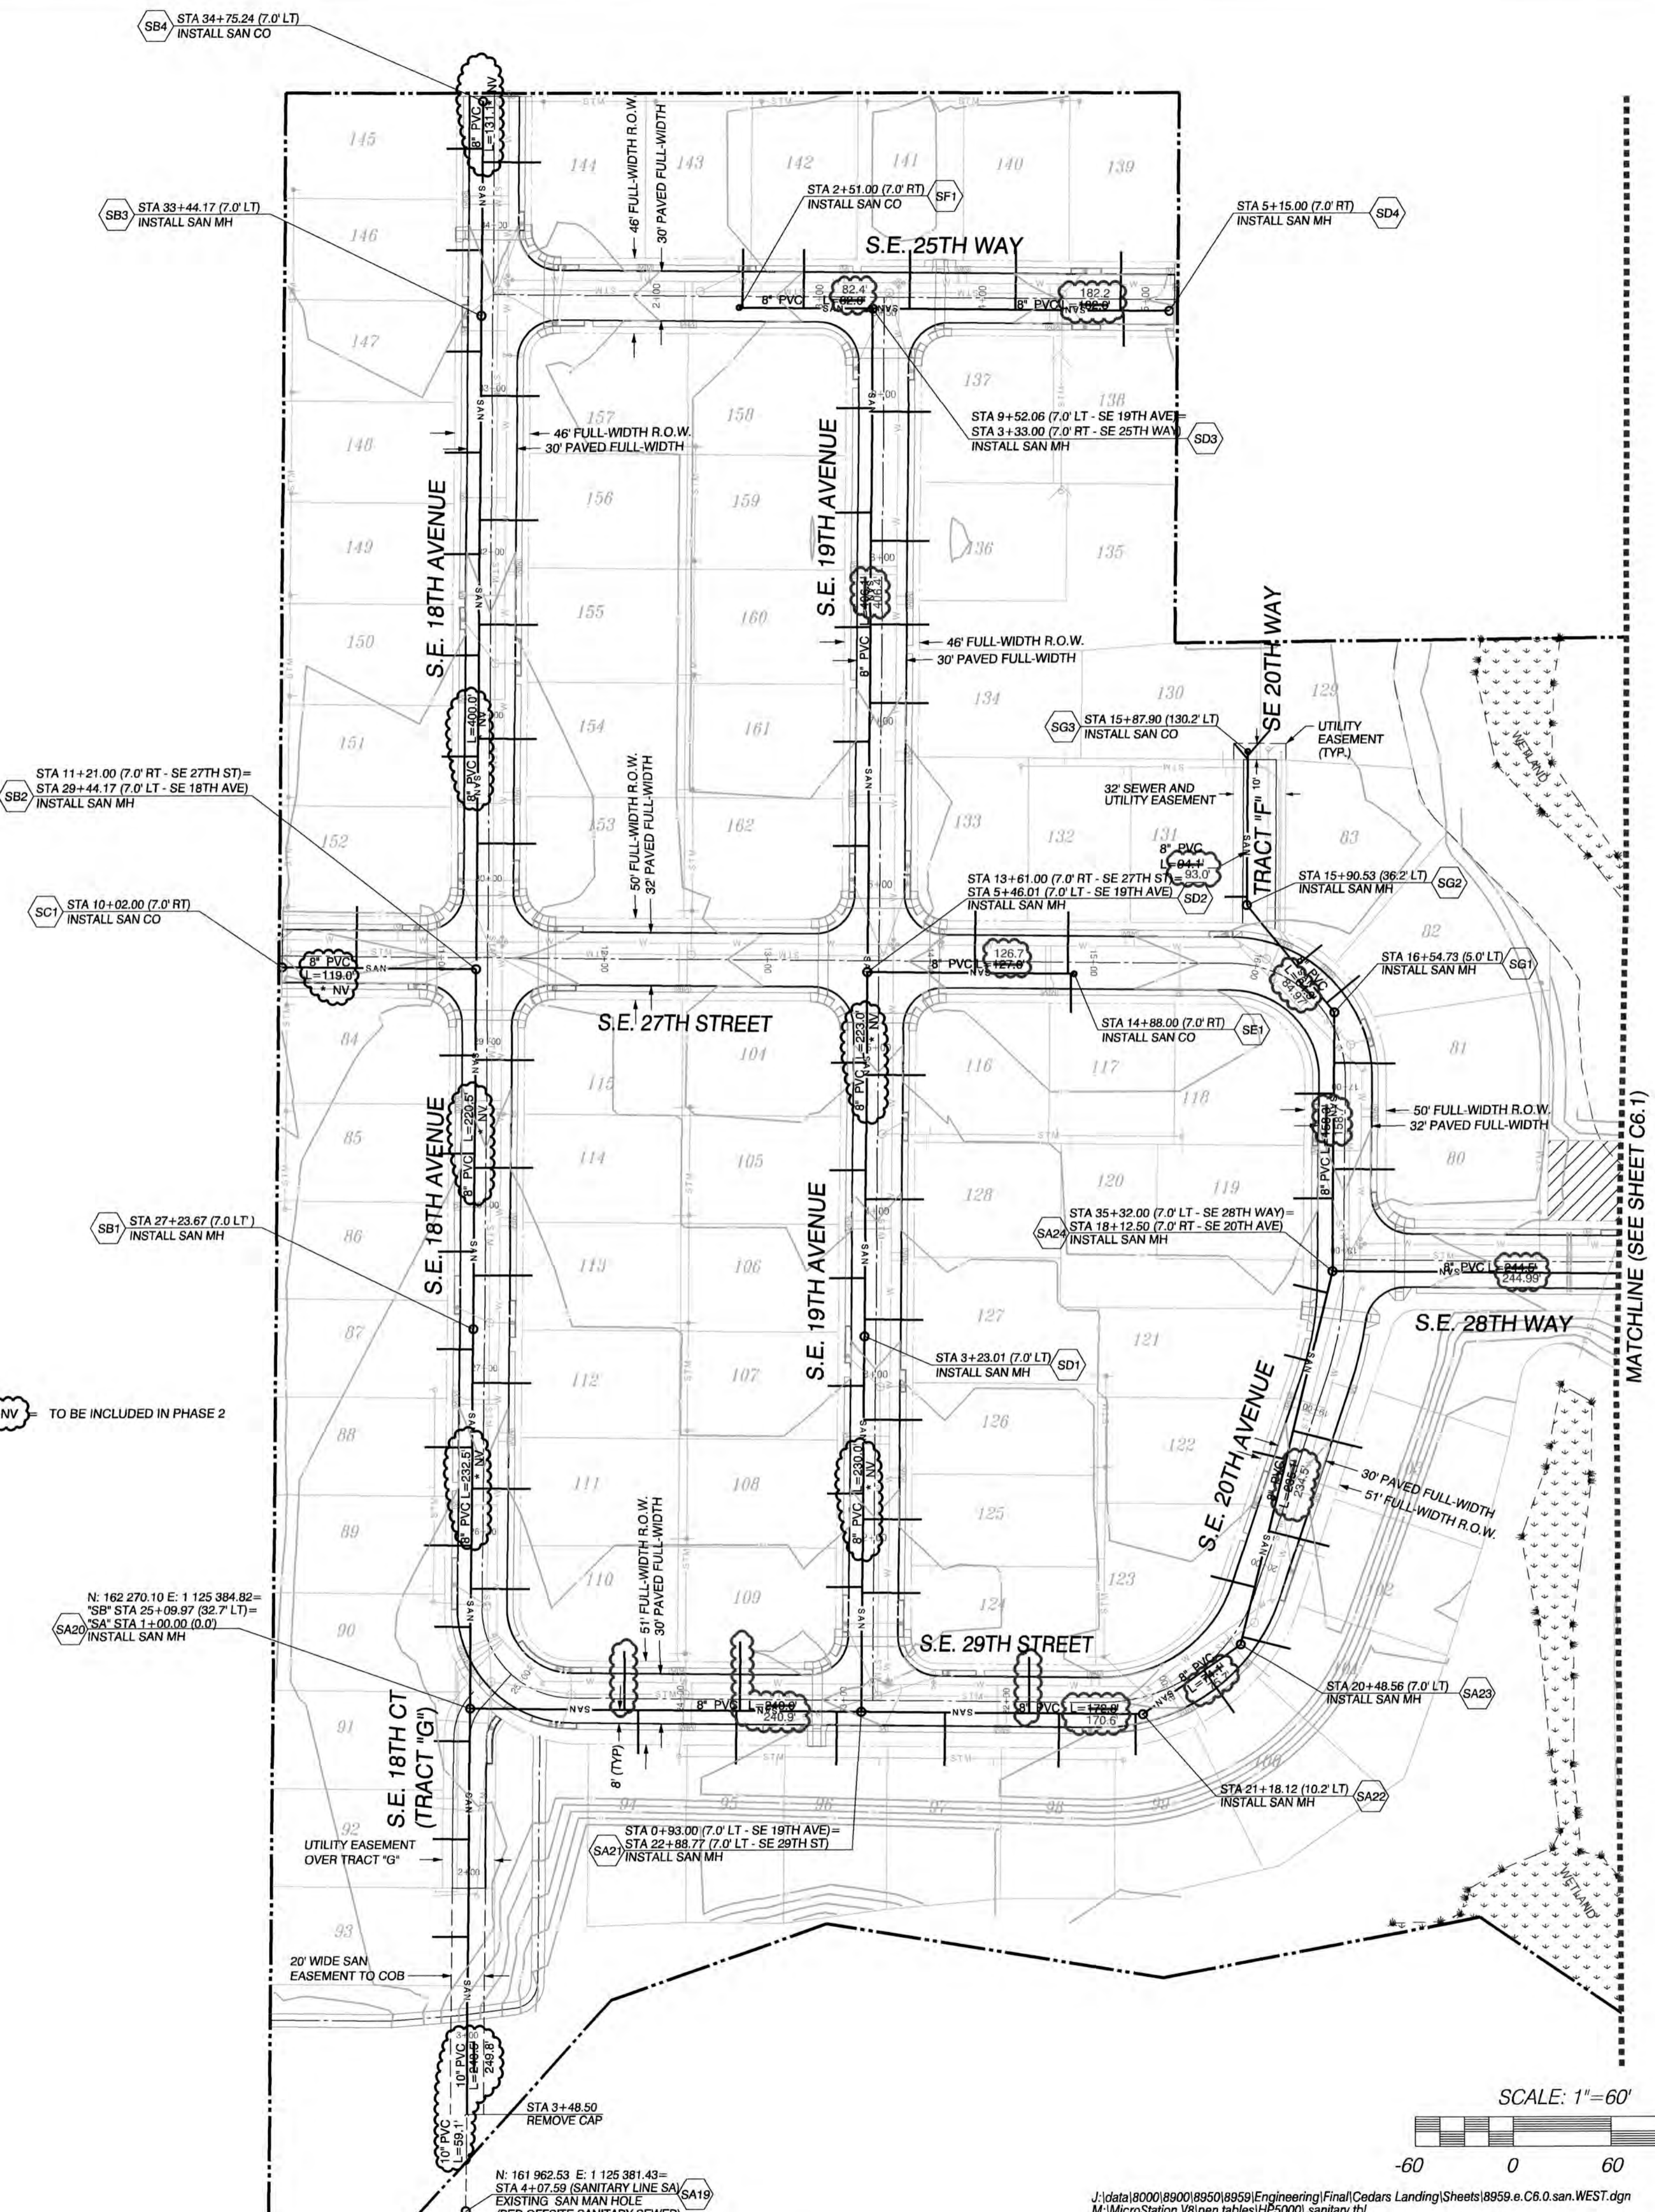
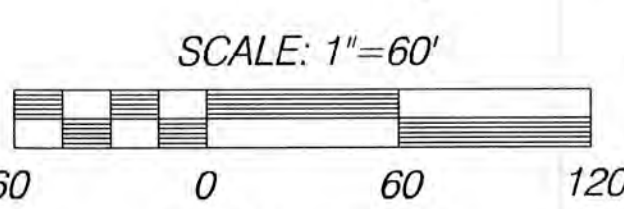
J:\data\8000\8900\8950\8959\Engineering\Final\Cedars Landing\Sheets\8959.e.C6.0.san.WEST.dgn
 M:\MicroStation\89\plan\tables\HP\89000_sanitary.tbl

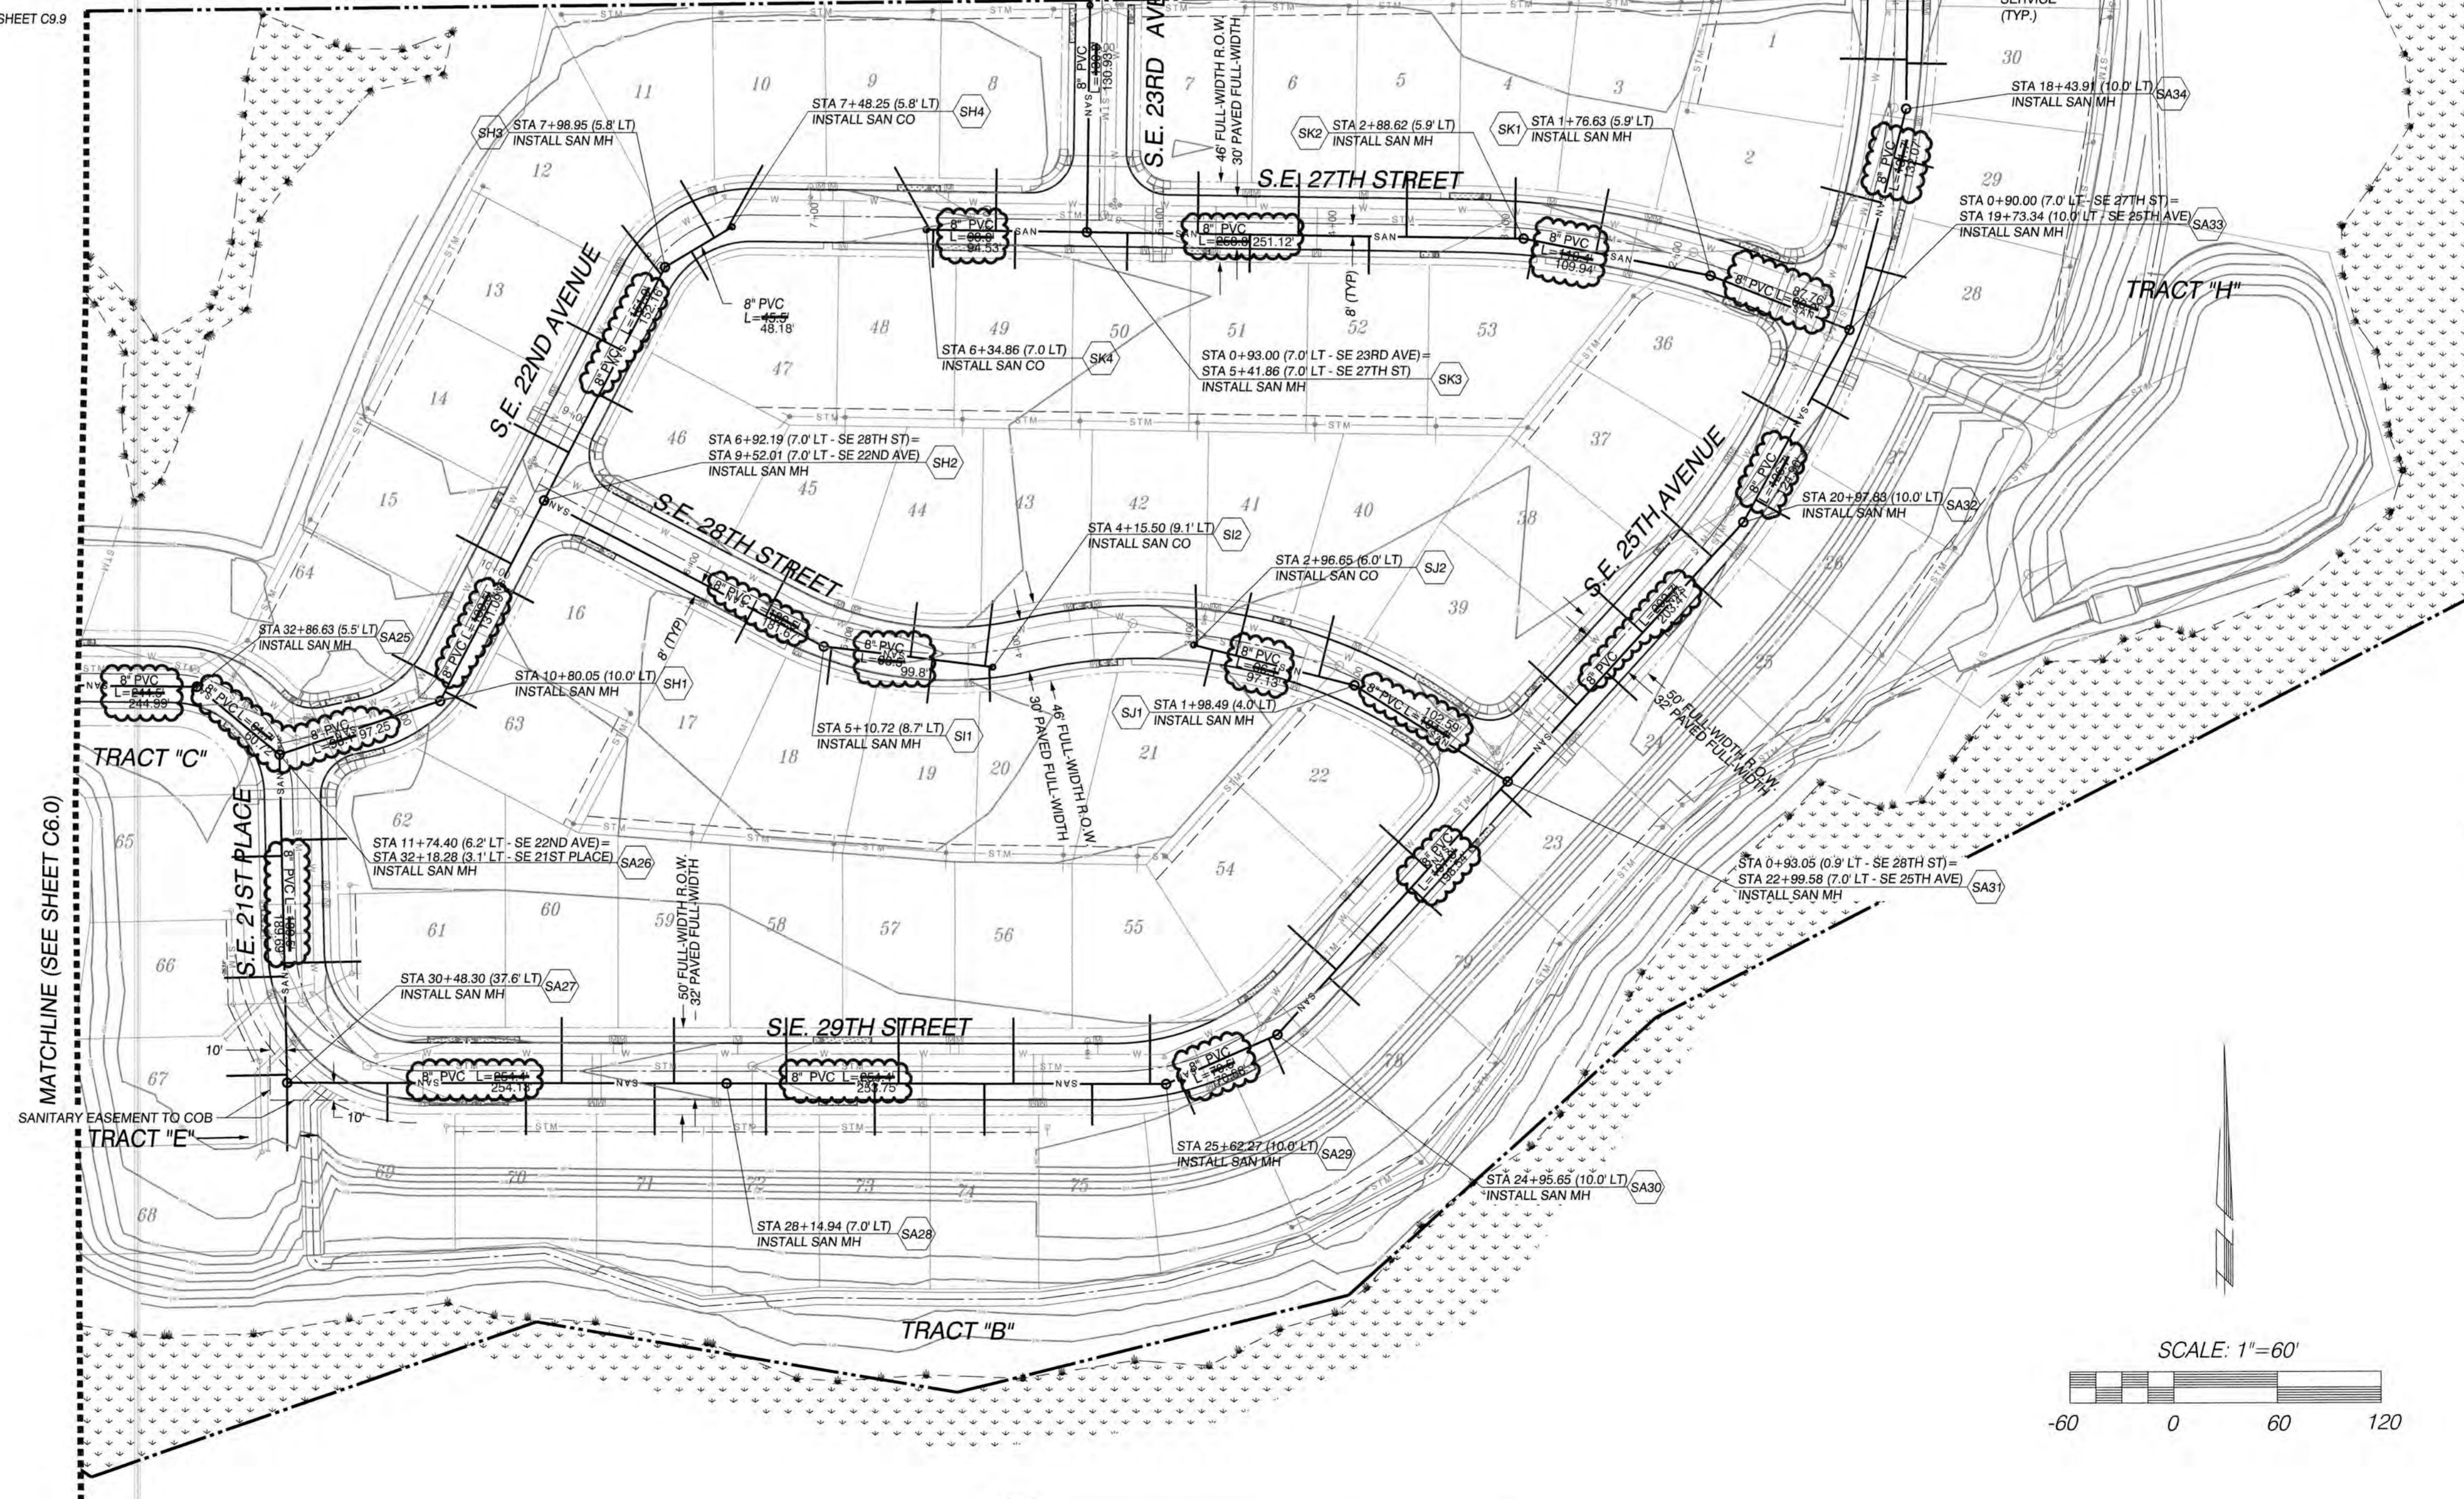
- NOTE:
- SEE C.O.B. STD. NOTES AND DETAILS FOR PIPE, LATERALS, MANHOLES AND CLEANOUT INSTALLATION ON SHEETS C9.8 AND C9.9.
 - ALL PVC SANITARY MAINS TO BE 3034 PVC.

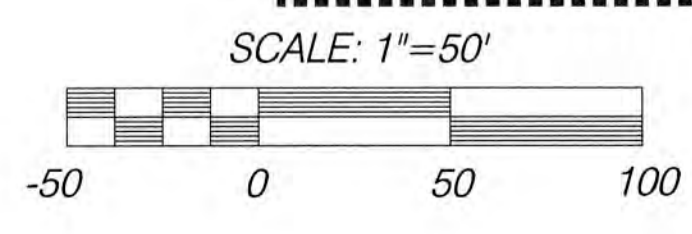
J:\data\8000\8900\8950\8959\Engineering\Final\Cedars Village\Design\Asbuilts\8959.e.C6.0.san.north.ASBUILT20180711.dgn
 M:\MicroStation V8i\pen\tablets\OCE\table\setup\OCE_sanitary.tbl

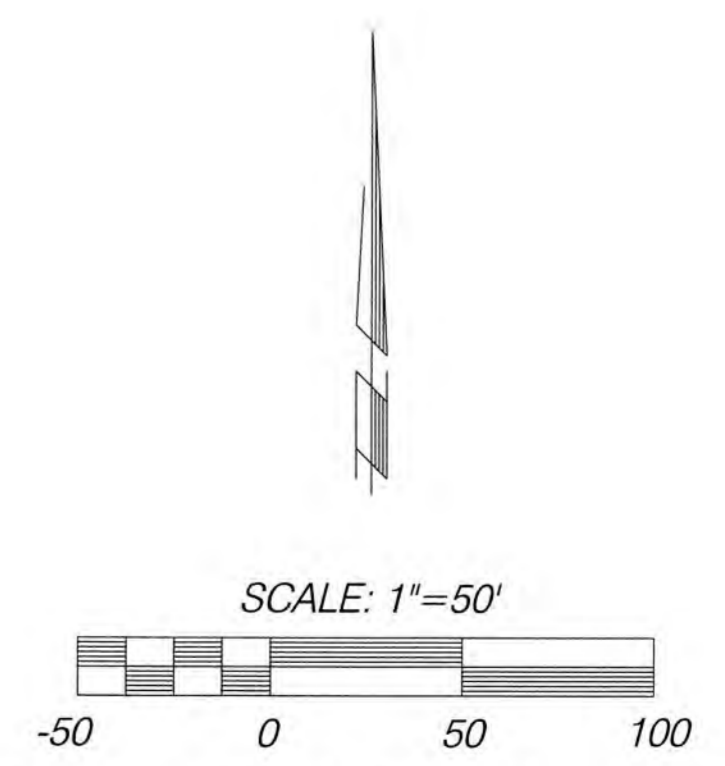
J:\data\8000\8900\8959\Engineering\Final\Cedars Village\Design\Asbuilts\8959.e.c6.3.san.west.ASBUILT20180711.dgn
 M:\MicroStation V8\pen tables\OC table setup\OC sanitary.tbl

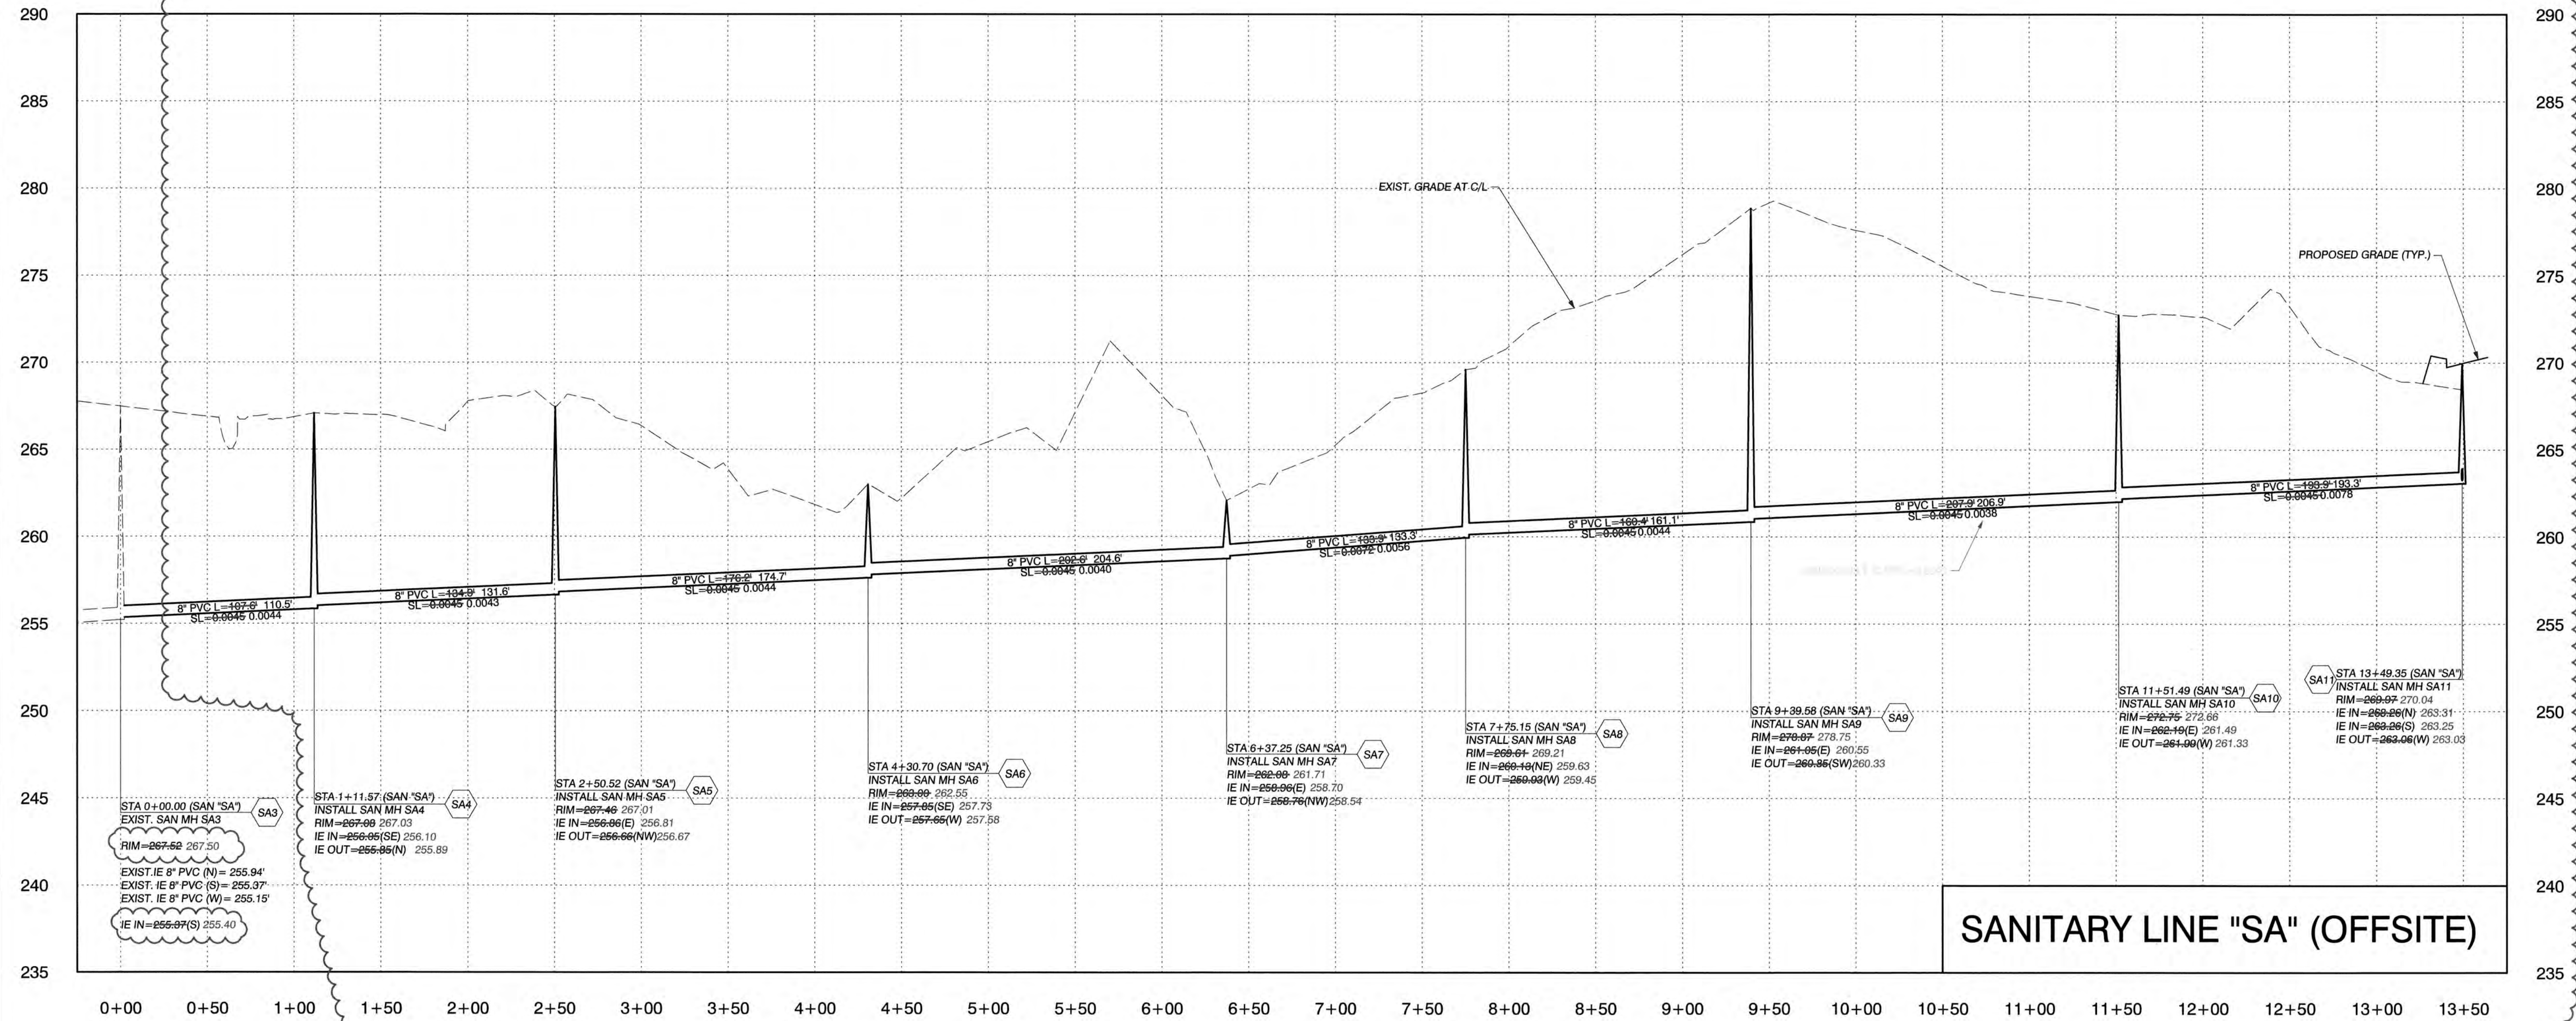
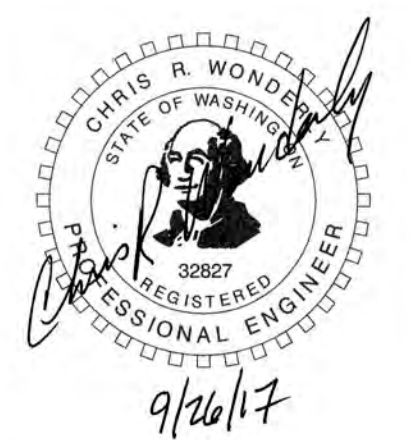
CHANGES / REVISIONS	
DESCRIPTION:	DATE:
REVISE IE'S FOR SA5 - SA9	1/25/2018

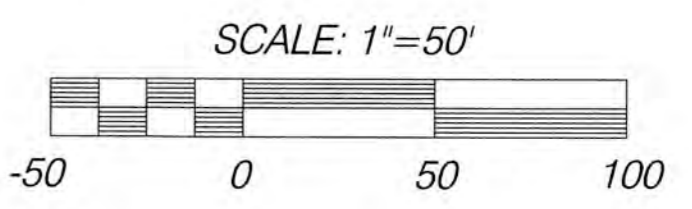
J:\data\180001\89001\89501\Engineering\Final\Cedars Village\Design\Asbuilts\8959.e.C8.0.profile sheets.ASBUILTS20180711.dgn
 M:\MicroStation V8i\pen tables\OC table setup\OC utilities.tbl

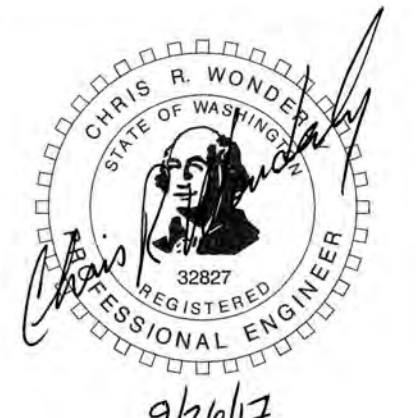
THIS STAMP APPLIES TO THE HORIZONTAL AND VERTICAL AS-BUILT INFORMATION SHOWN ON THIS SHEET ONLY BY:

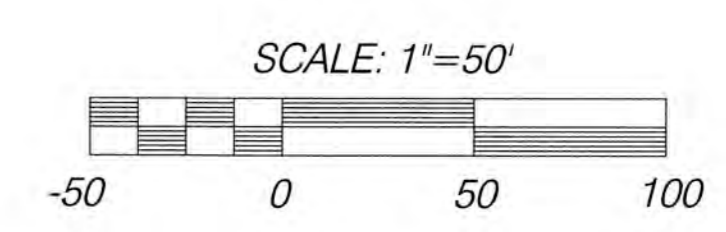
J:\data\8000\8900\8950\8959\Engineering\Final\Cedars Village\Design\Asbuilts\8959.e.C8.0.profile sheets.ASBUILTS20180711.dgn
 M:\MicroStation V8\pen tables\OCE table setup\OCE utilities.tbl

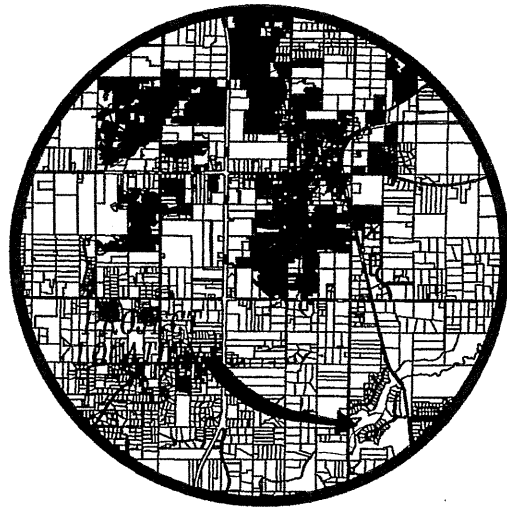
VICINITY MAP
SCALE: 1"=4000'

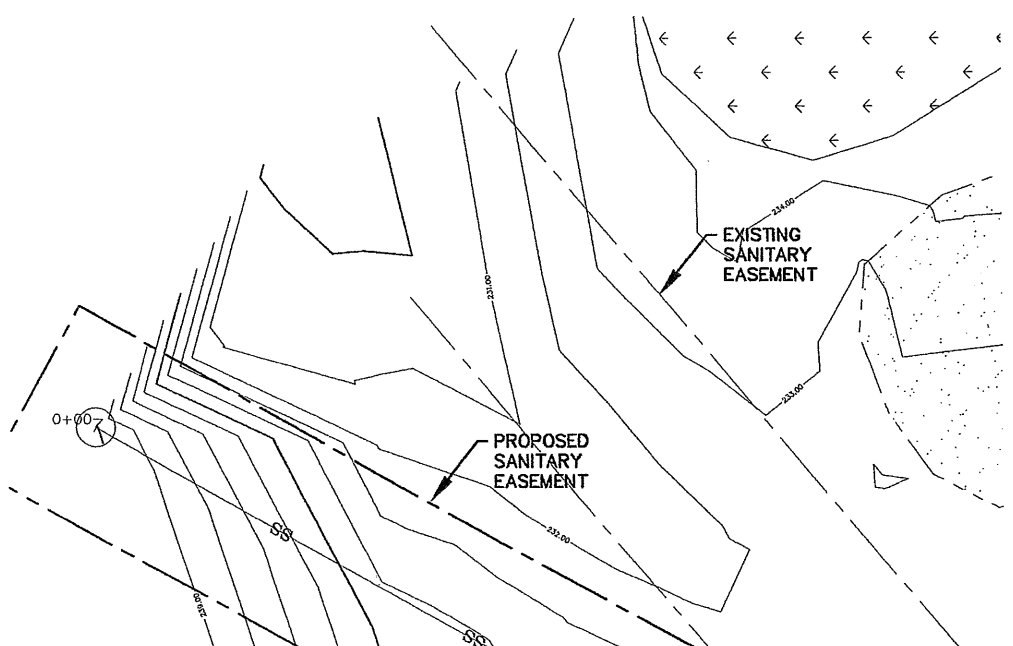
EROSION CONTROL GENERAL NOTES ER-1.0

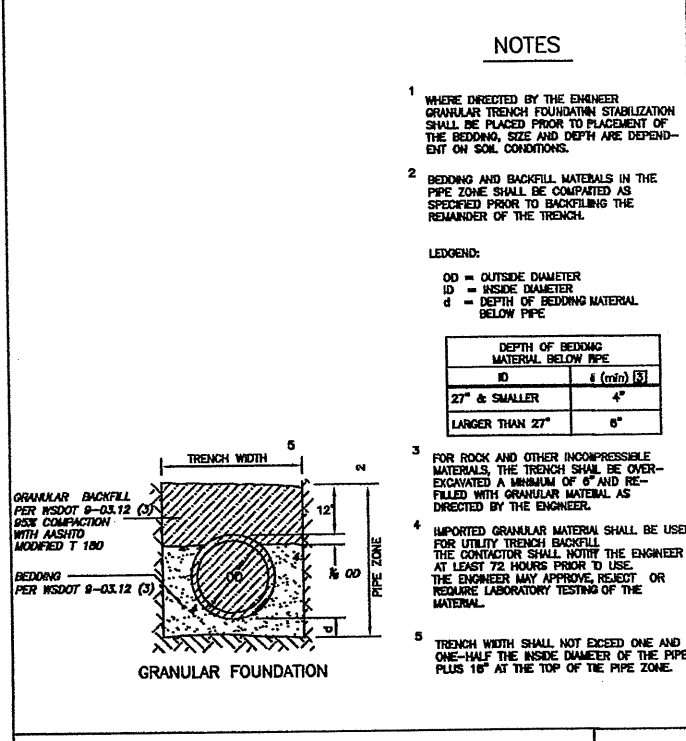
- NOTES:**
- WHERE DICTATED BY THE ENGINEER GRANULAR TRENCH FOUNDATION STABILIZATION SHALL BE PLACED PRIOR TO PLACEMENT OF THE BEDDING, SIZE AND DEPTH ARE DEPENDENT ON SOIL CONDITIONS.
 - BEDDING AND BACKFILL MATERIALS IN THE PIPE ZONE SHALL BE COMPACTED AS SPECIFIED PRIOR TO BACKFILLING THE REMAINDER OF THE TRENCH.
 - FOR ROCK AND OTHER INCOMPRESSIBLE MATERIALS, THE TRENCH SHALL BE OVER-EXCAVATED A MINIMUM OF 6" AND RE-FILLED WITH GRANULAR MATERIAL AS DICTATED BY THE ENGINEER.
 - IMPORTED GRANULAR MATERIAL SHALL BE USED FOR UTILITY TRENCH BACKFILL. THE CONTRACTOR SHALL NOTIFY THE ENGINEER AT LEAST 72 HOURS PRIOR TO USE. THE ENGINEER MAY APPROVE, REJECT OR REQUIRE LABORATORY TESTING OF THE MATERIAL.
 - TRENCH WIDTH SHALL NOT EXCEED ONE AND ONE-HALF THE INSIDE DIAMETER OF THE PIPE PLUS 16" AT THE TOP OF THE PIPE ZONE.

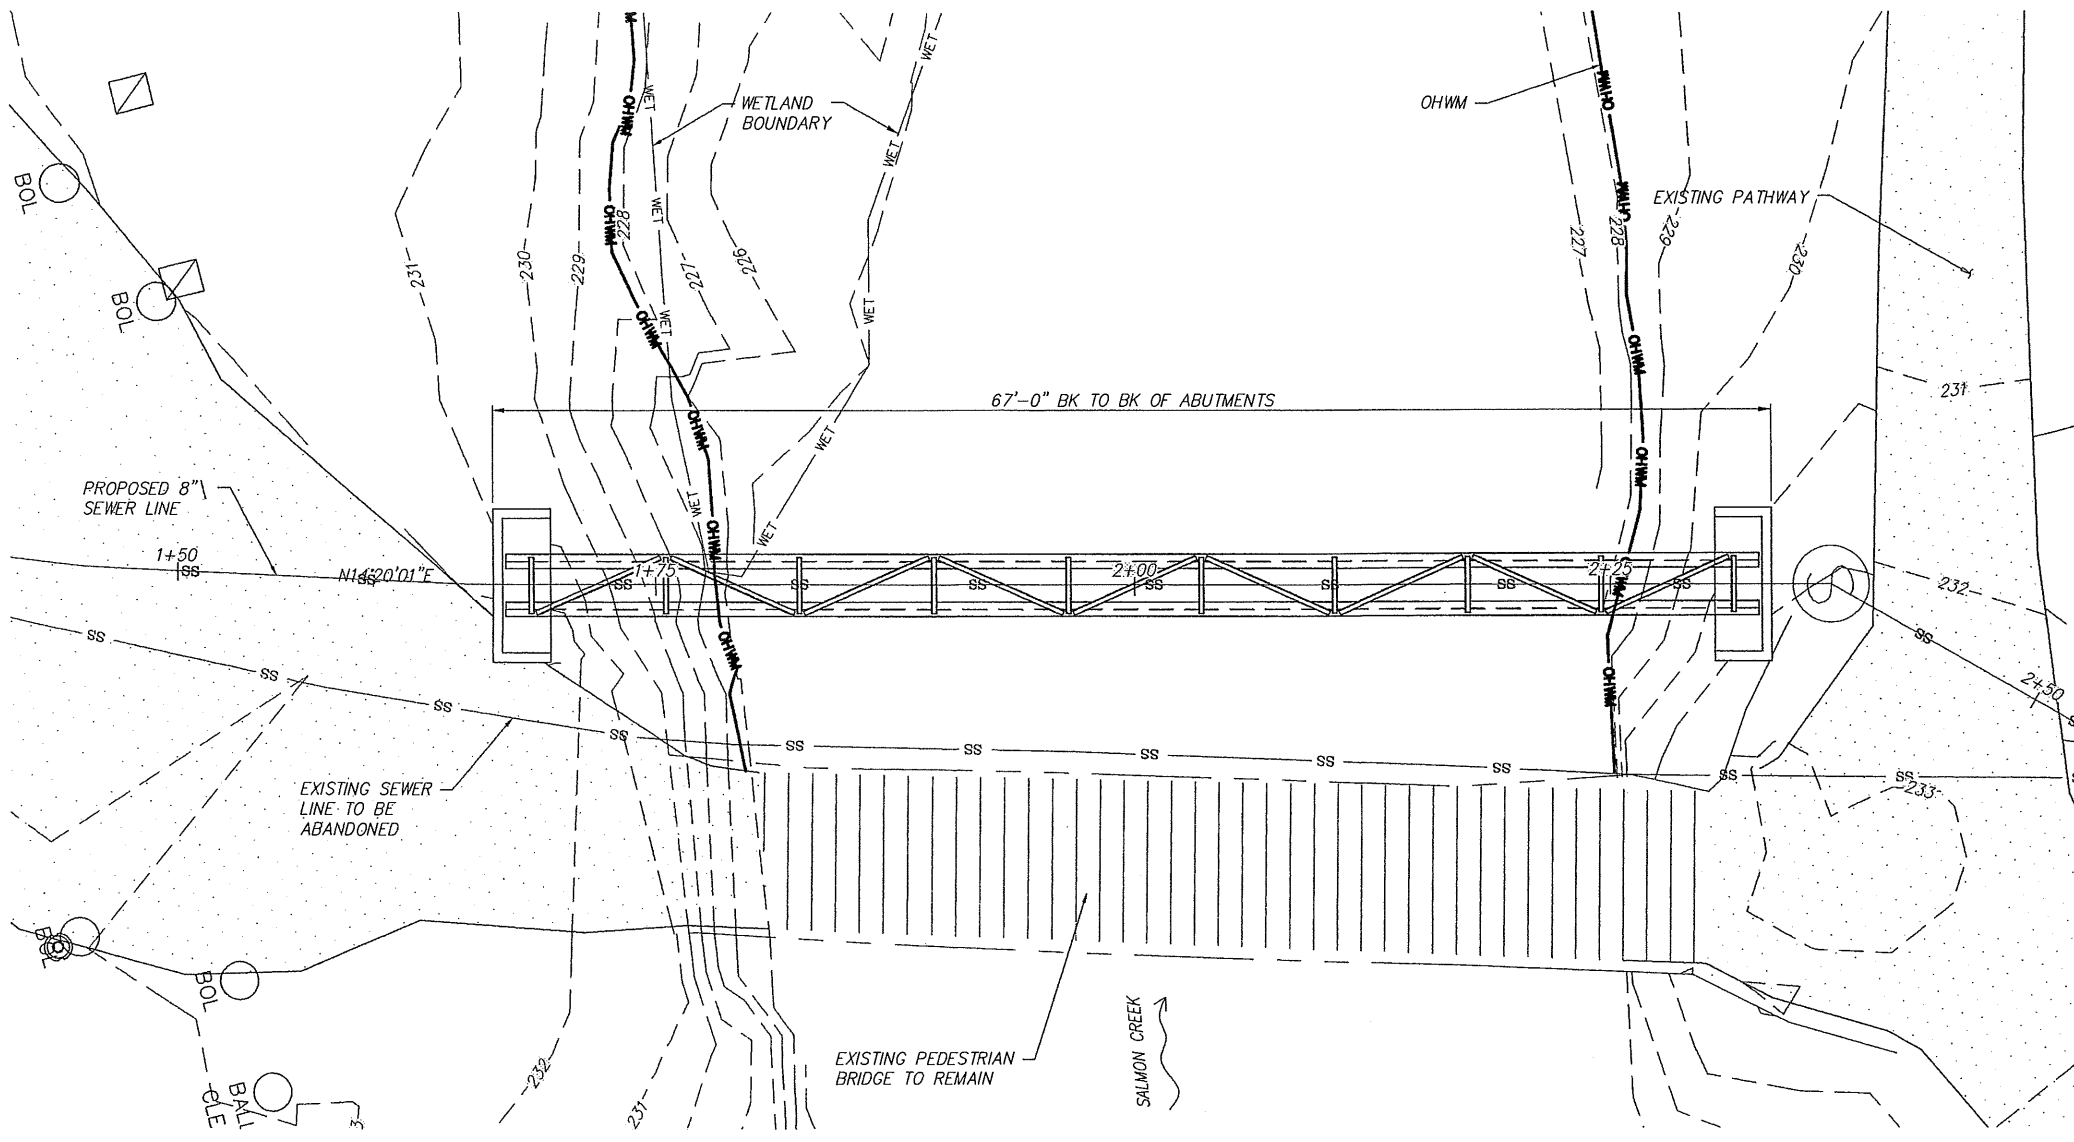
A
B01 BRIDGE PLAN
1"=5'-0"

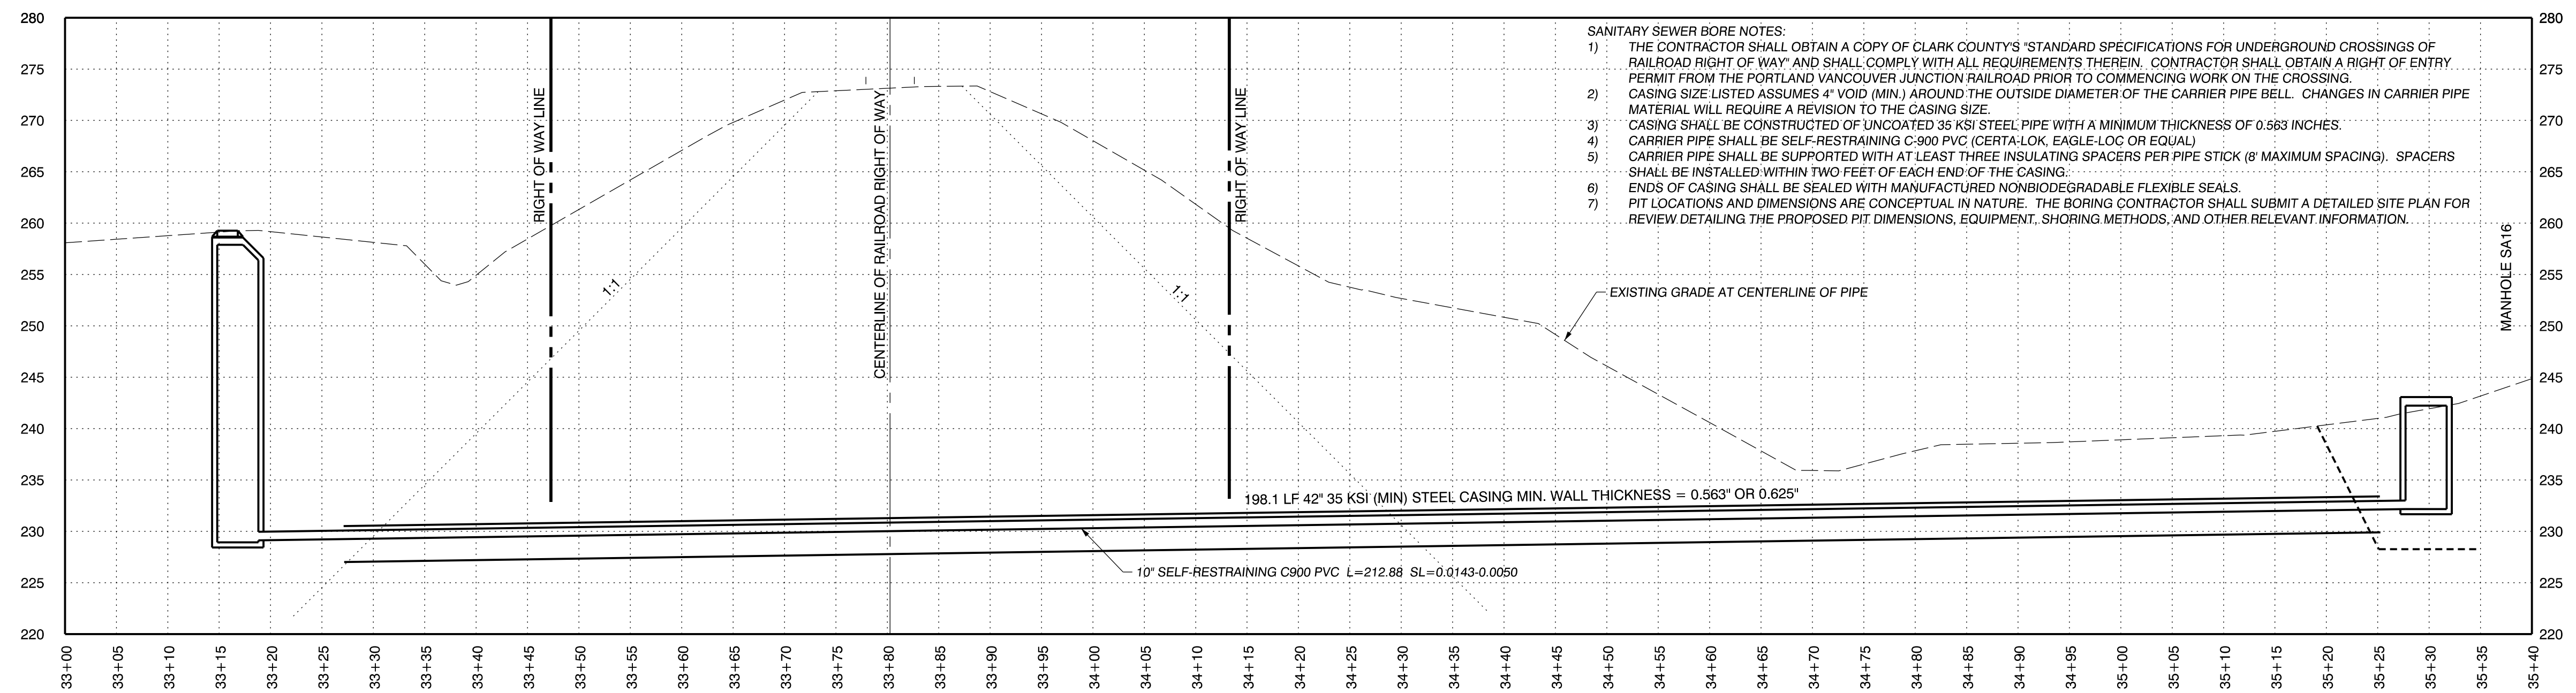
- SANITARY SEWER BORE NOTES:**
- 1) THE CONTRACTOR SHALL OBTAIN A COPY OF CLARK COUNTY'S "STANDARD SPECIFICATIONS FOR UNDERGROUND CROSSINGS OF RAILROAD RIGHT OF WAY" AND SHALL COMPLY WITH ALL REQUIREMENTS THEREIN. CONTRACTOR SHALL OBTAIN A RIGHT OF ENTRY PERMIT FROM THE PORTLAND VANCOUVER JUNCTION RAILROAD PRIOR TO COMMENCING WORK ON THE CROSSING.

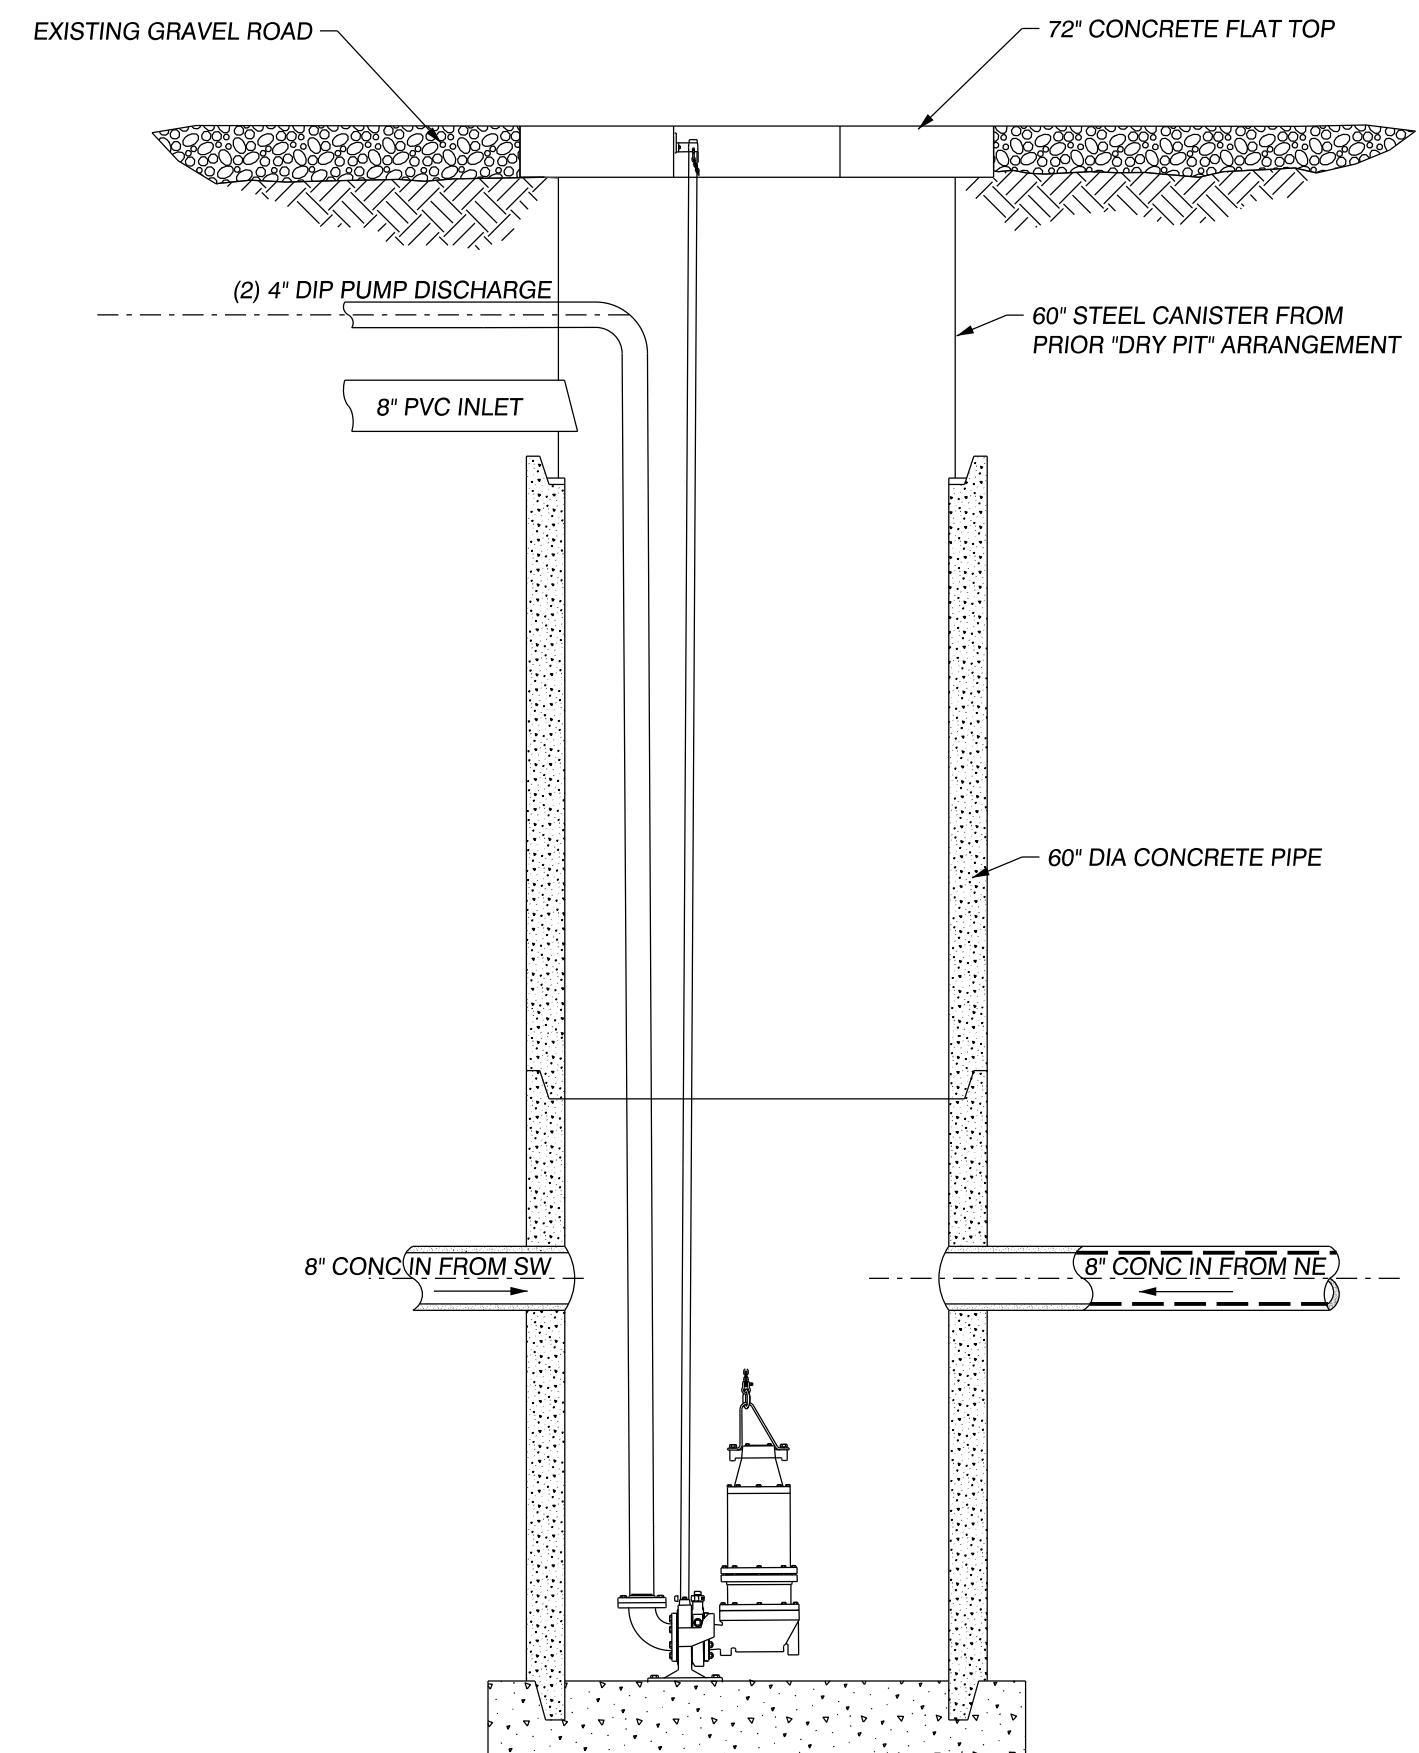
EXISTING CONDITION
NTS
