Project Background Information

Salmon Creek Reconnection Design – Project area map
Landowner: Clark County
Project sponsor: Cowlitz Indian Tribe
SRFB # 23-1151

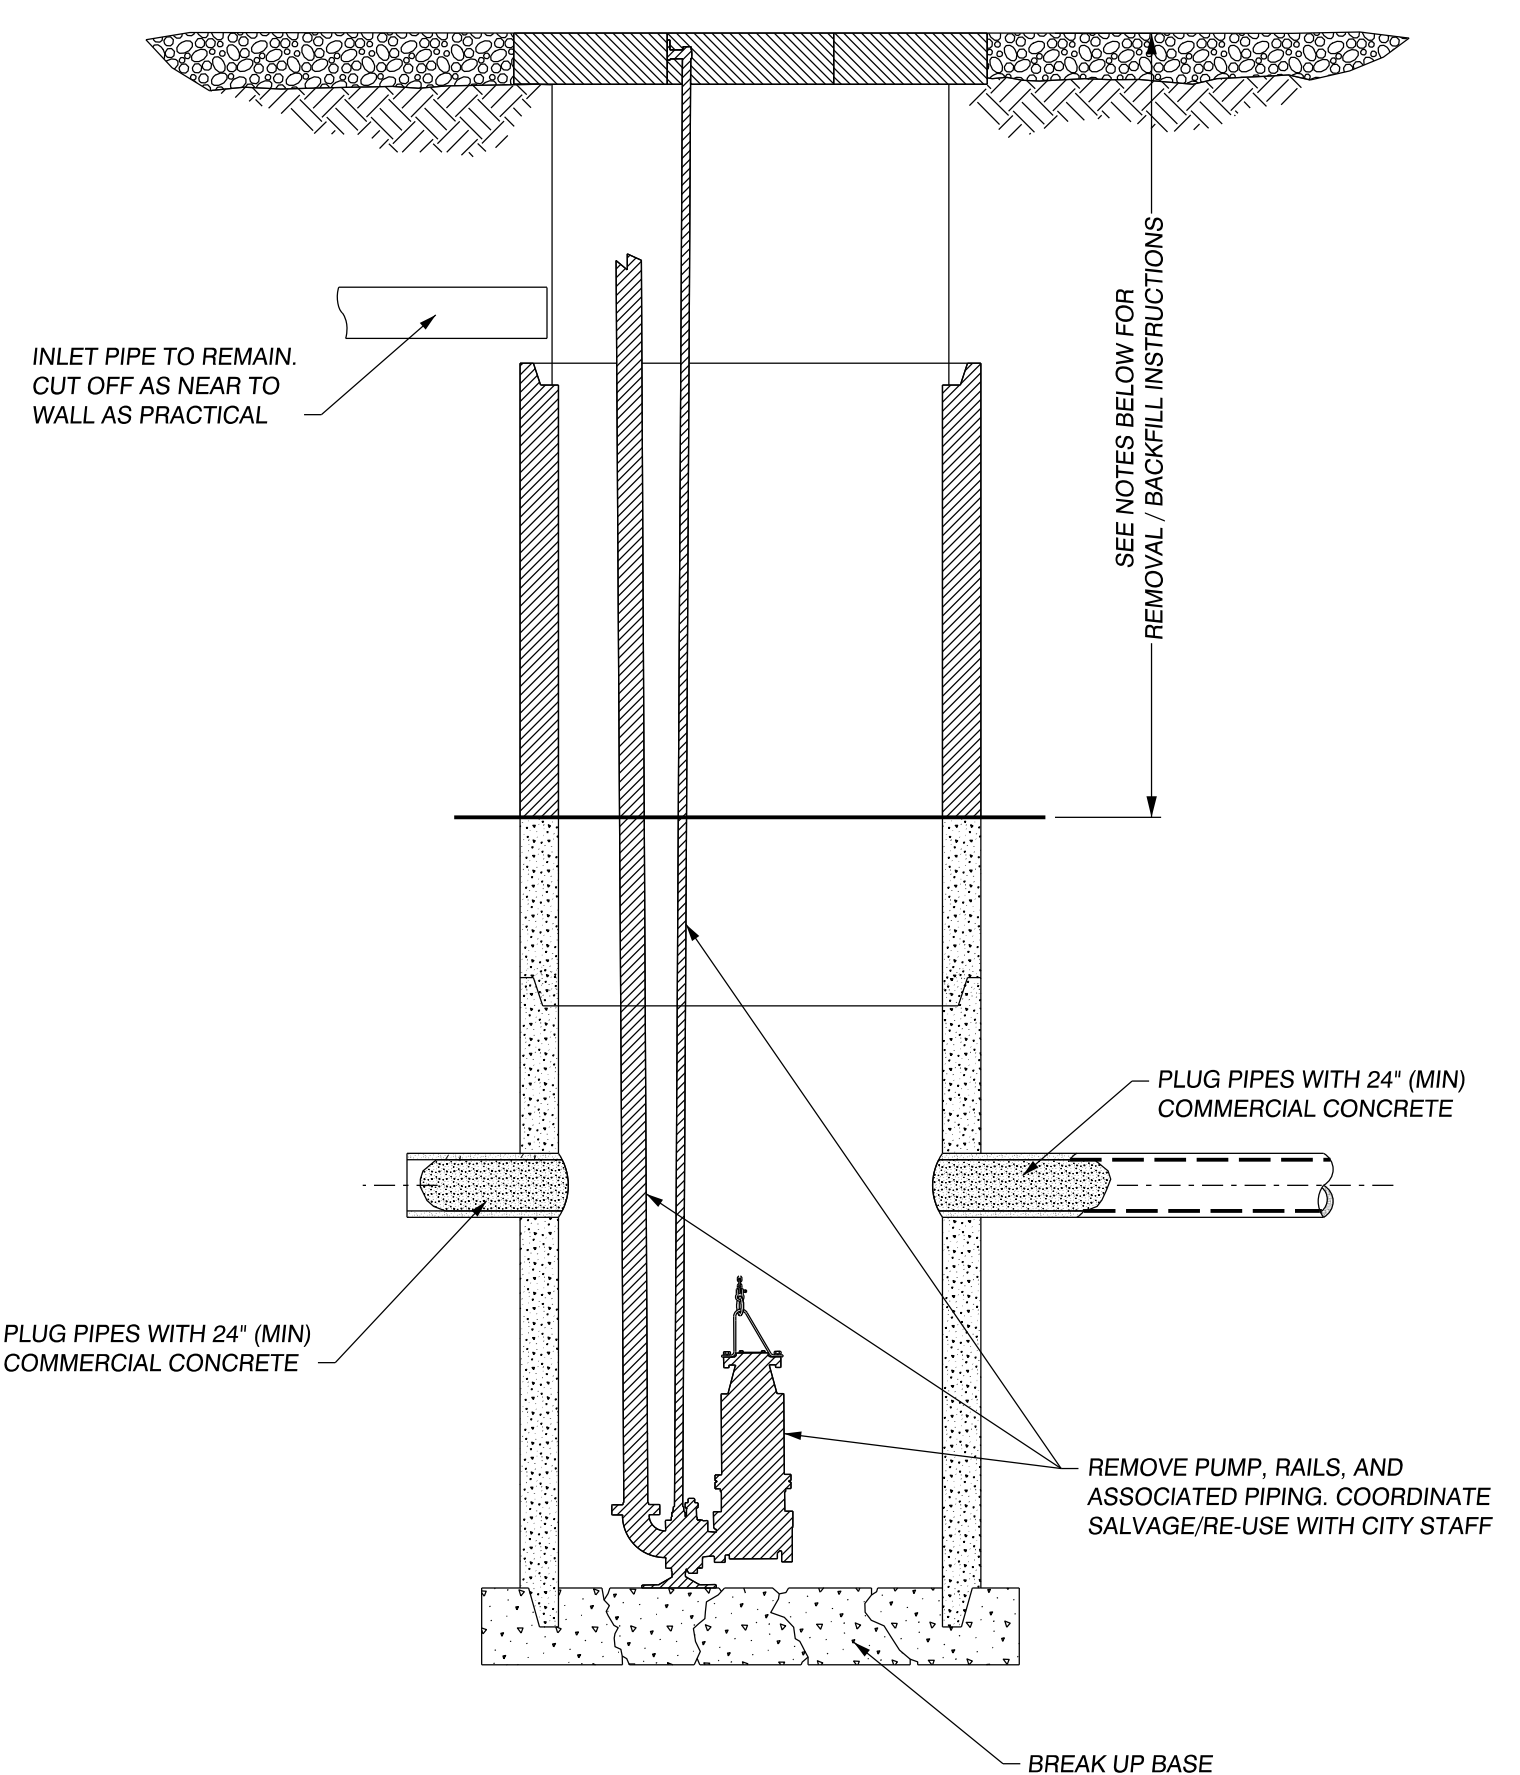
DEMOLITION PHASE
NTS

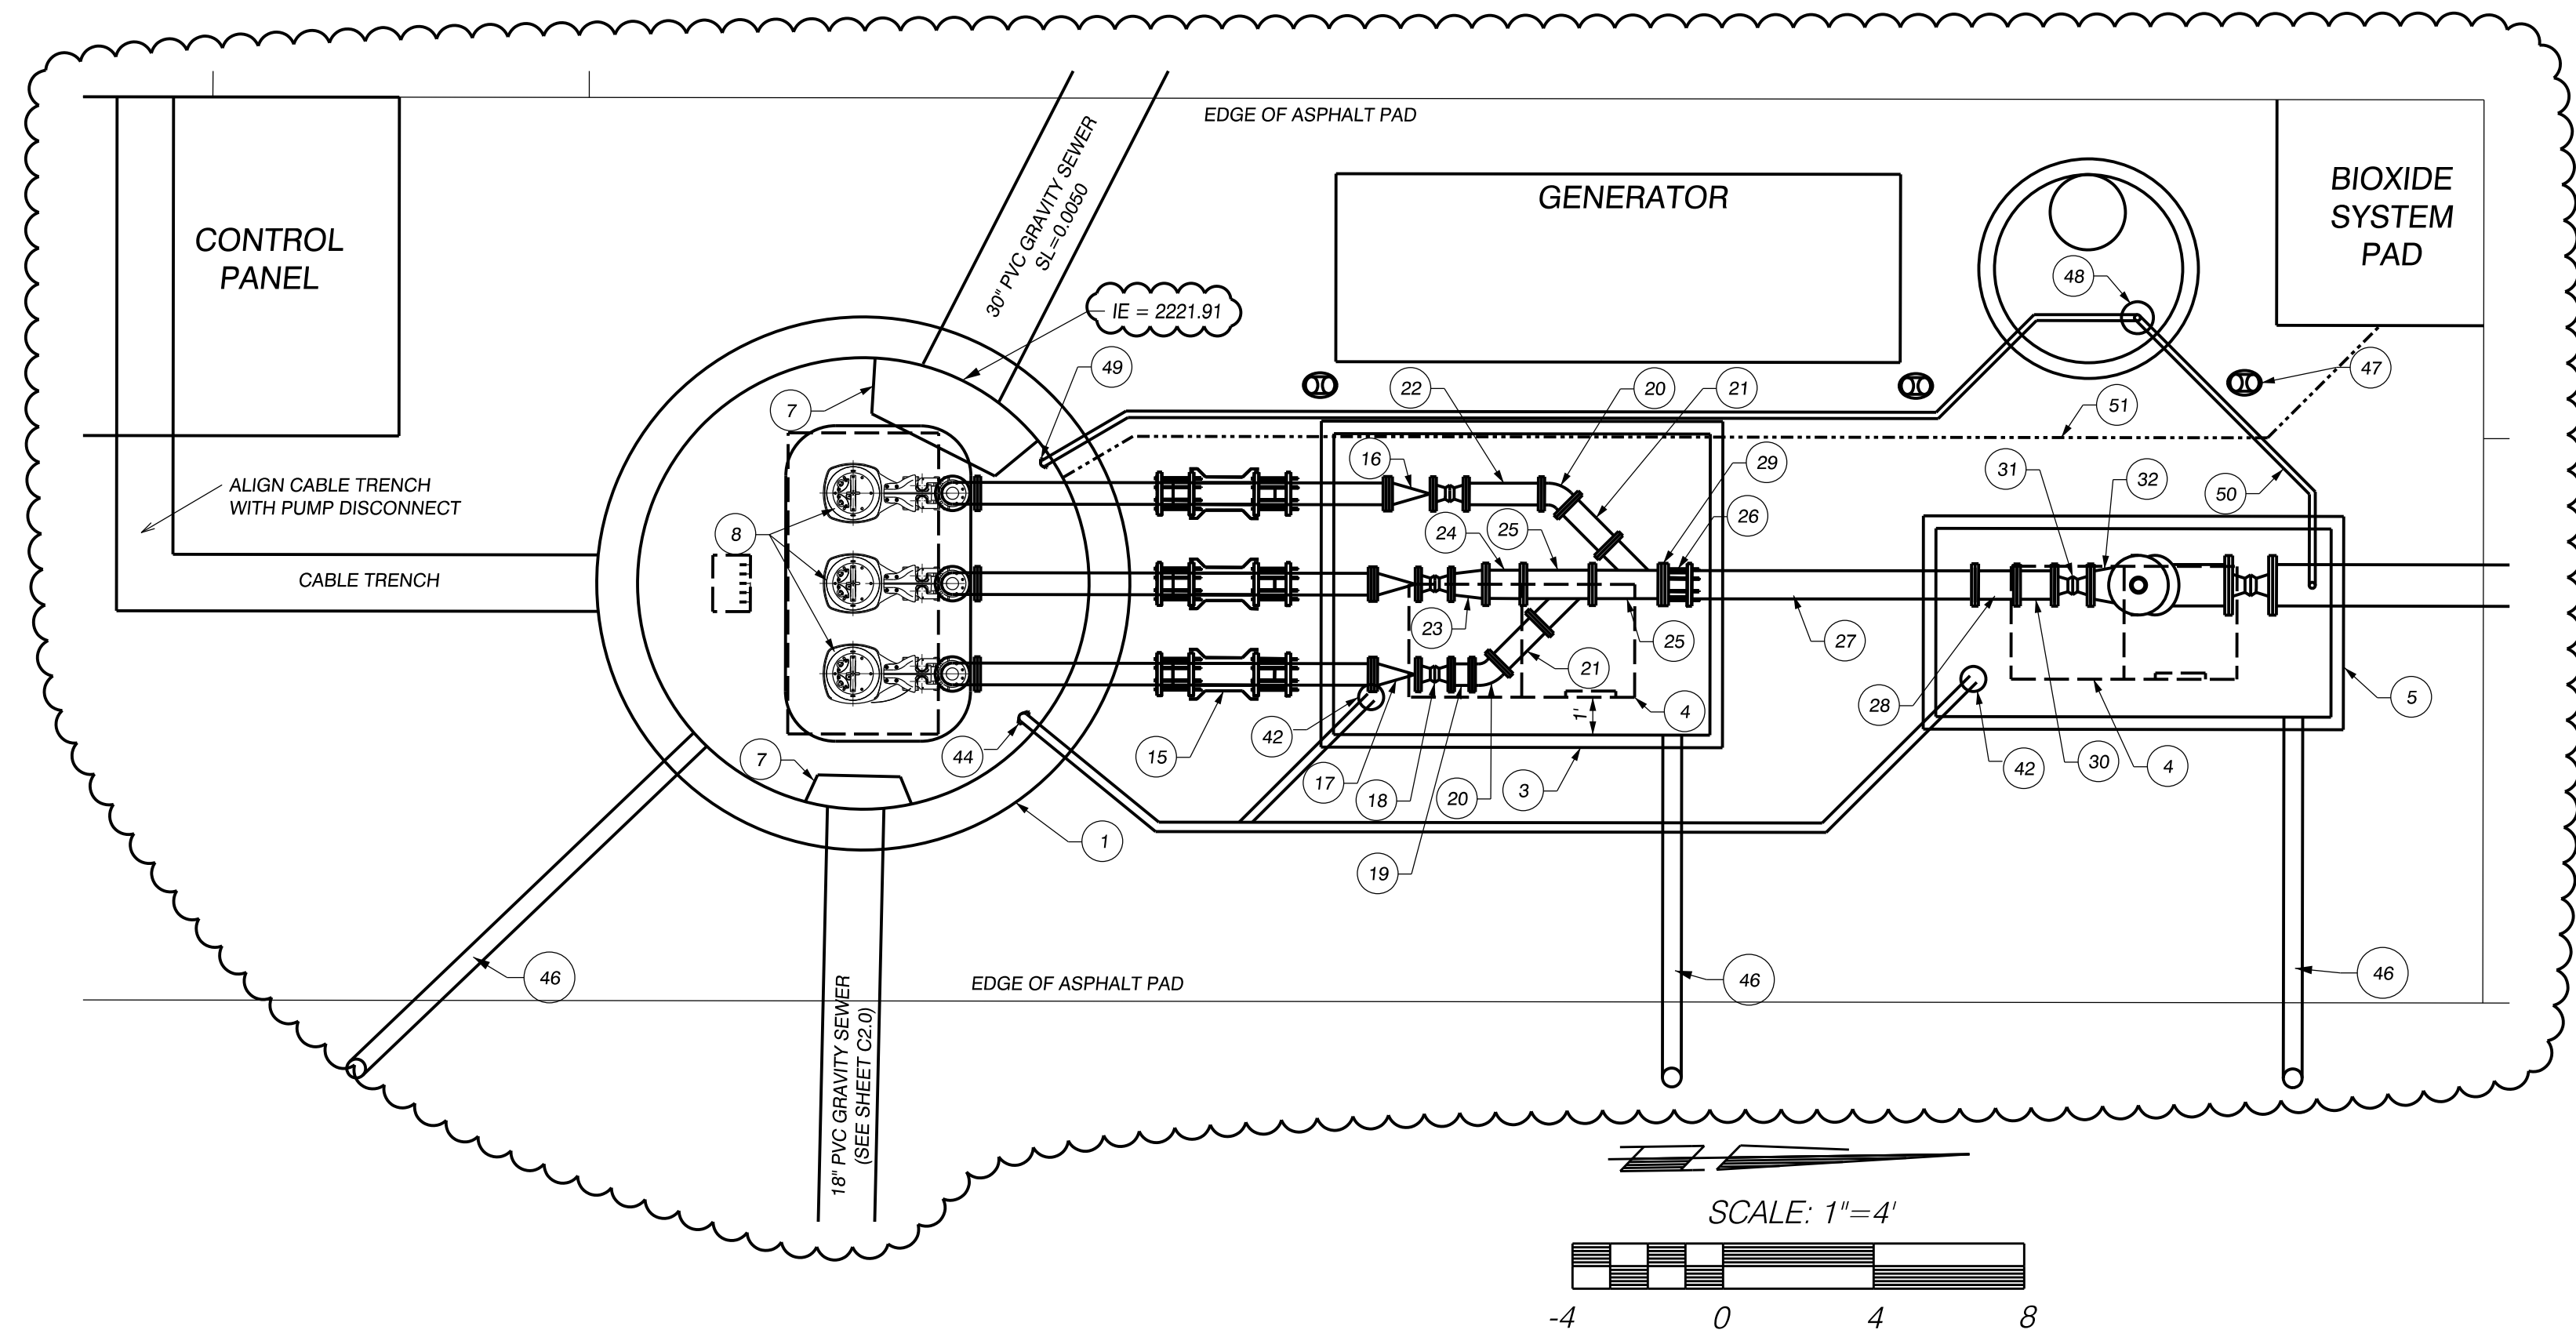
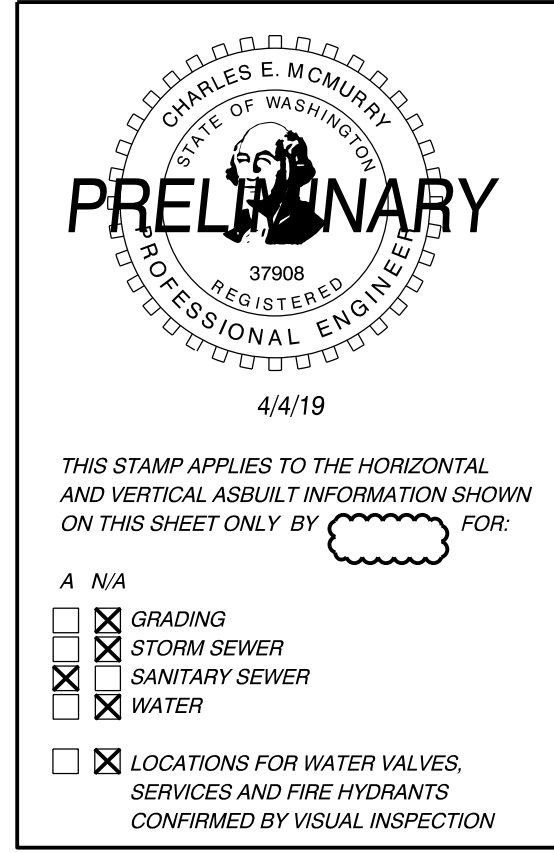
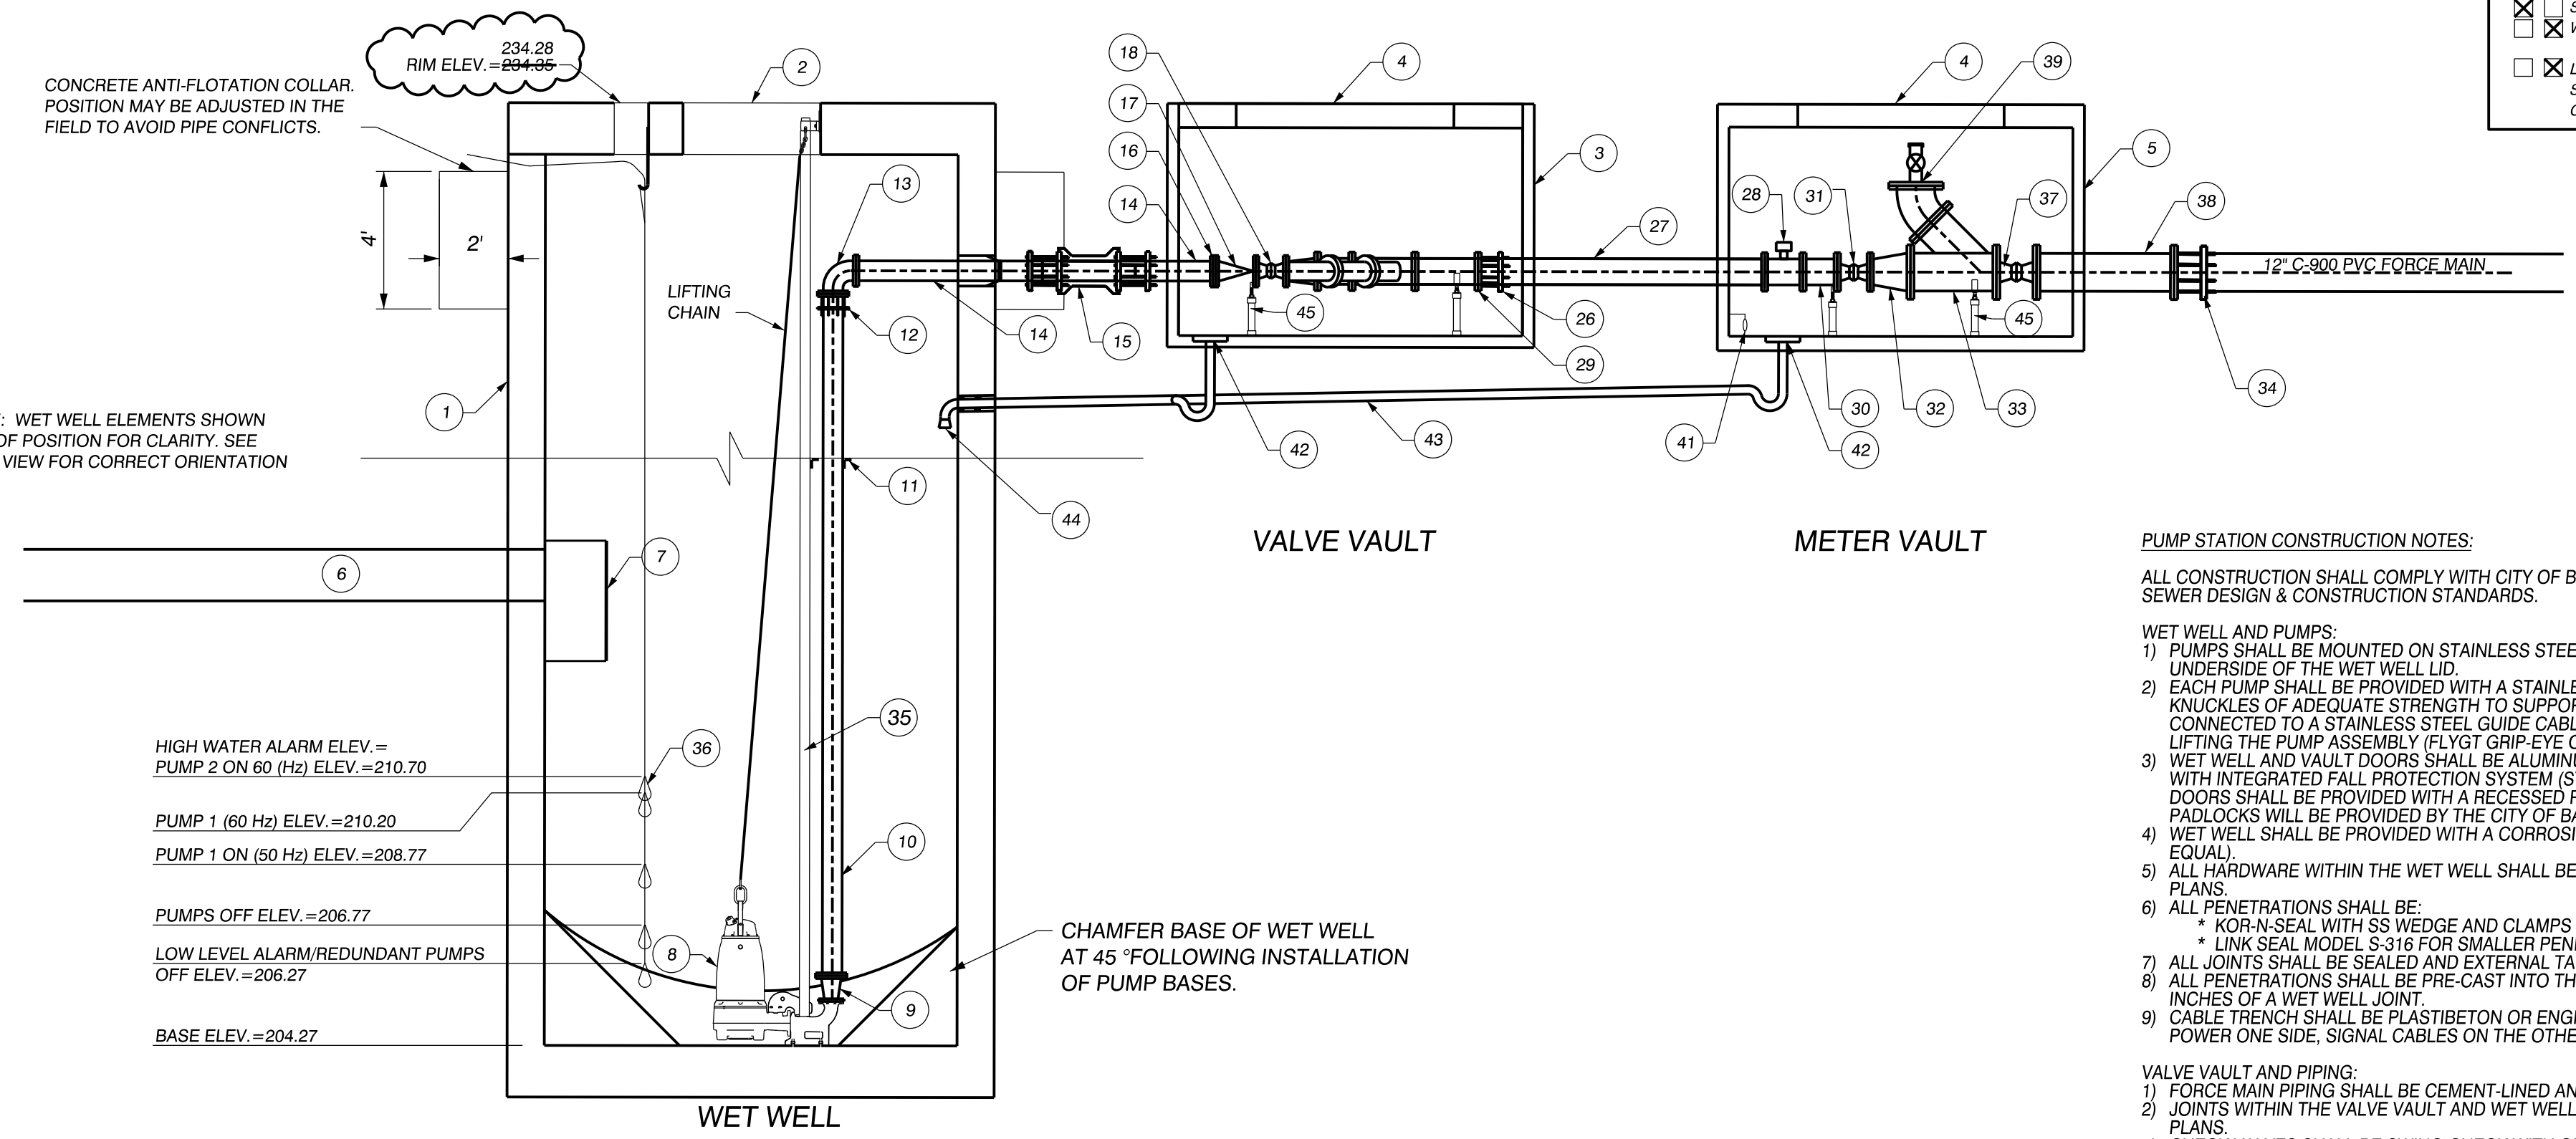
- PUMP STATION CONSTRUCTION NOTES:**
- ALL CONSTRUCTION SHALL COMPLY WITH CITY OF BATTLE GROUND WASTEWATER PUMP STATION AND PRESSURE SEWER DESIGN & CONSTRUCTION STANDARDS.

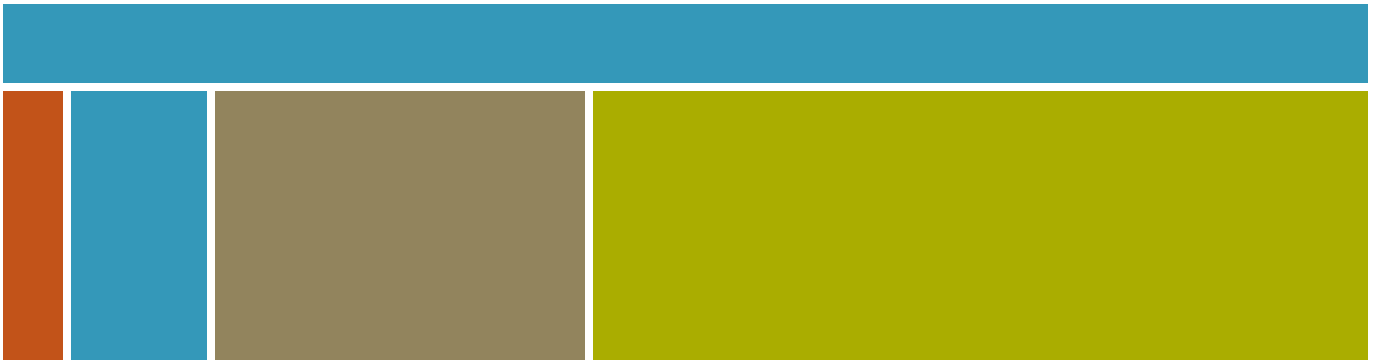
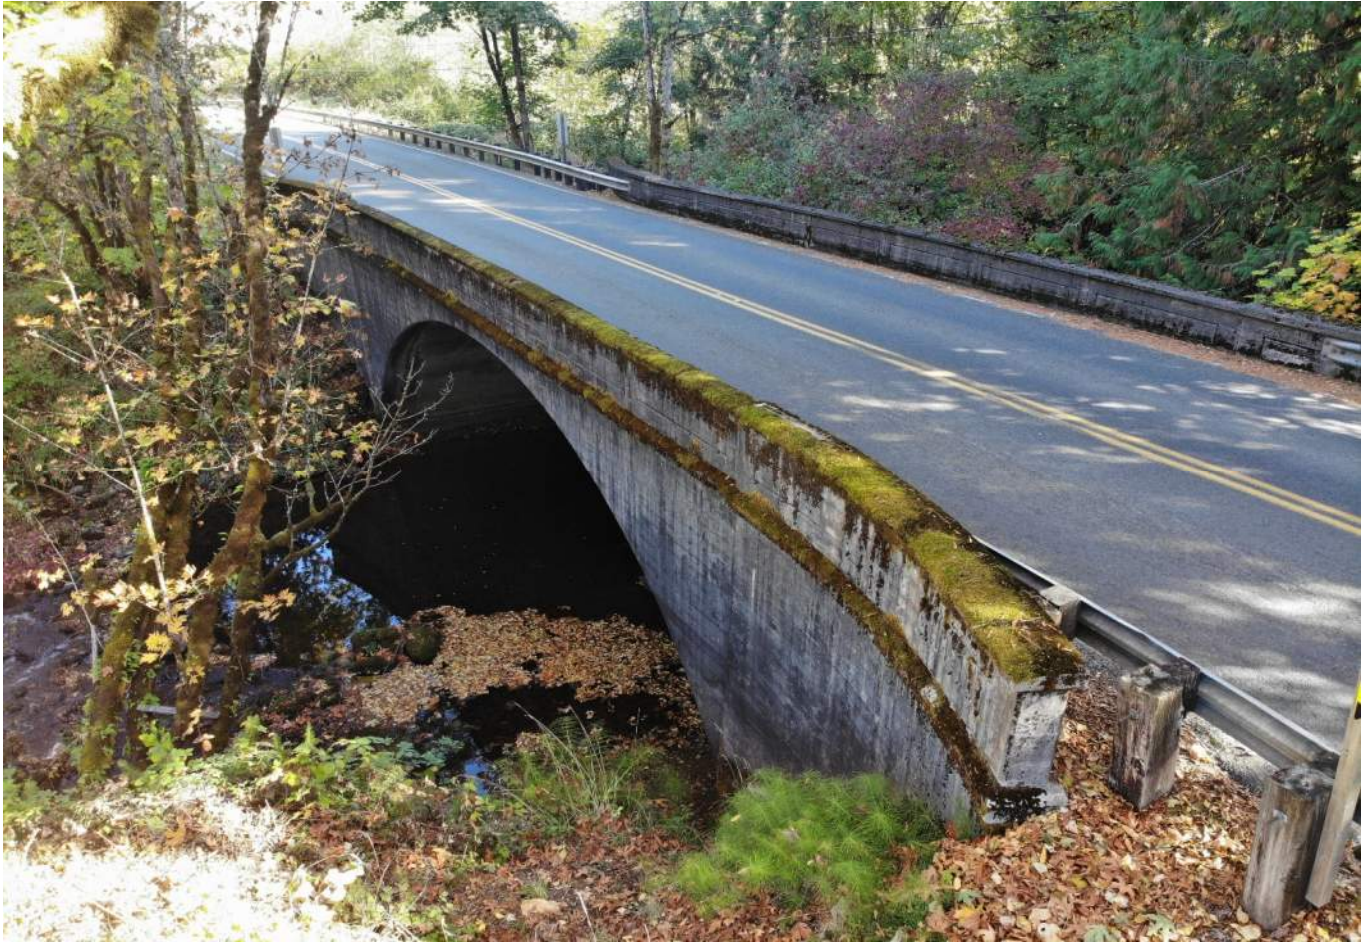
Salmon Creek Bridge Scour Repair Project

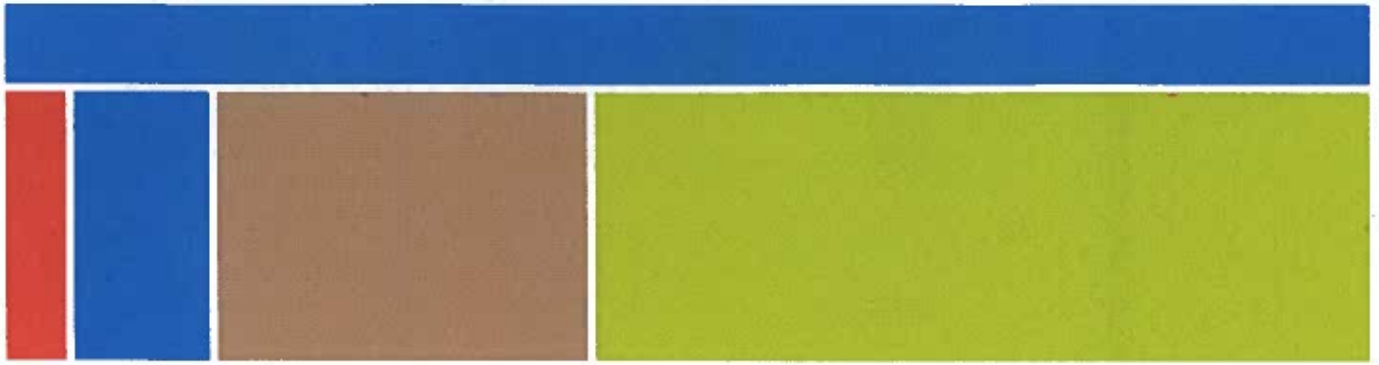
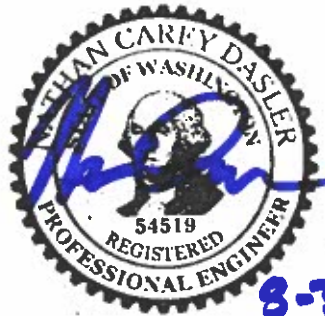
Salmon Creek Bridge Scour Repair Project

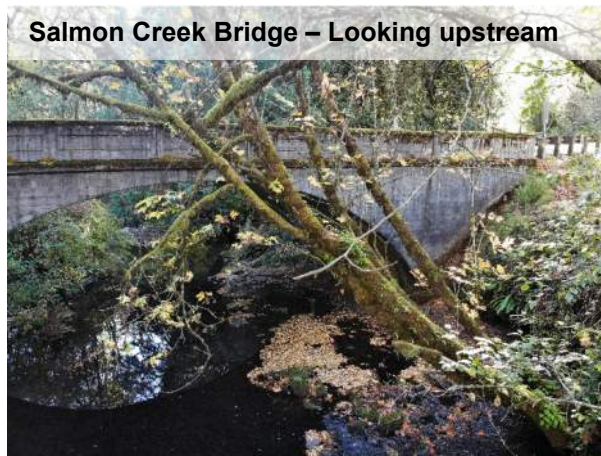
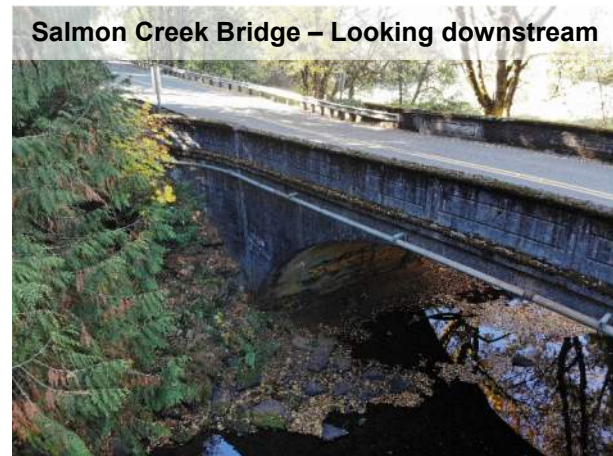
A Phase One and Two Scour Analysis was conducted by Vigil-Agrimis, Inc. in 2006. This analysis used hydraulic calculations to determine the bridge had a scour code of 5 indicating that the bridge foundations were stable. County bridge inspectors visually observed significant scour at both footings in 2016 and 2017 and adjusted the scour code to 3 indicating that the bridge foundations were unstable. The complete list of bridge scour ratings from the Washington State Bridge System Coding Guide has been included in **Appendix C**.

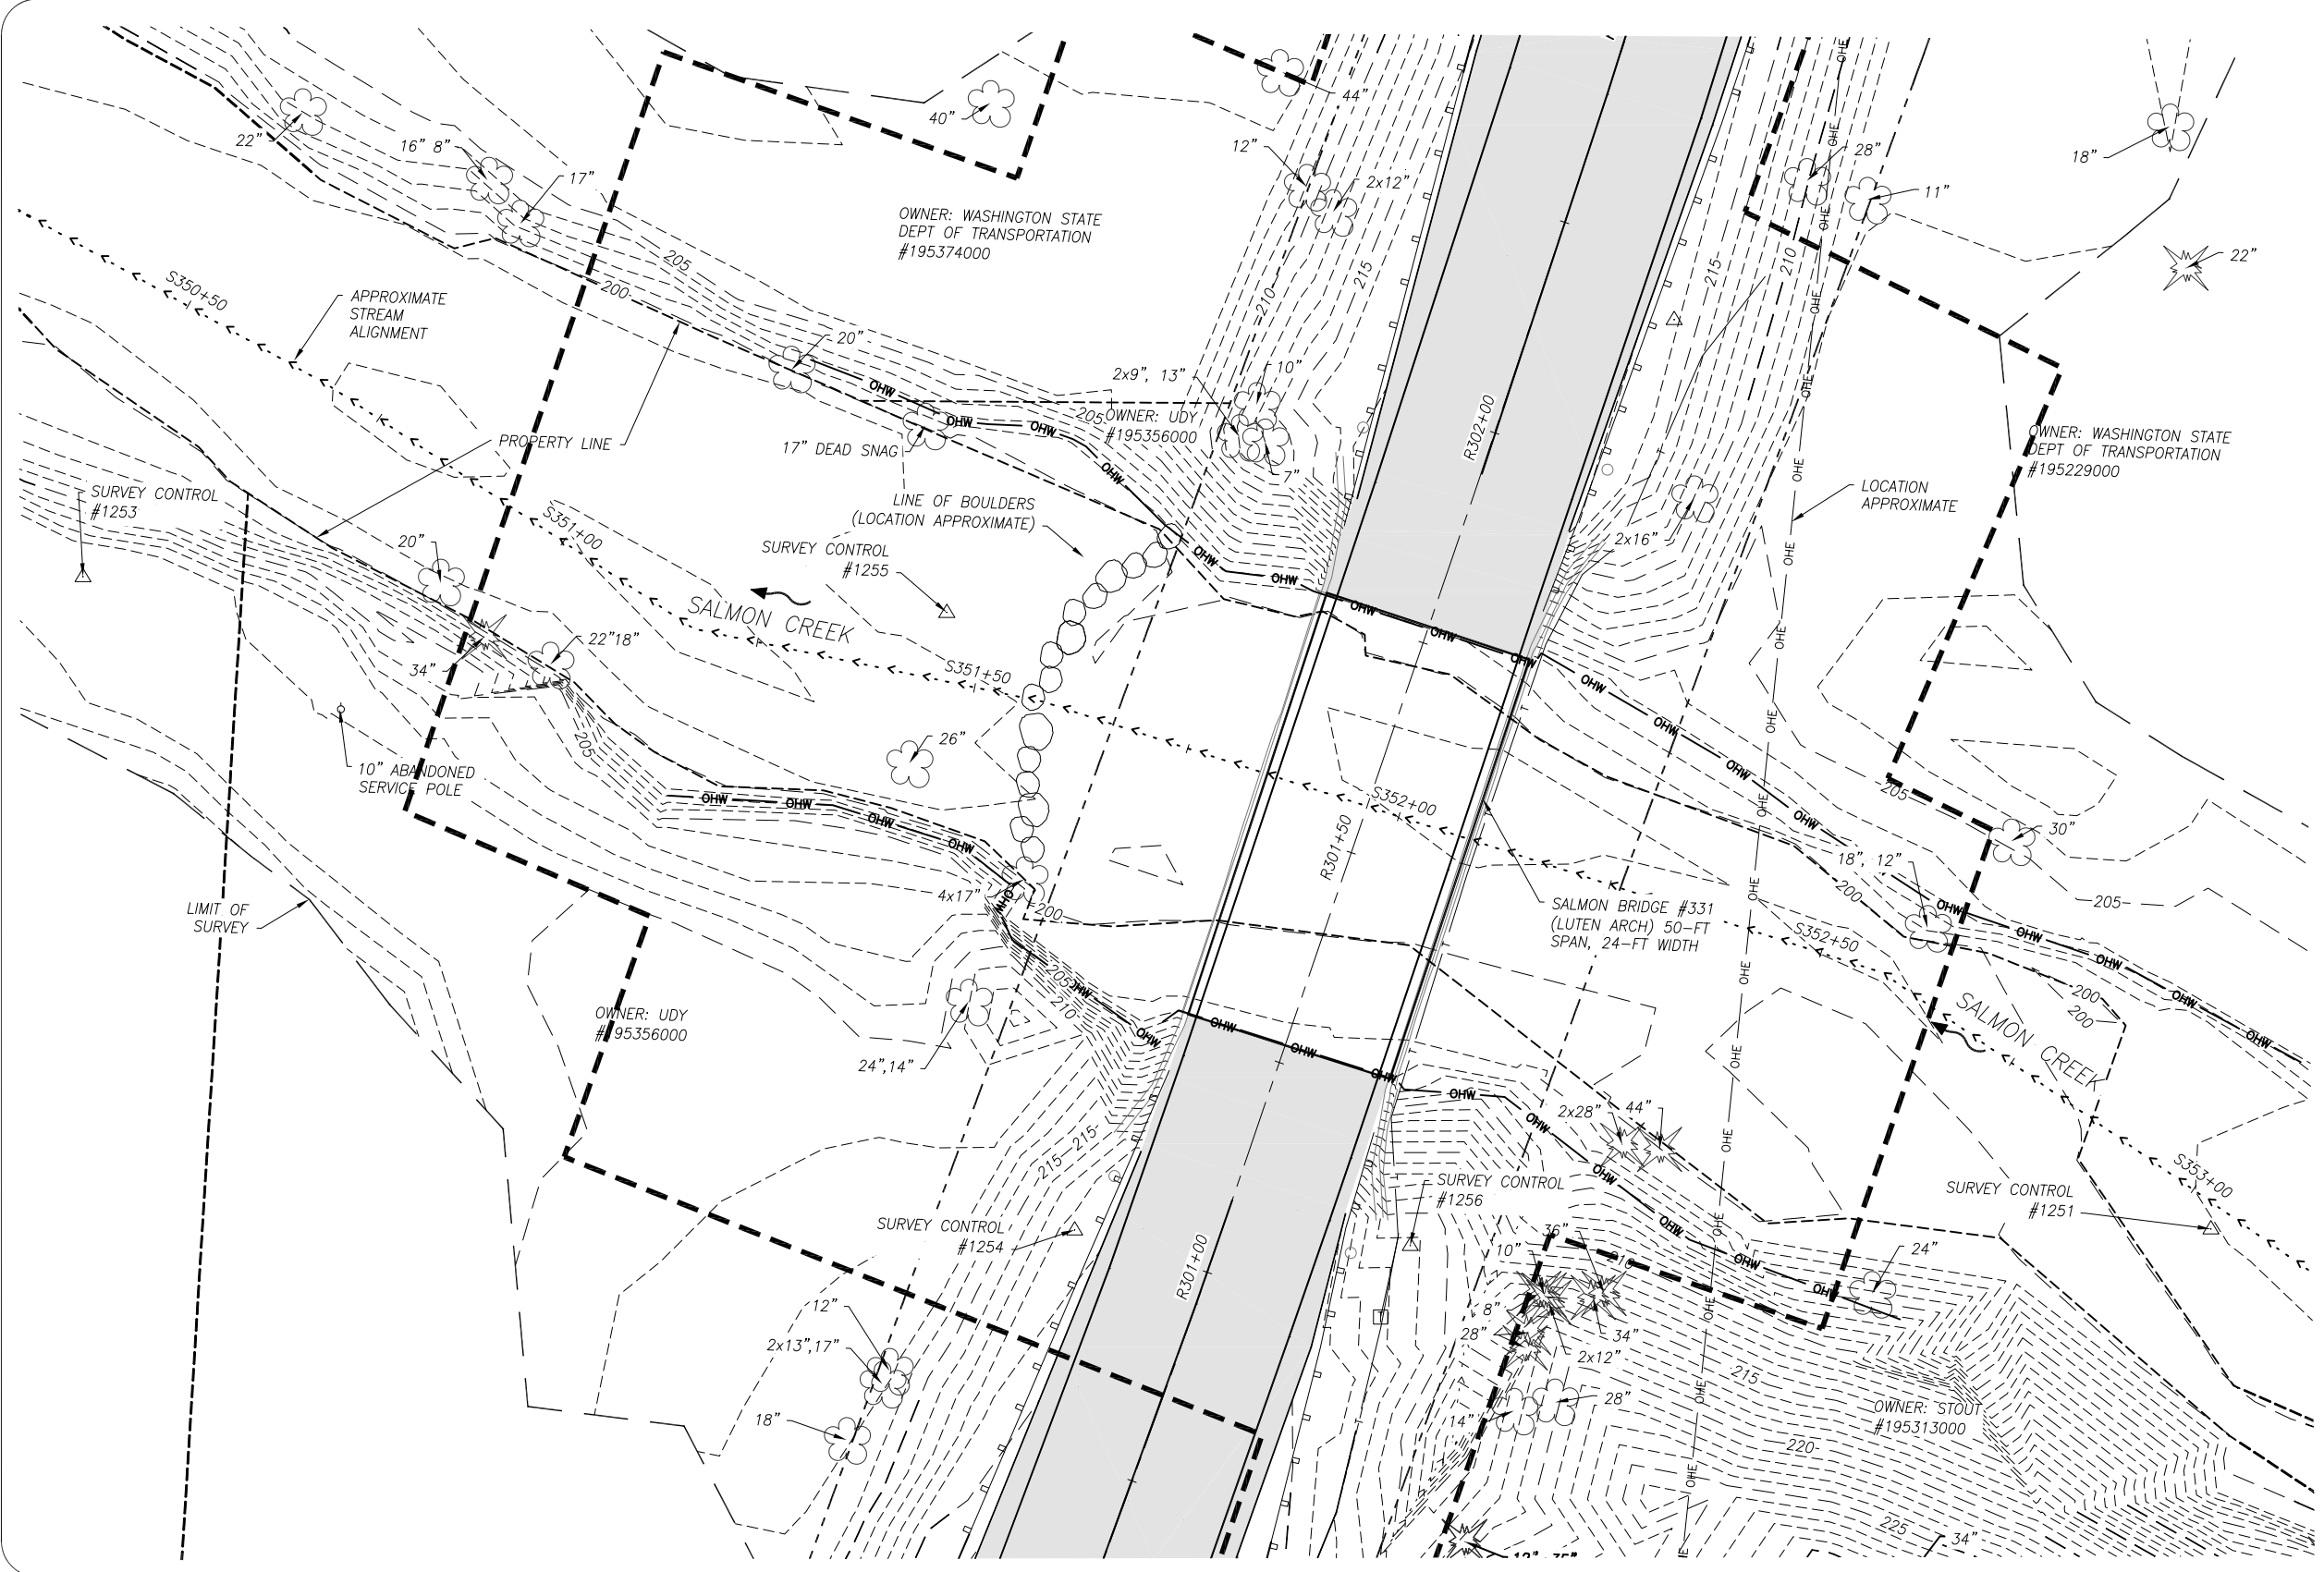
- GENERAL NOTES**
1. COORDINATES ARE IN WASHINGTON STATE PLANE SOUTH ZONE, NAD83(HARN).
 2. PROJECT ELEVATIONS ARE IN THE NATIONAL GEODETIC VERTICAL DATUM (NGVD) OF 1929.
 3. SURVEY PERFORMED BY CLARK COUNTY IN NOVEMBER 2018.
 4. UNITS IN US FEET.

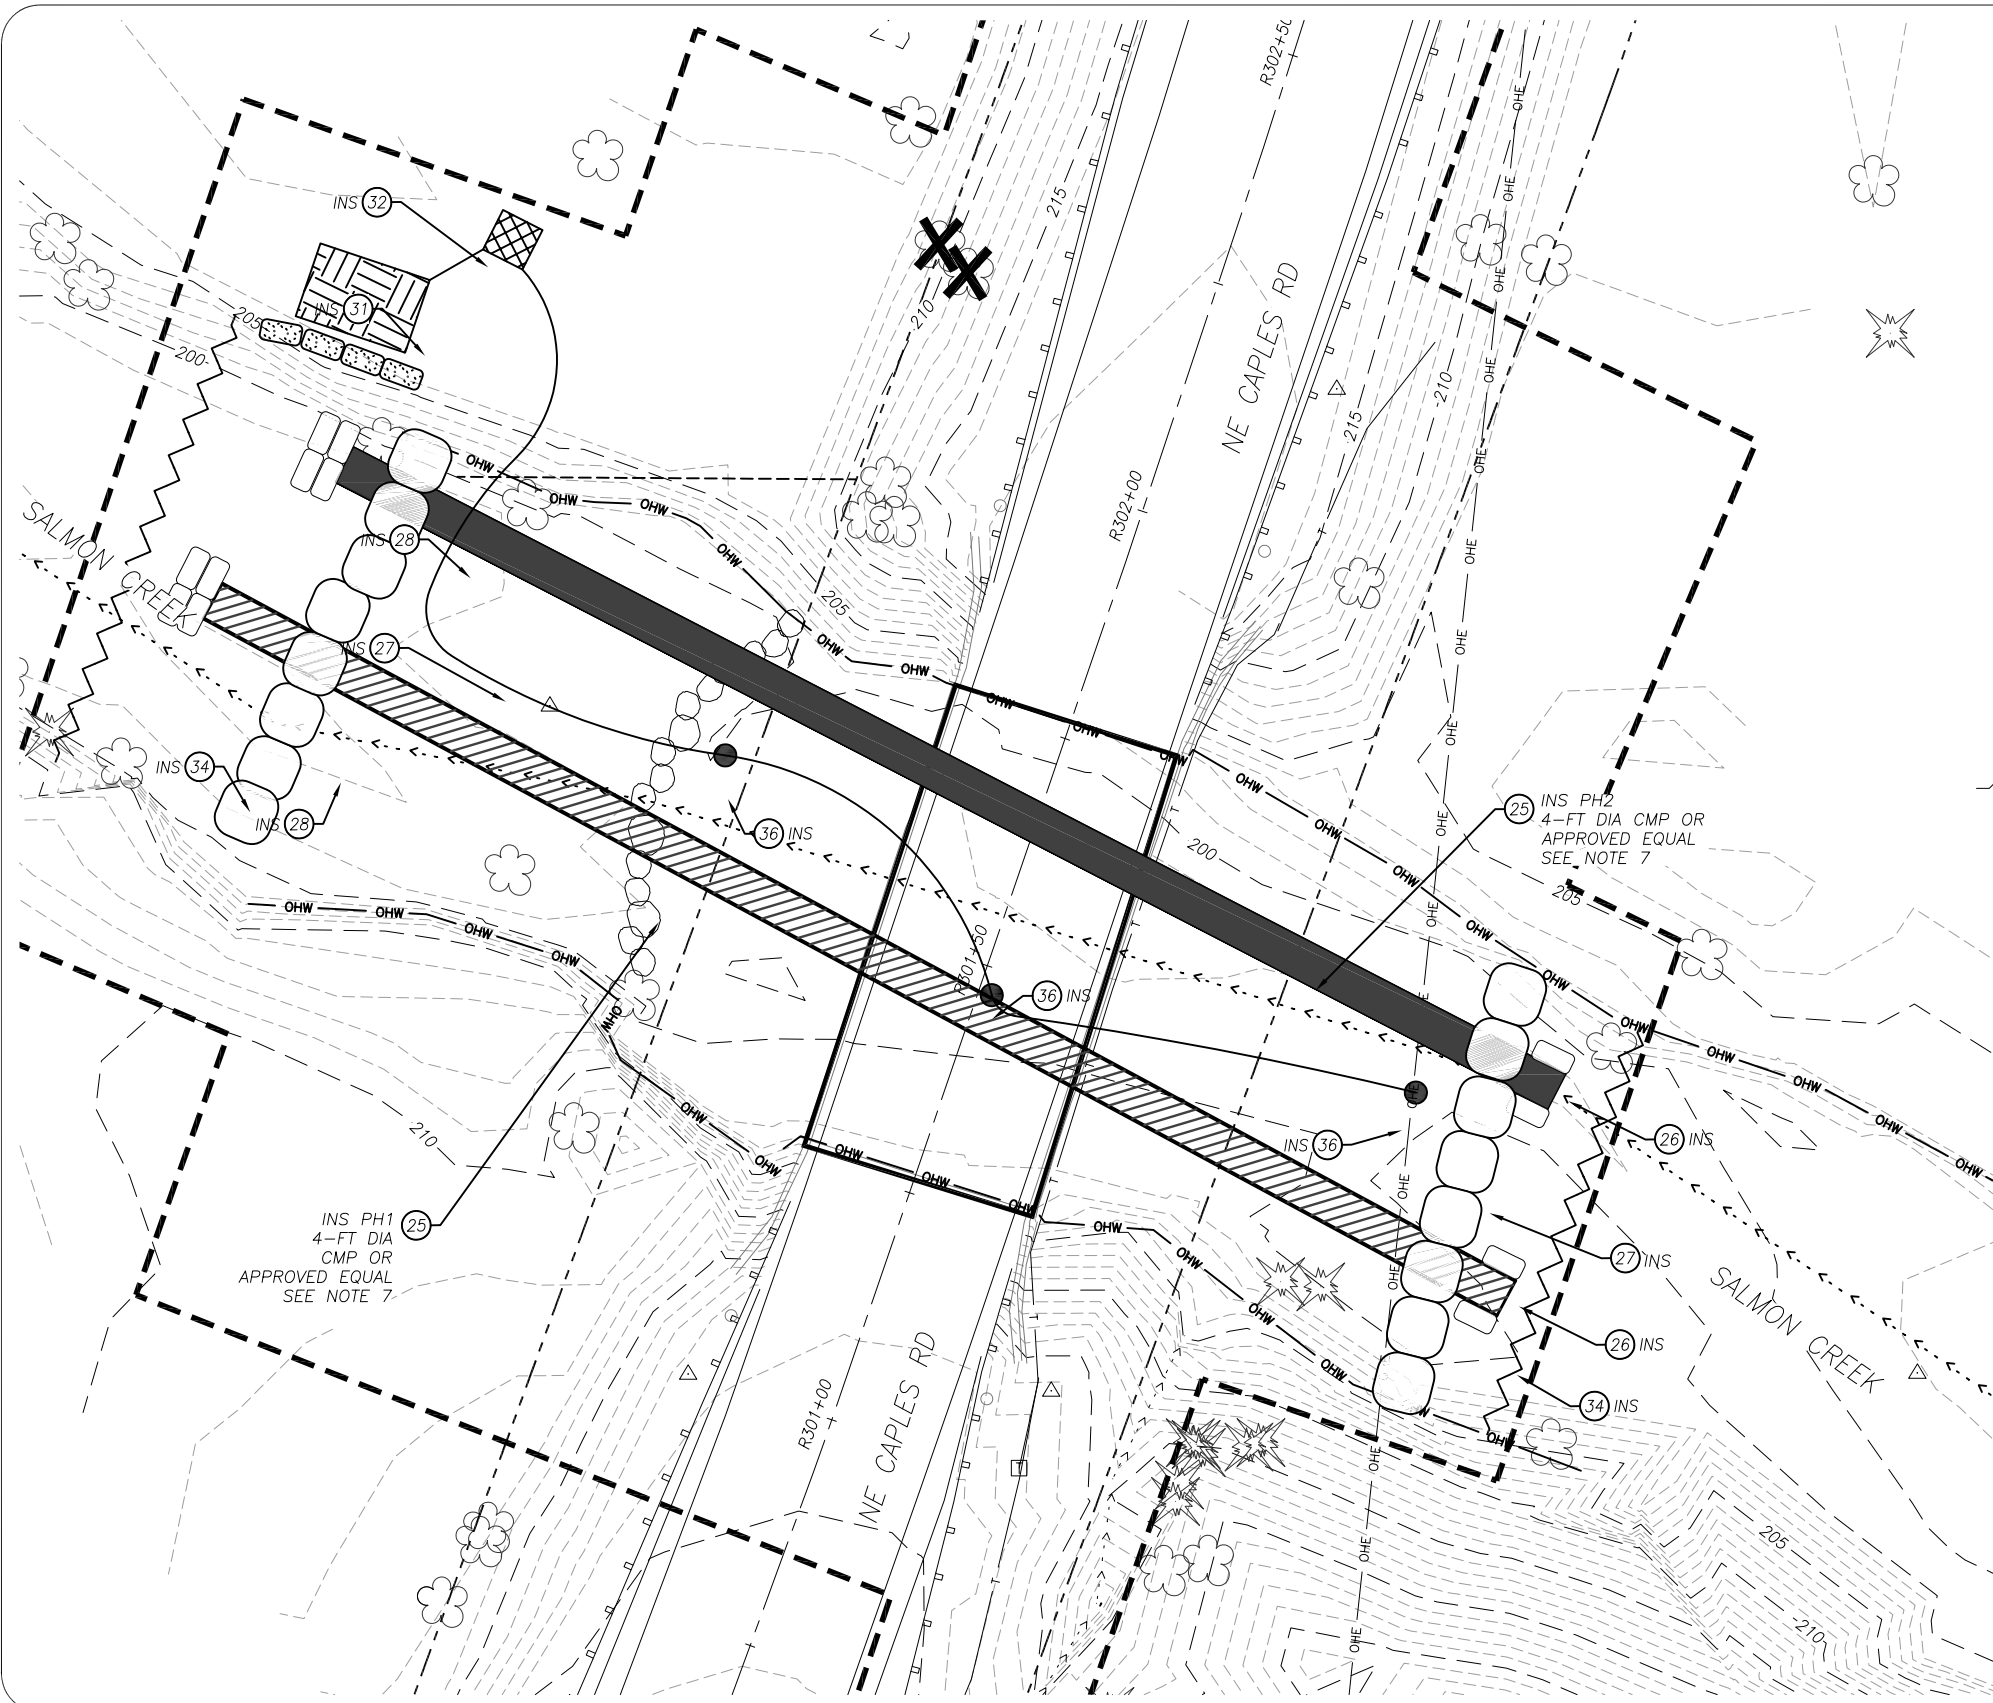
STREAM, STORM & UTILITIES
