Project Background Information

Salmon Creek Reconnection Design – Project area map
Landowner: Clark County
Project sponsor: Cowlitz Indian Tribe
SRFB # 23-1151

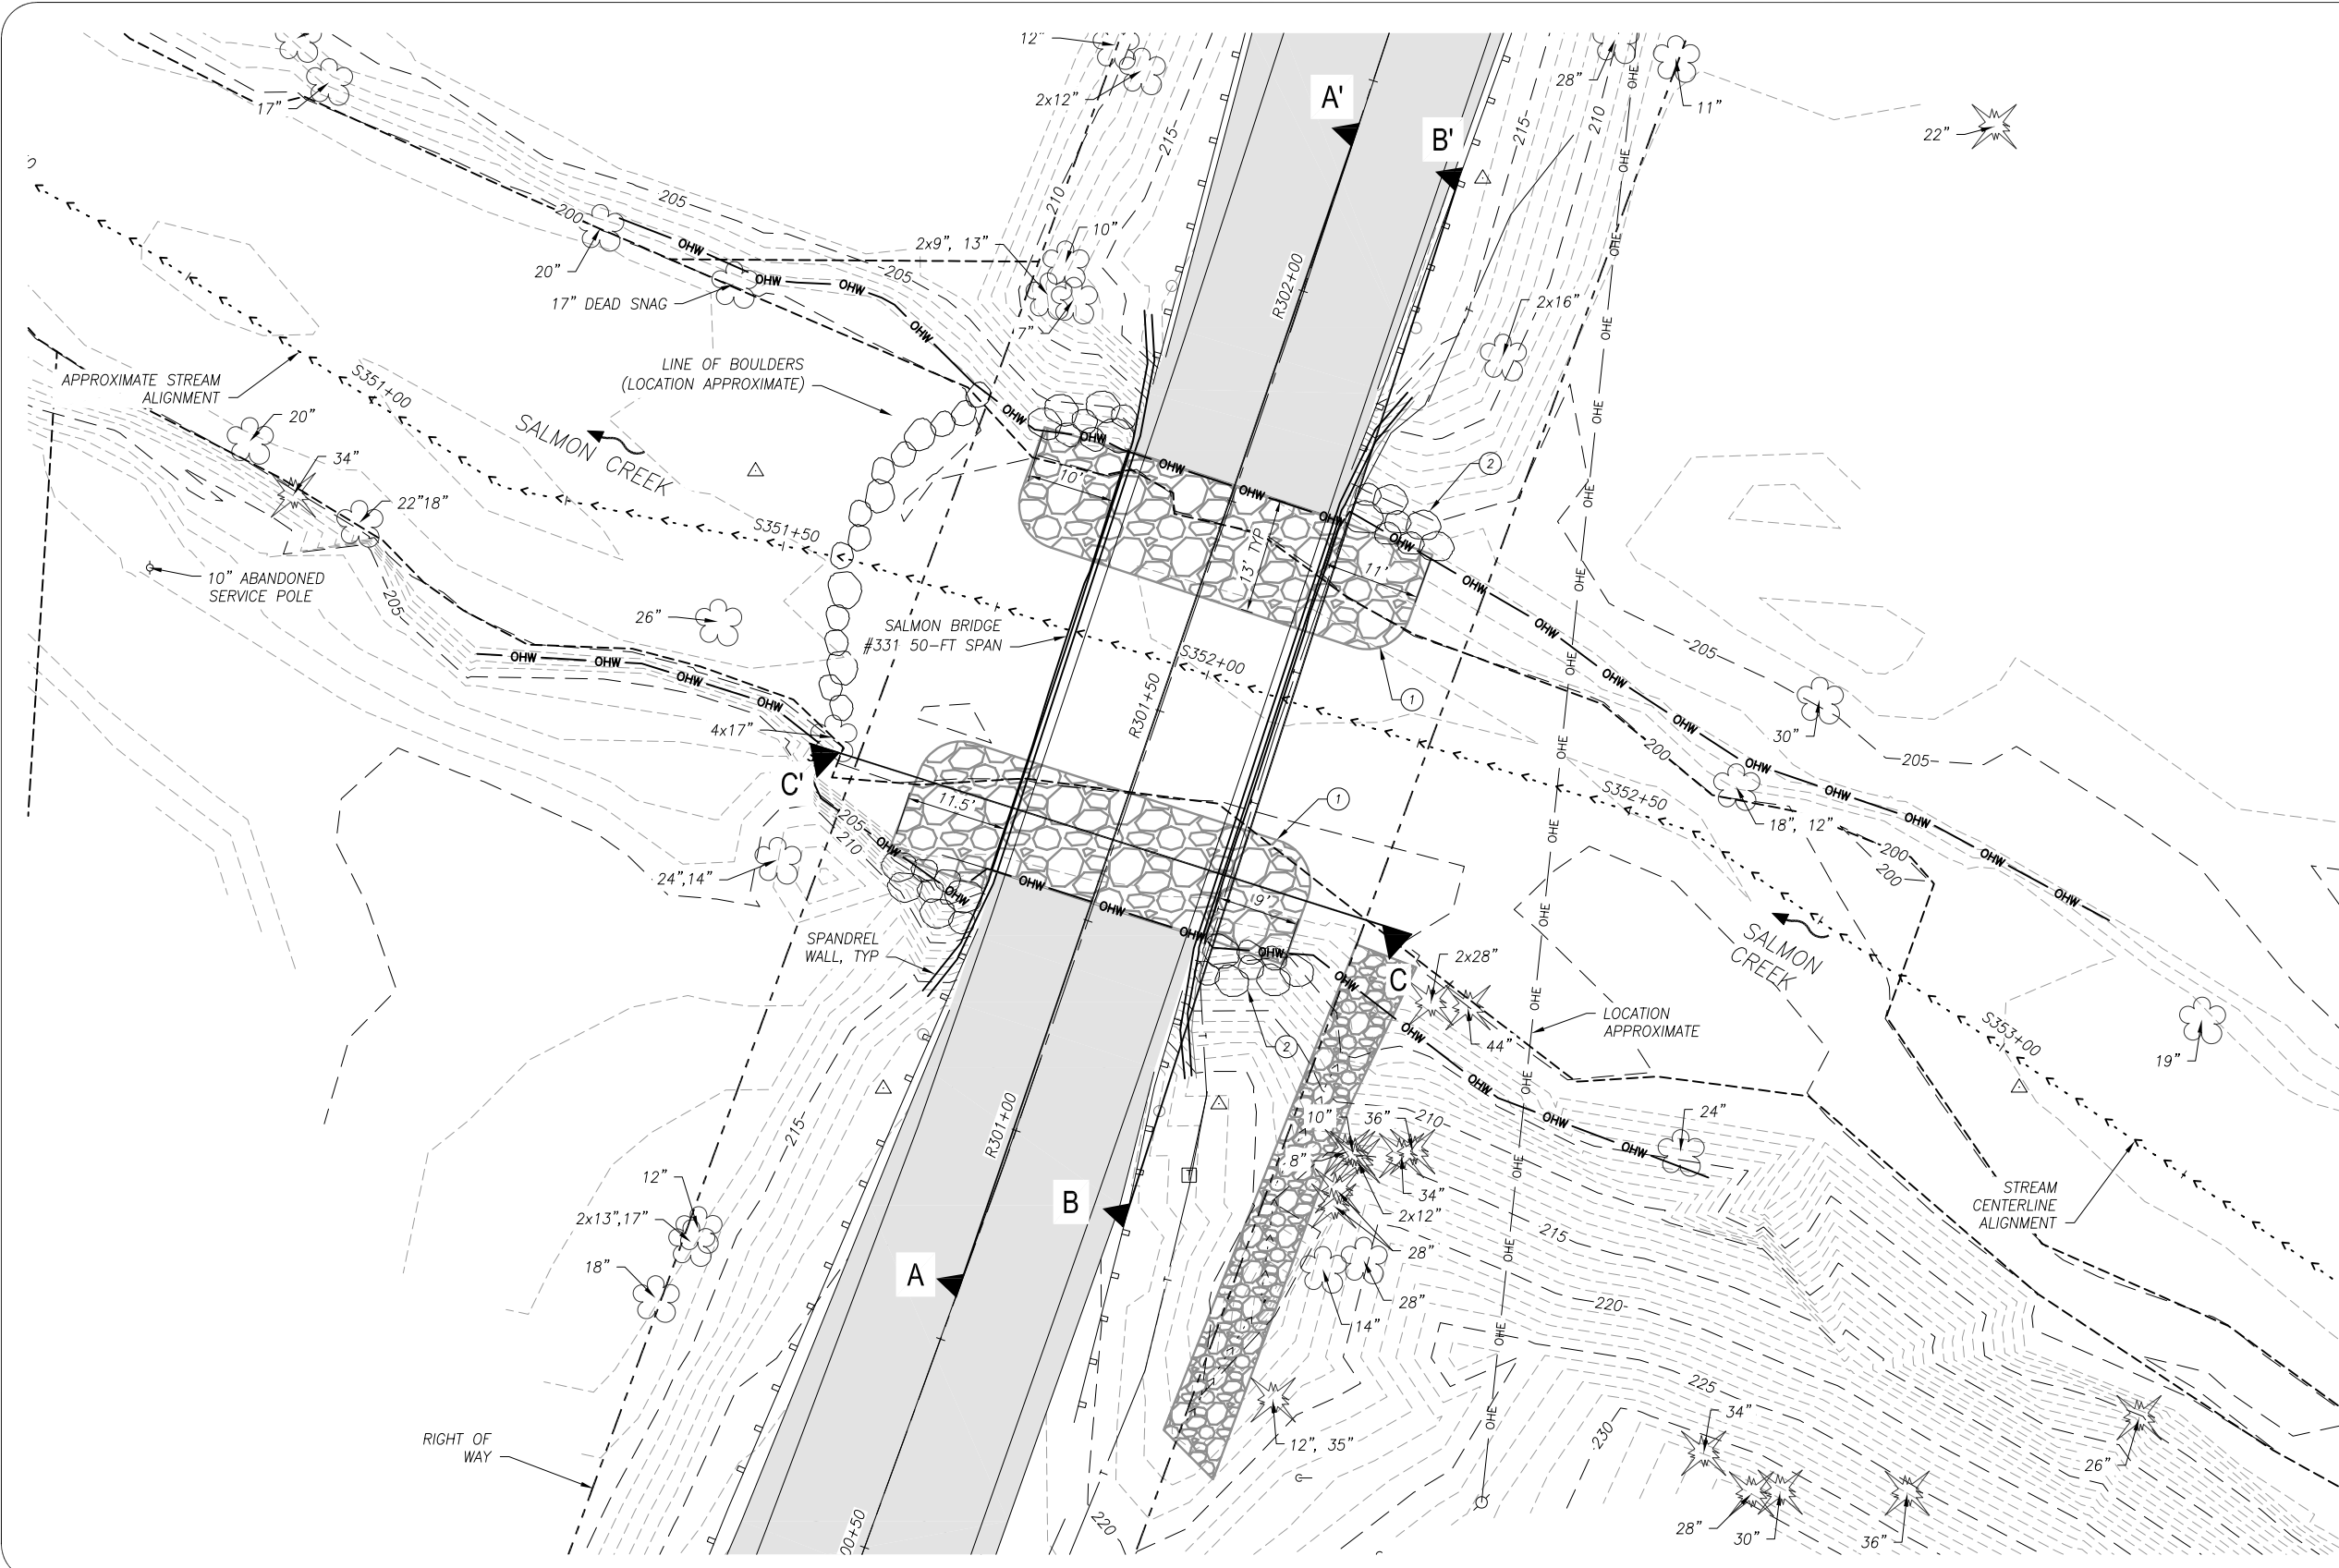
- GENERAL NOTES**
1. COORDINATES ARE IN WASHINGTON STATE PLANE SOUTH ZONE, NAD83(HARN).
 2. PROJECT ELEVATIONS ARE IN THE NATIONAL GEODETIC VERTICAL DATUM (NGVD) OF 1929.
 3. SURVEY PERFORMED BY CLARK COUNTY ON NOVEMBER 16, 2018.
 4. UNITS IN US FEET.
 5. IN-WATER WORK WINDOW AUGUST 1 TO SEPTEMBER 30.

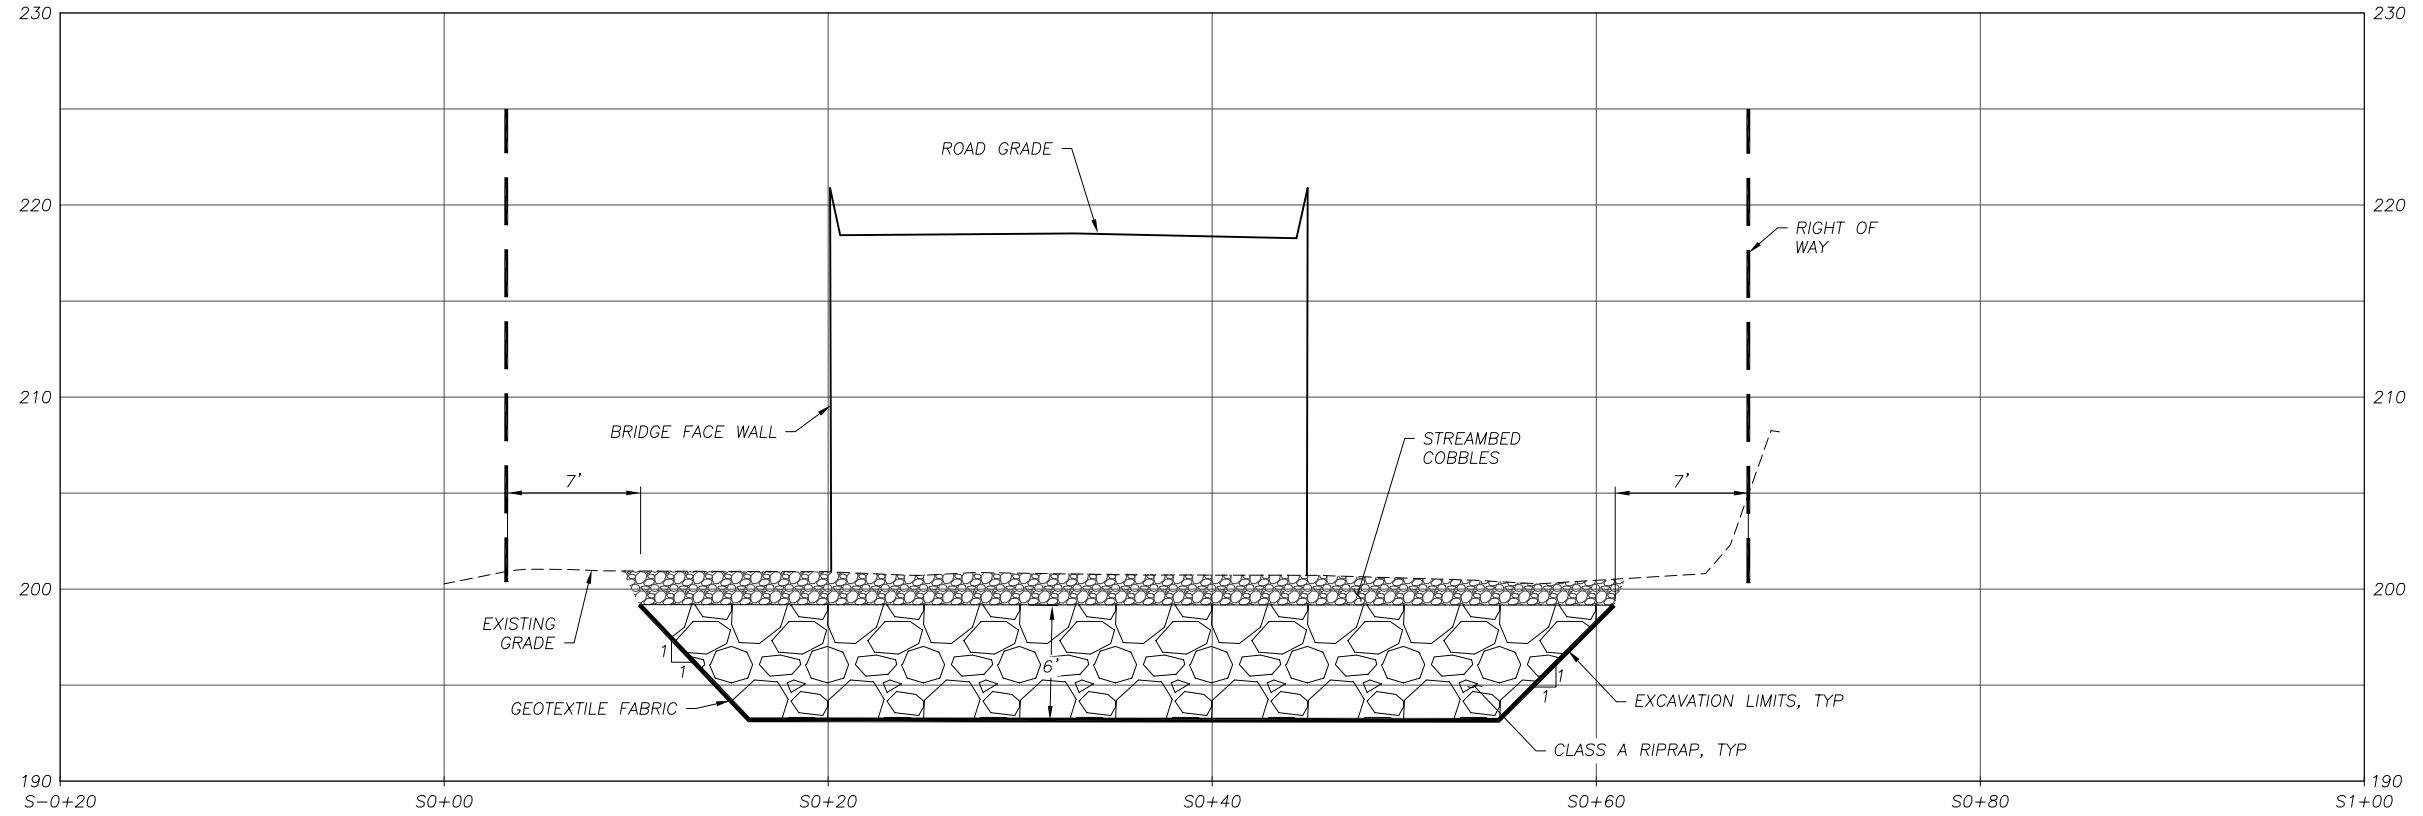
NE CAPLES RD RIGHT OF BANK SECTION C-C' (LOOKING SOUTH)

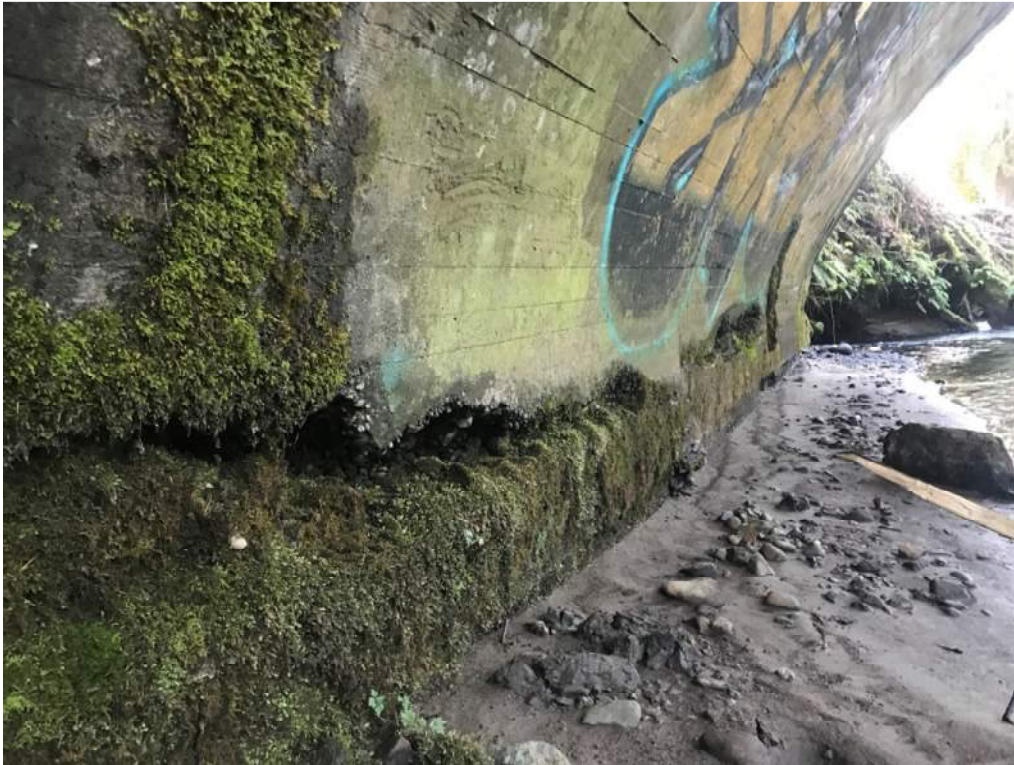
Photo 3: Salmon Creek Bridge – Concrete spalling

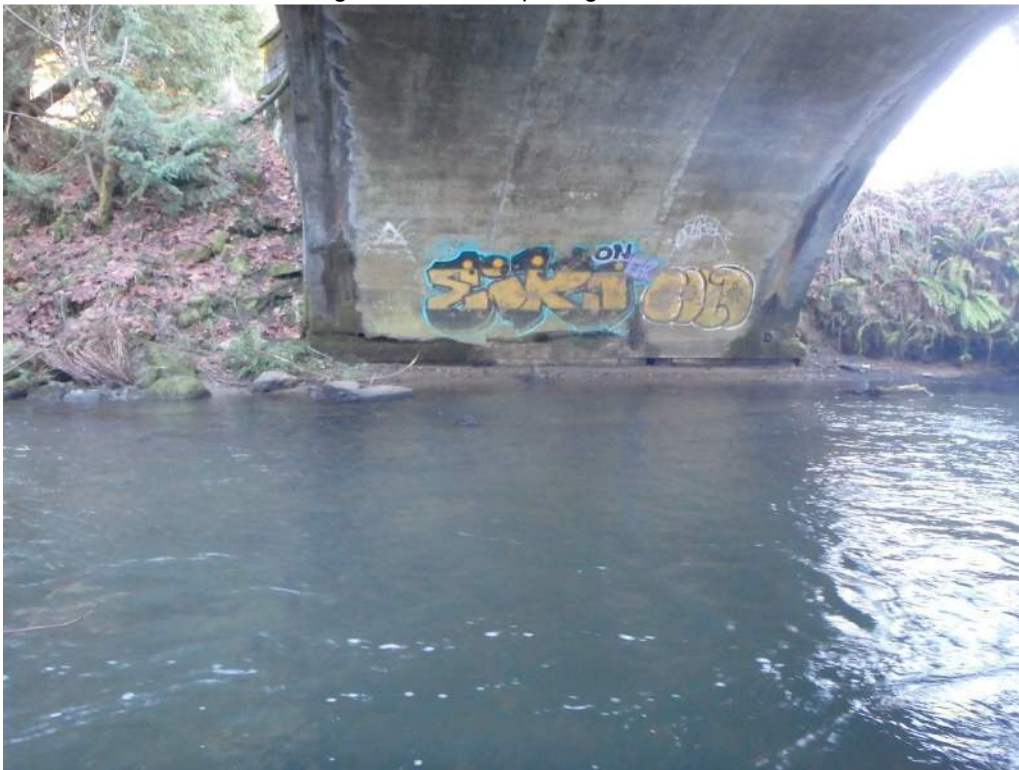
Photo 4: Salmon Creek Bridge – South Abutment

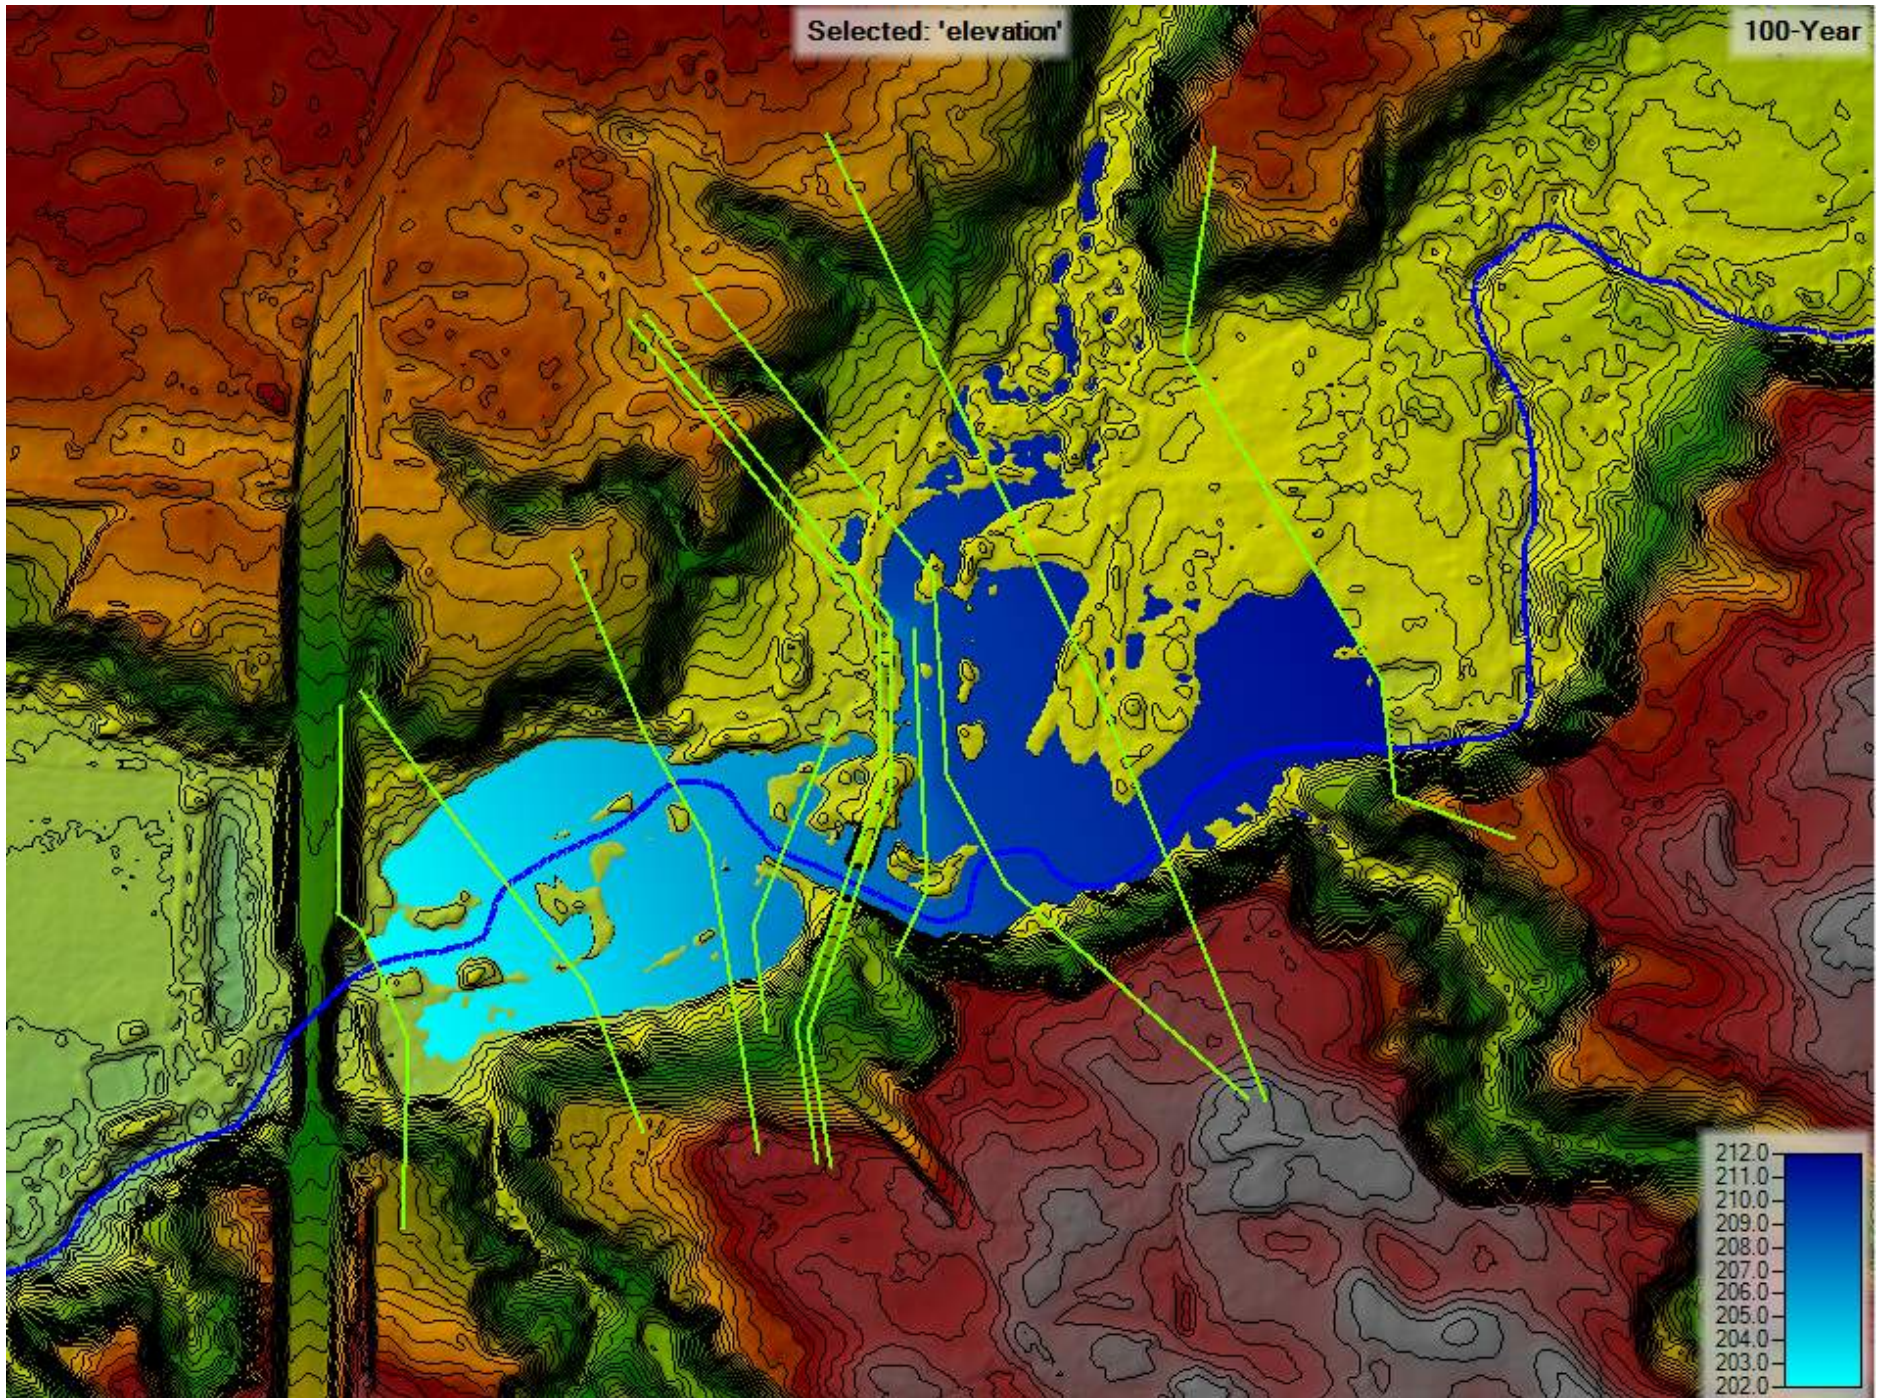
100-YEAR FLOOD MAP PROVIDED FOR CONTEXT ONLY AND IS NOT INTENDED TO REPLACE FEMA FIRM

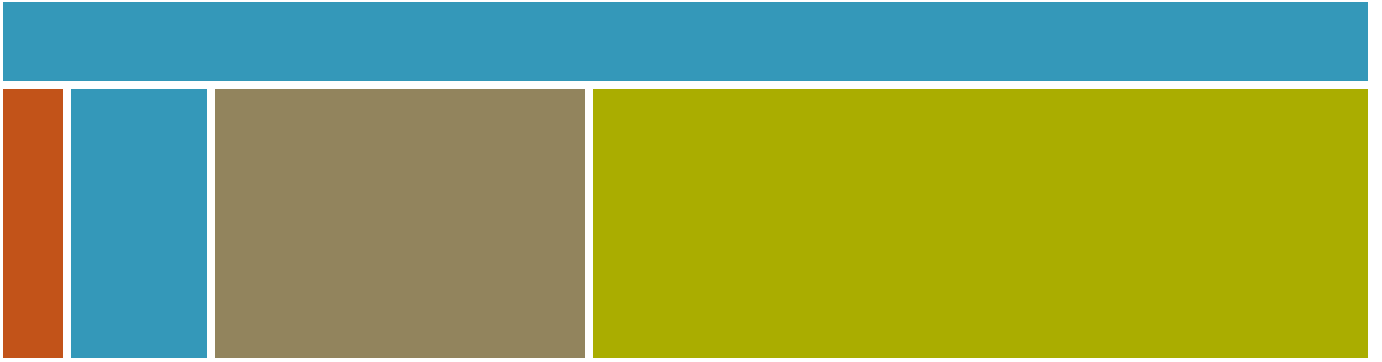
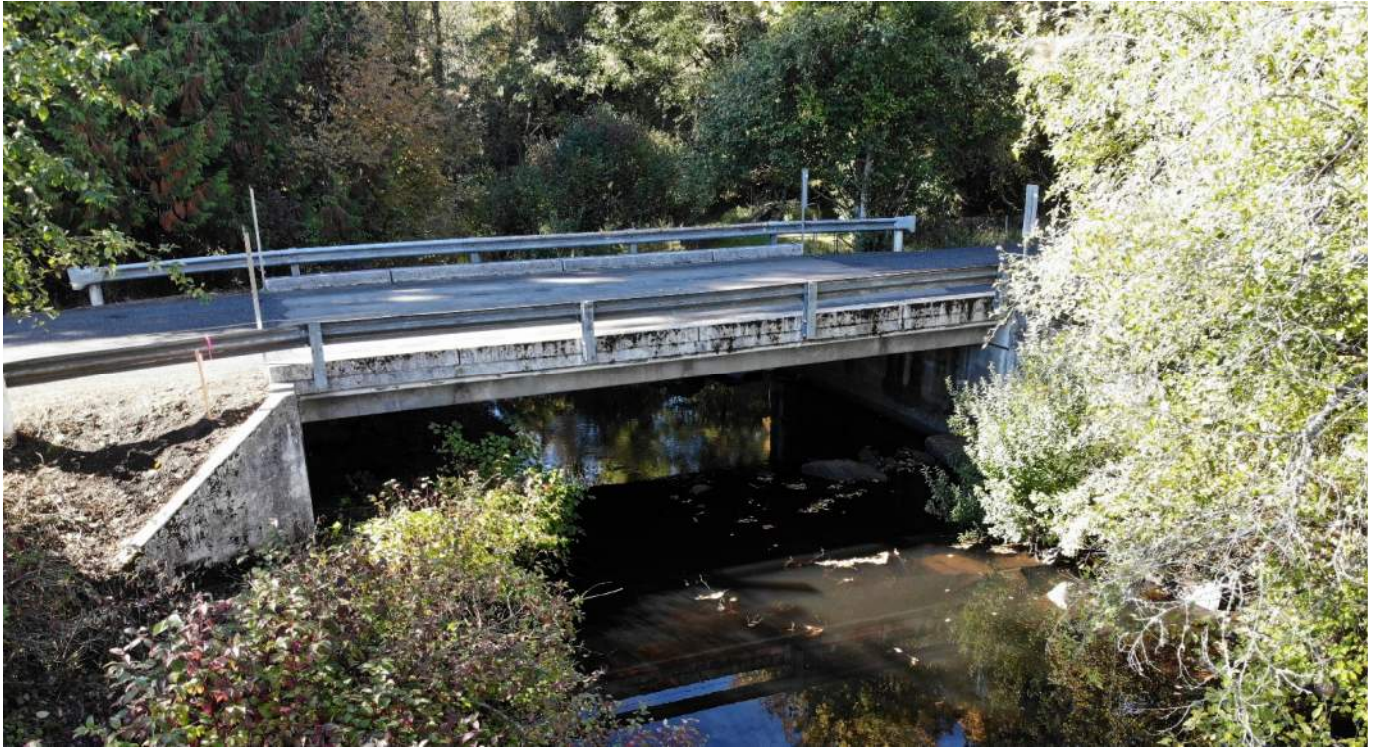
Smith Bridge Scour Repair Project

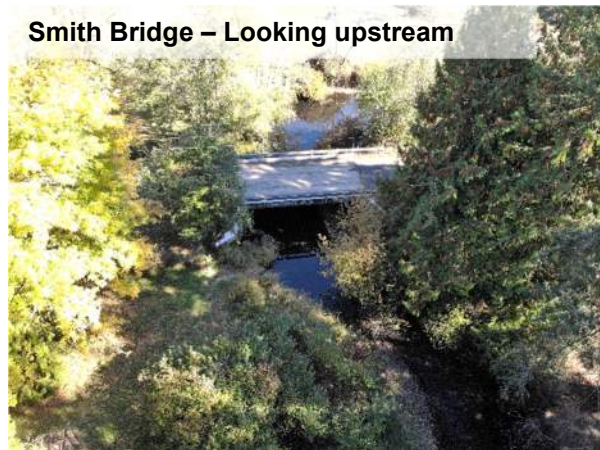
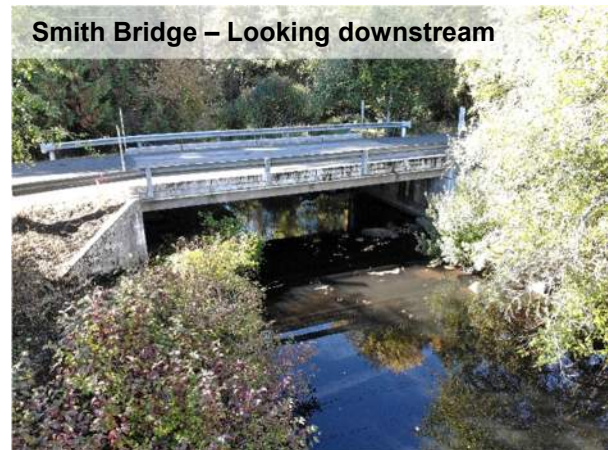
Scour is occurring along the south abutment and has been documented in bridge inspection reports provided by the County. Additionally, there is high potential for scour along the northern abutment initiated by a substantial bend in the creek just upstream of the bridge. Riprap is in the channel along the northern abutment but is not configured in a way that will ensure protection against potential scour. Additionally, there is an exposed 6-inch waterline located approximately 12 feet upstream of the bridge edge. This waterline is currently in use. The County will lead coordination with the utility.

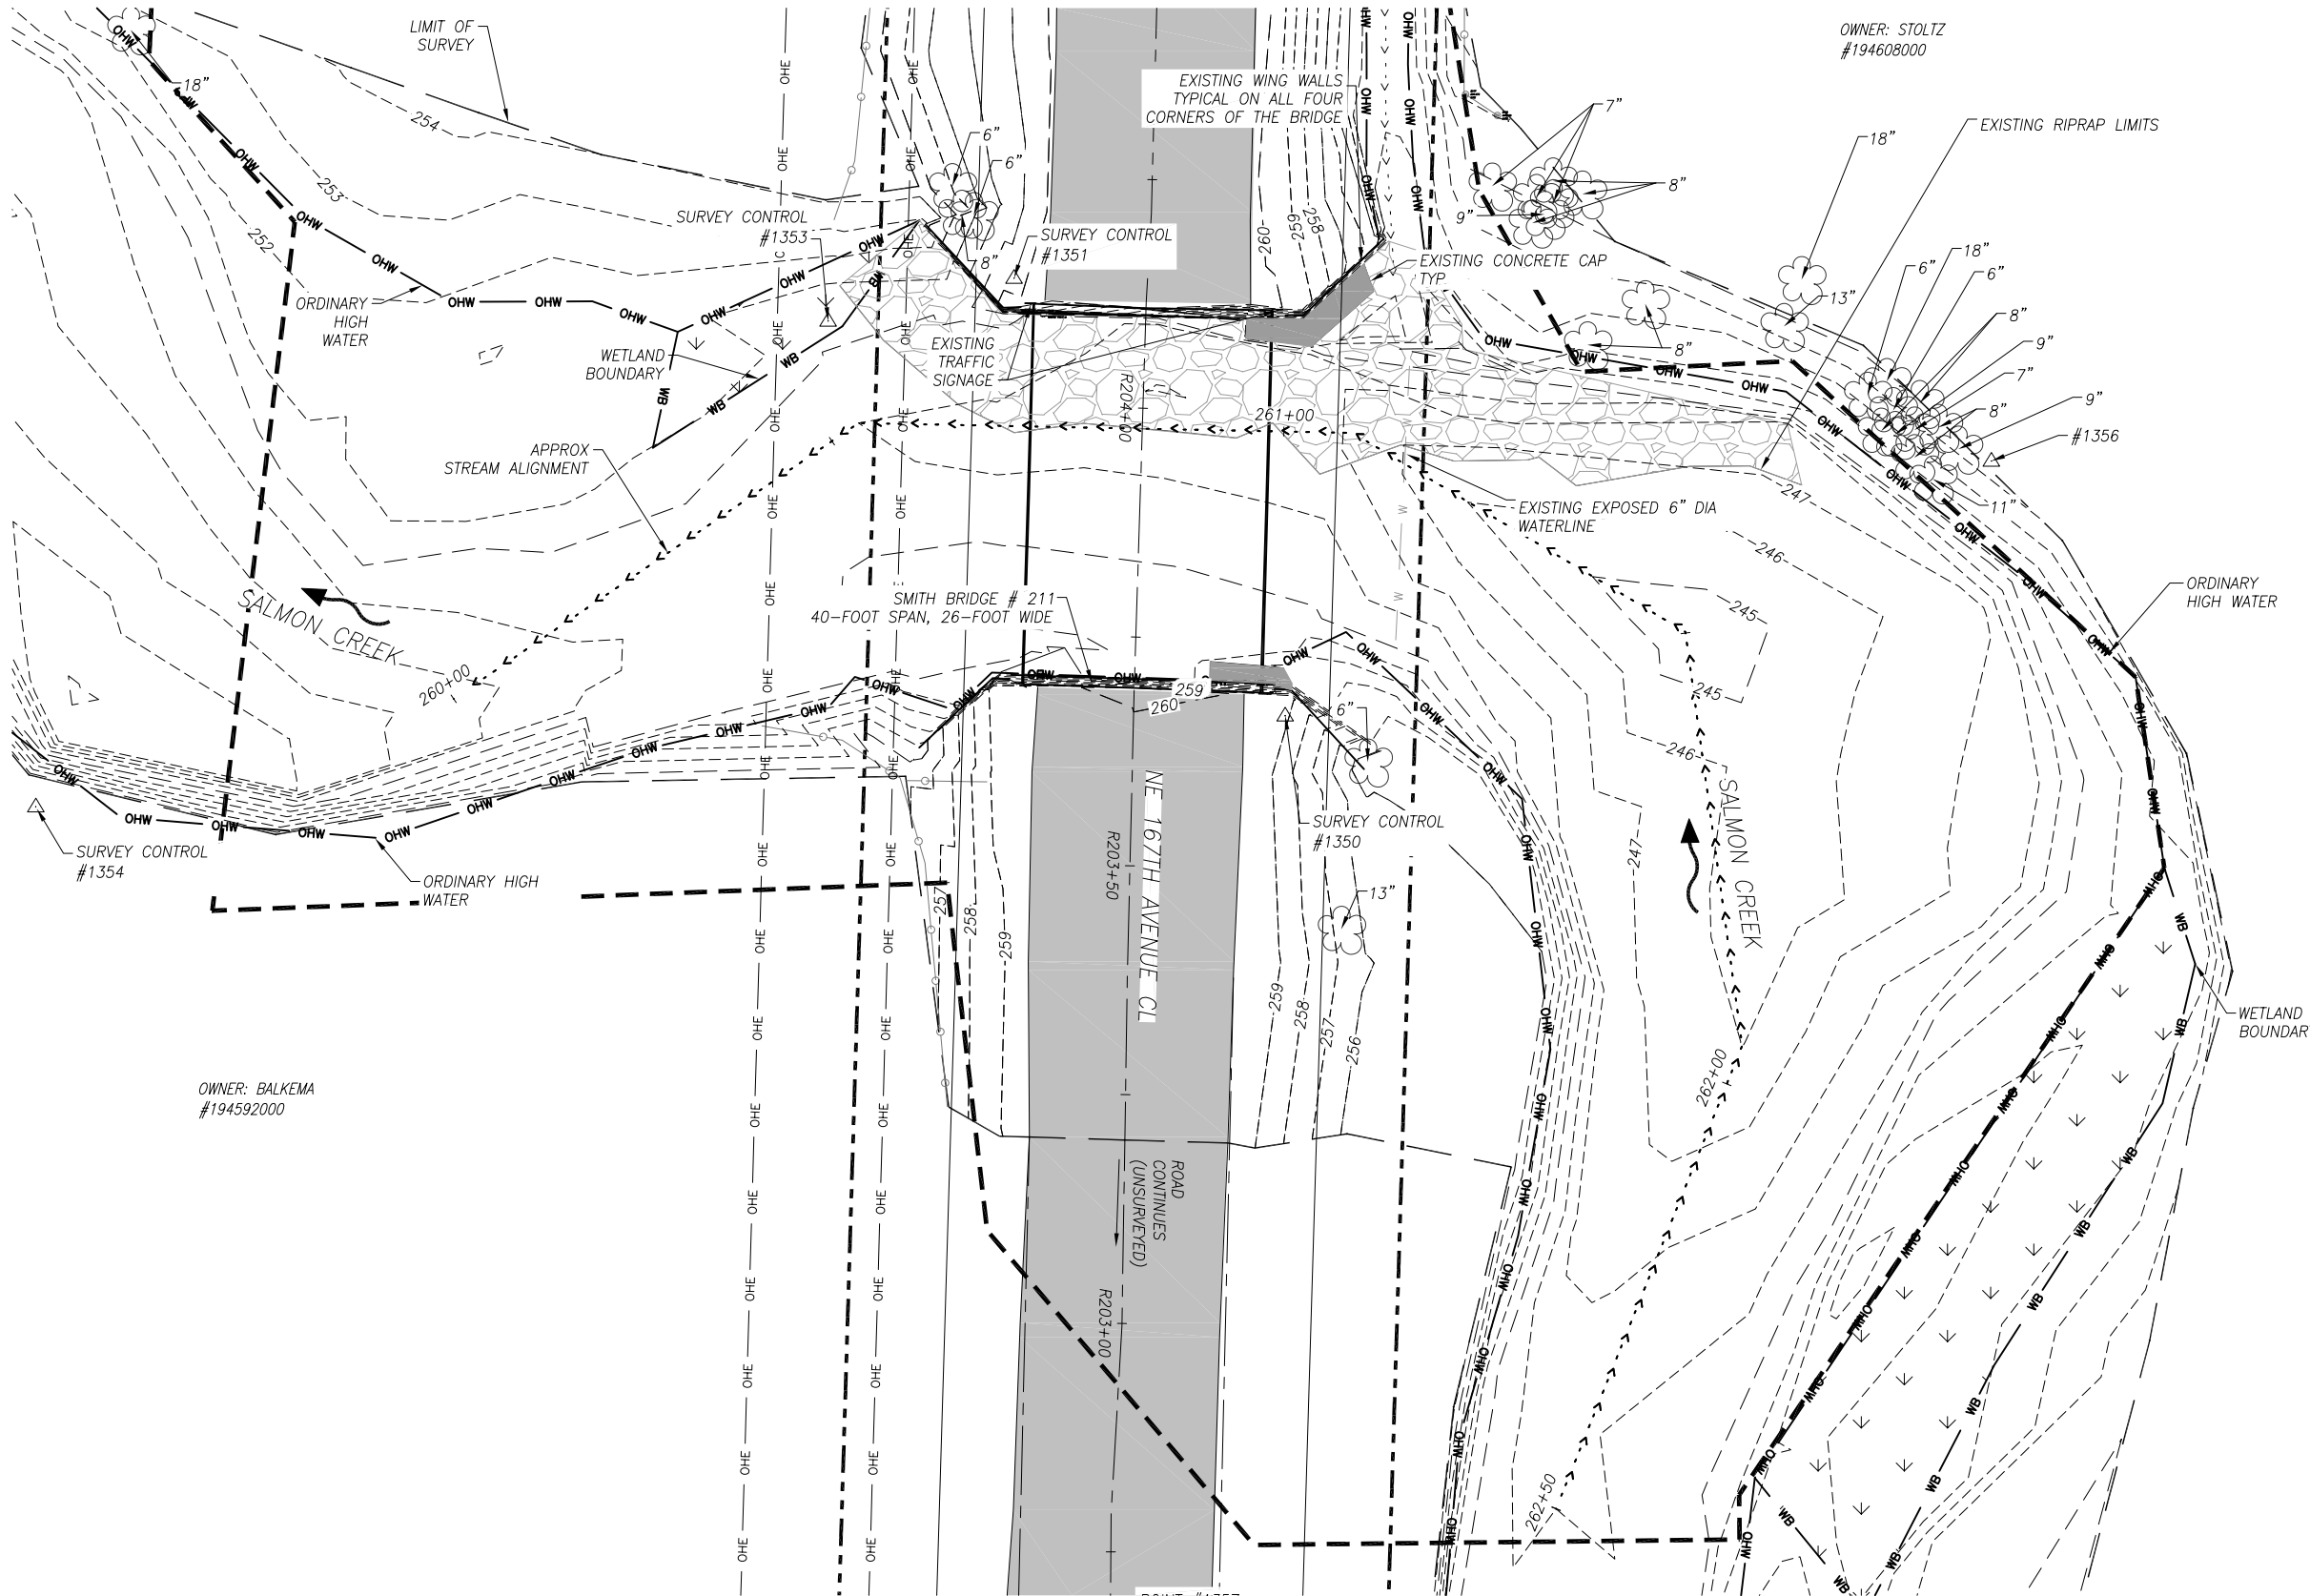
- GENERAL NOTES**
- COORDINATES ARE IN WASHINGTON STATE PLANE SOUTH ZONE, NAD83(HARN).
 - PROJECT ELEVATIONS ARE IN THE NATIONAL GEODETIC VERTICAL DATUM (NGVD) OF 1929.
 - SURVEY PERFORMED BY CLARK COUNTY IN NOVEMBER 2018.
 - UNITS IN US FEET.

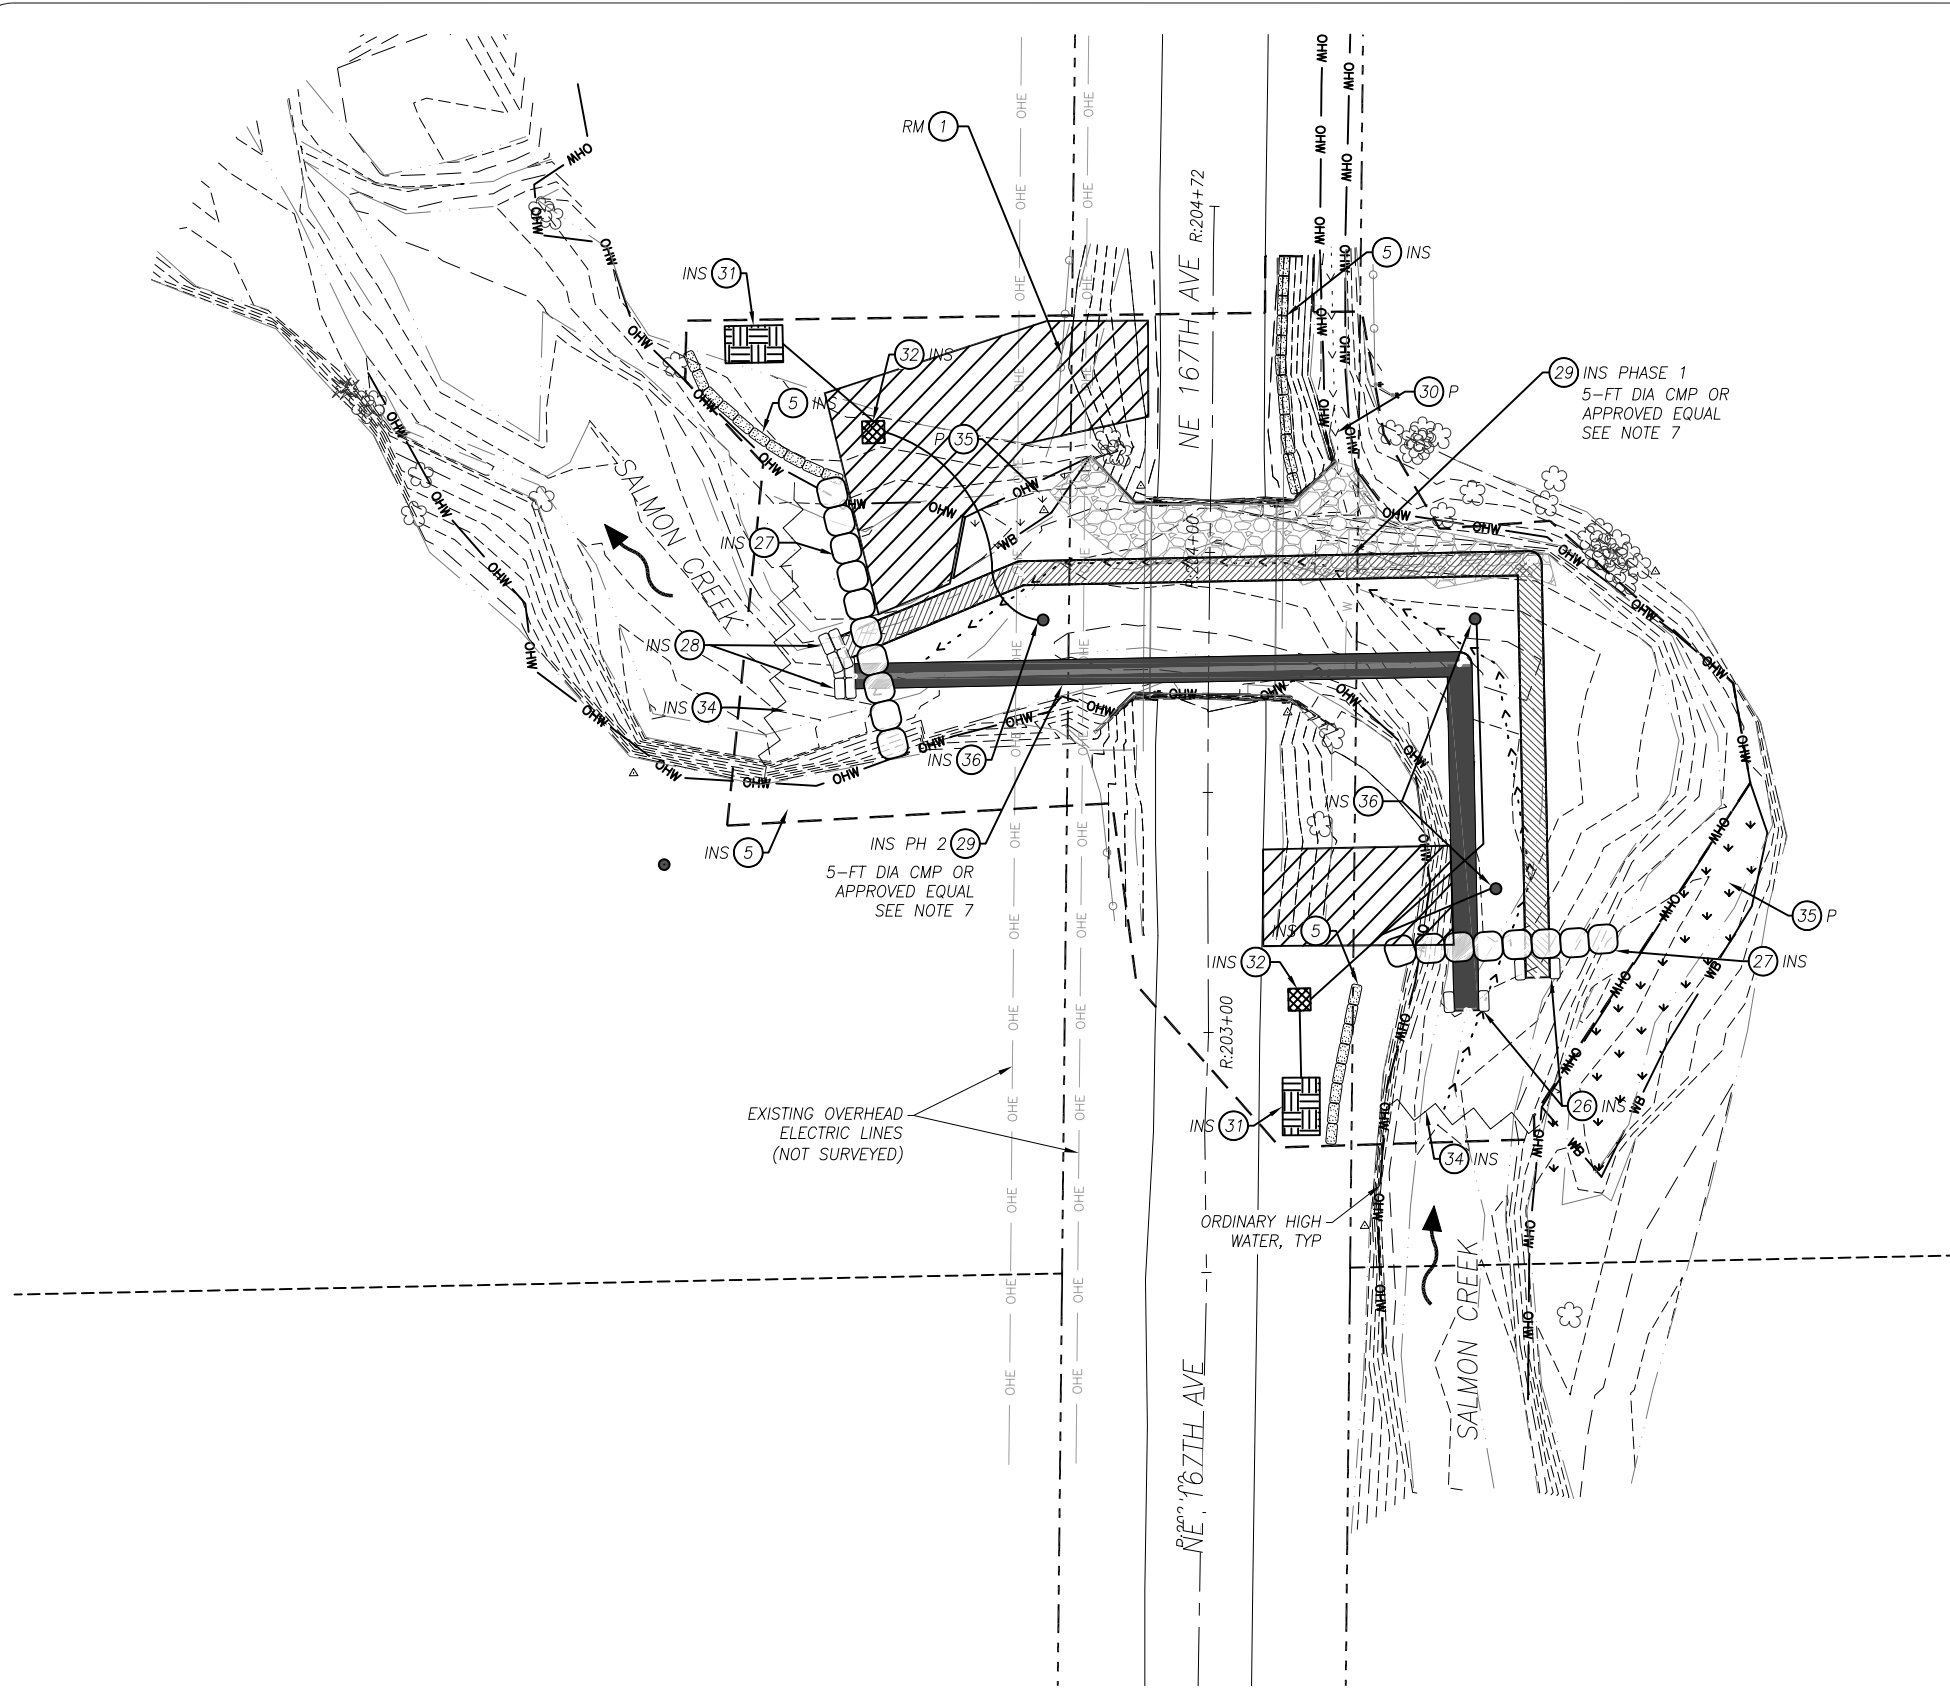
- ROADWAY**
- 1 - FENCE
 - 2 - TREE/SHRUB
 - 5 - STRAW WATTLES
- STREAM, UTILITIES, & STRUCTURAL**
- 25 - PIPE/CULVERT
 - 26 - TEMP INLET PROTECTION
 - 27 - WORK AREA ISOLATION DAM
 - 28 - OUTLET EROSION PROTECTION
 - 29 - BYPASS PIPE
 - 30 - EXISTING DITCH
 - 31 - SEDIMENT CONTROL BAG
 - 32 - DE-WATERING PUMP
 - 33 - CONSTRUCTION ACCESS
 - 34 - FISH BLOCK NET
 - 35 - WETLAND
 - 36 - DE-WATERING PUMP INTAKE AND DISCHARGE HOSE
- SITE PREPARATION NOTE LEGEND**
- RM - REMOVE
 - P - PROTECT
 - INS - INSTALL
 - A - ADJUST
- # - BY CONTRACTOR
 □ - BY OTHERS
