Project Background Information

Salmon Creek Reconnection Design – Project area map
Landowner: Clark County
Project sponsor: Cowlitz Indian Tribe
SRFB # 23-1151

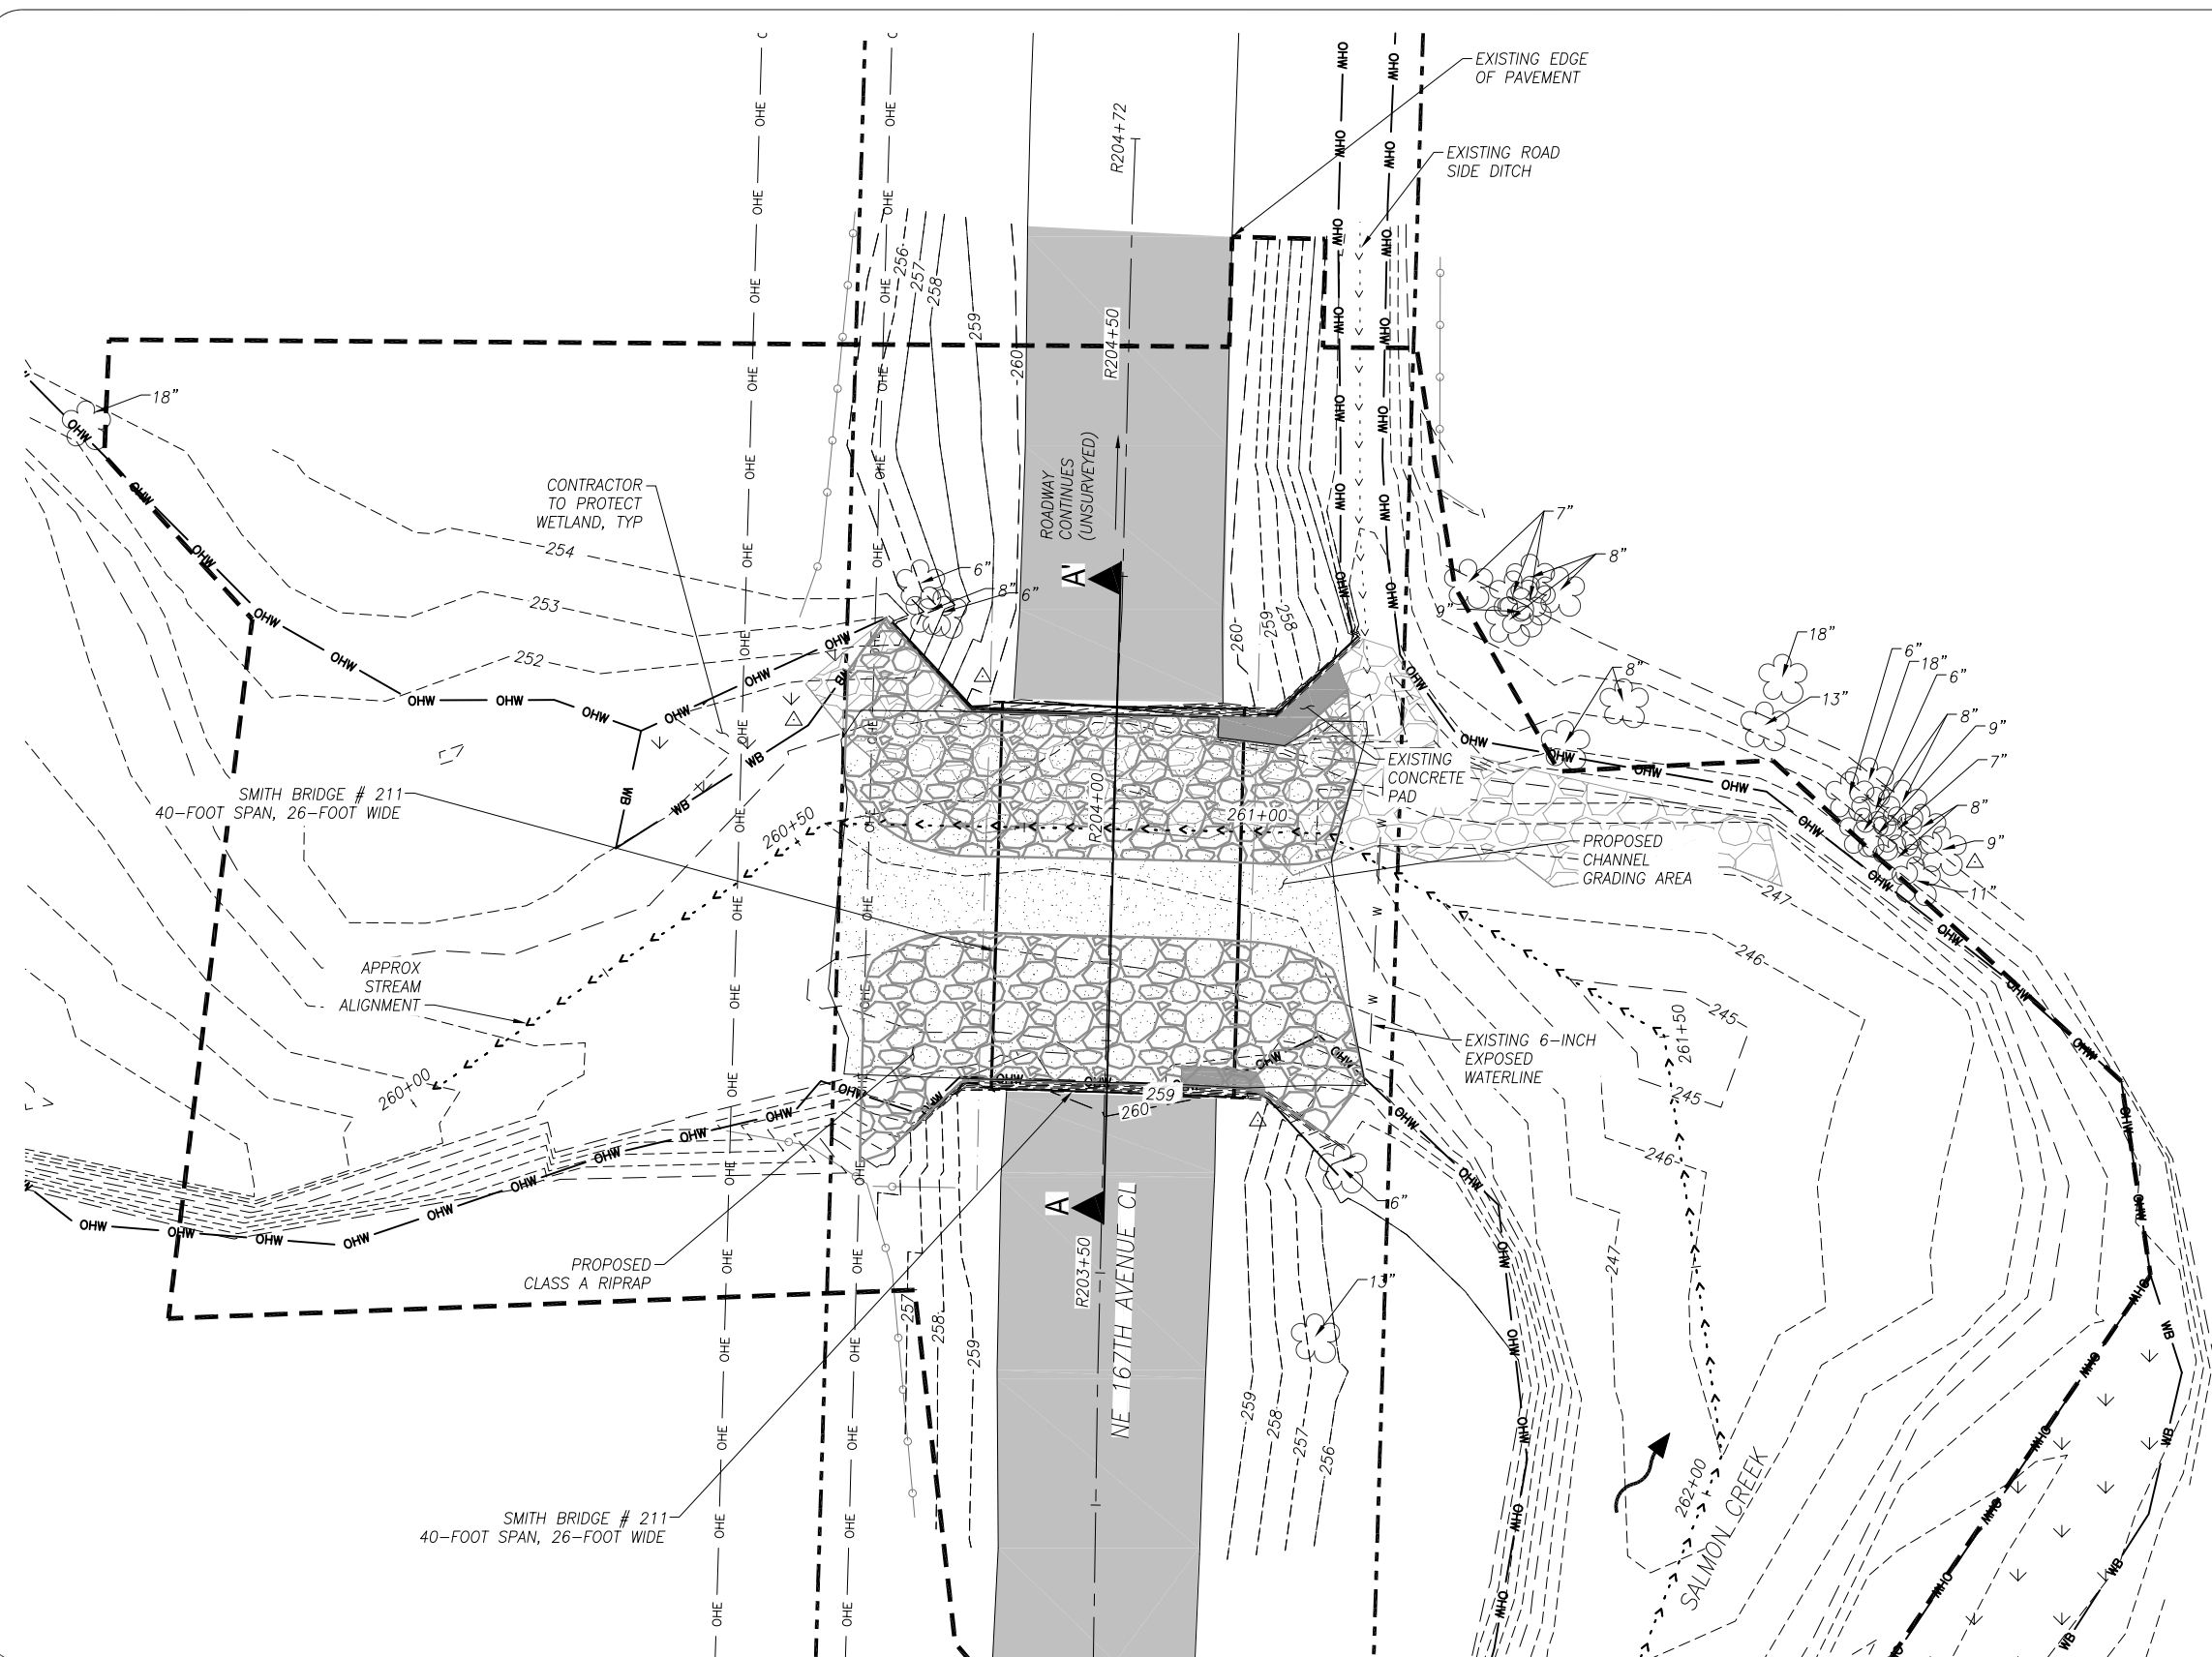
- GENERAL NOTES**
1. COORDINATES ARE IN WASHINGTON STATE PLANE SOUTH ZONE, NAD83(HARN).
 2. PROJECT ELEVATIONS ARE IN THE NATIONAL GEODETIC VERTICAL DATUM (NGVD) OF 1929.
 3. SURVEY PERFORMED BY CLARK COUNTY IN NOVEMBER 2018.
 4. UNITS IN US FEET.
 5. IN-WATER WORK WINDOW AUGUST 1 TO SEPTEMBER 30.

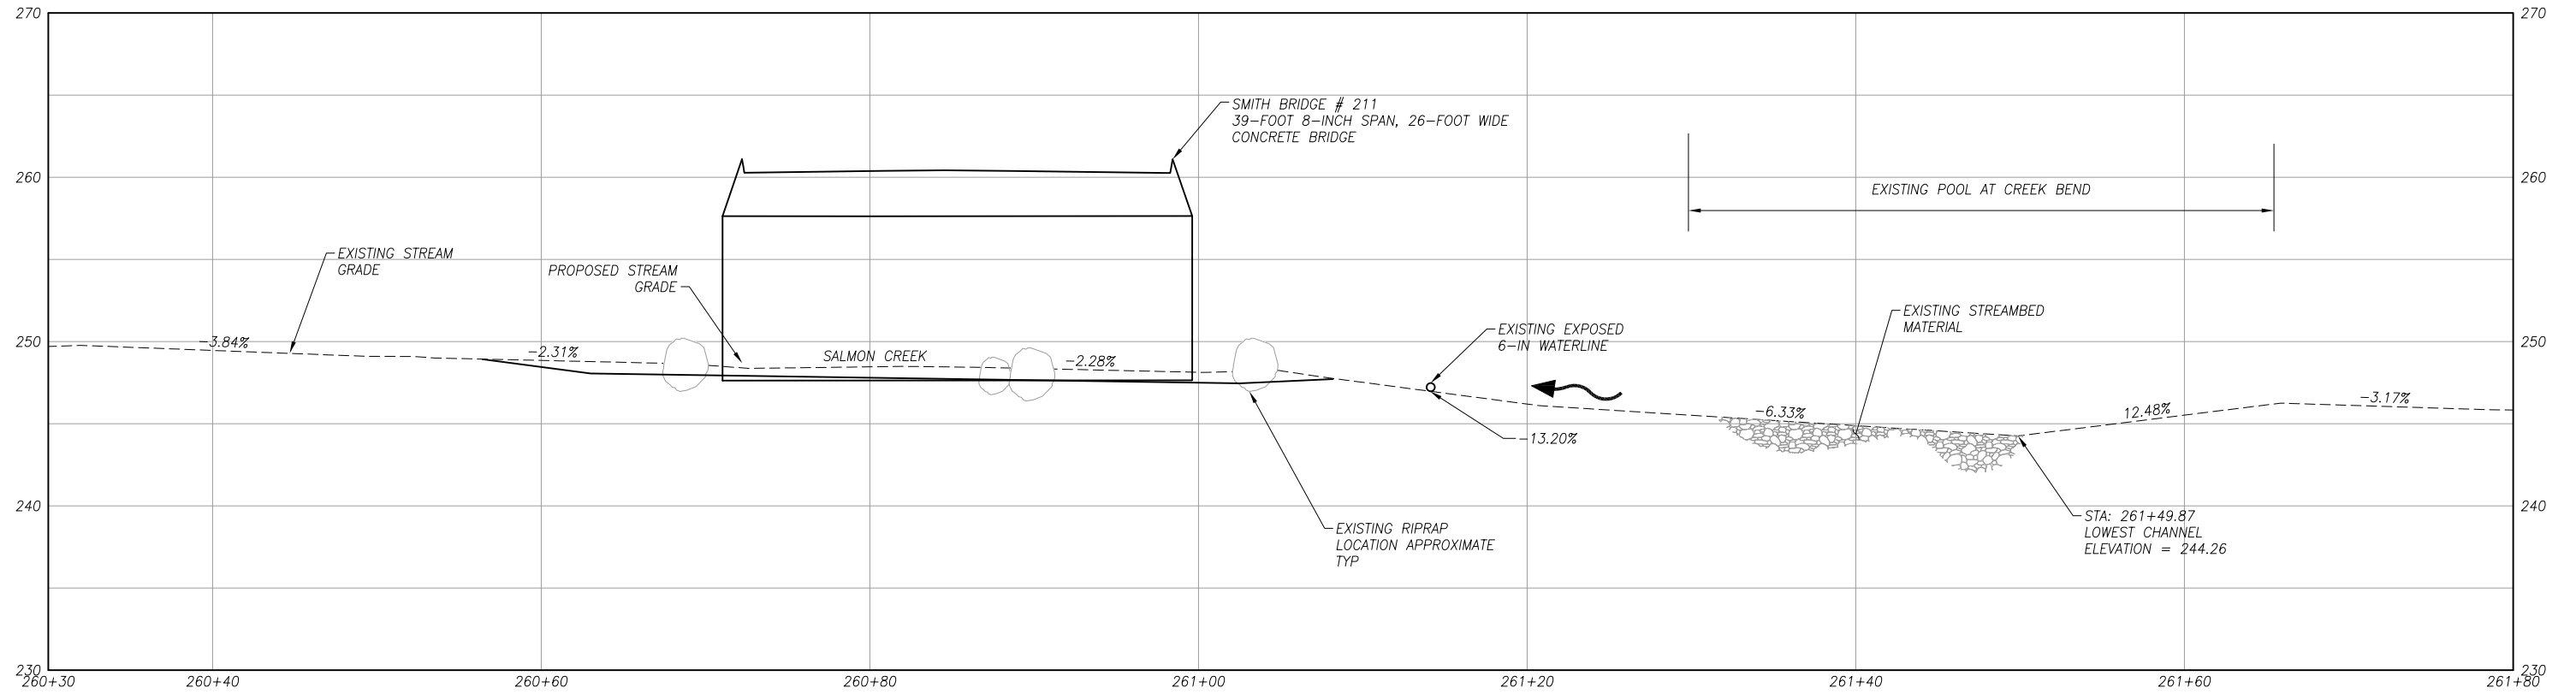
Lehto, Smith, and Salmon Creek Bridges
(3Bridges)
Scour Repair Project
Clark County, WA

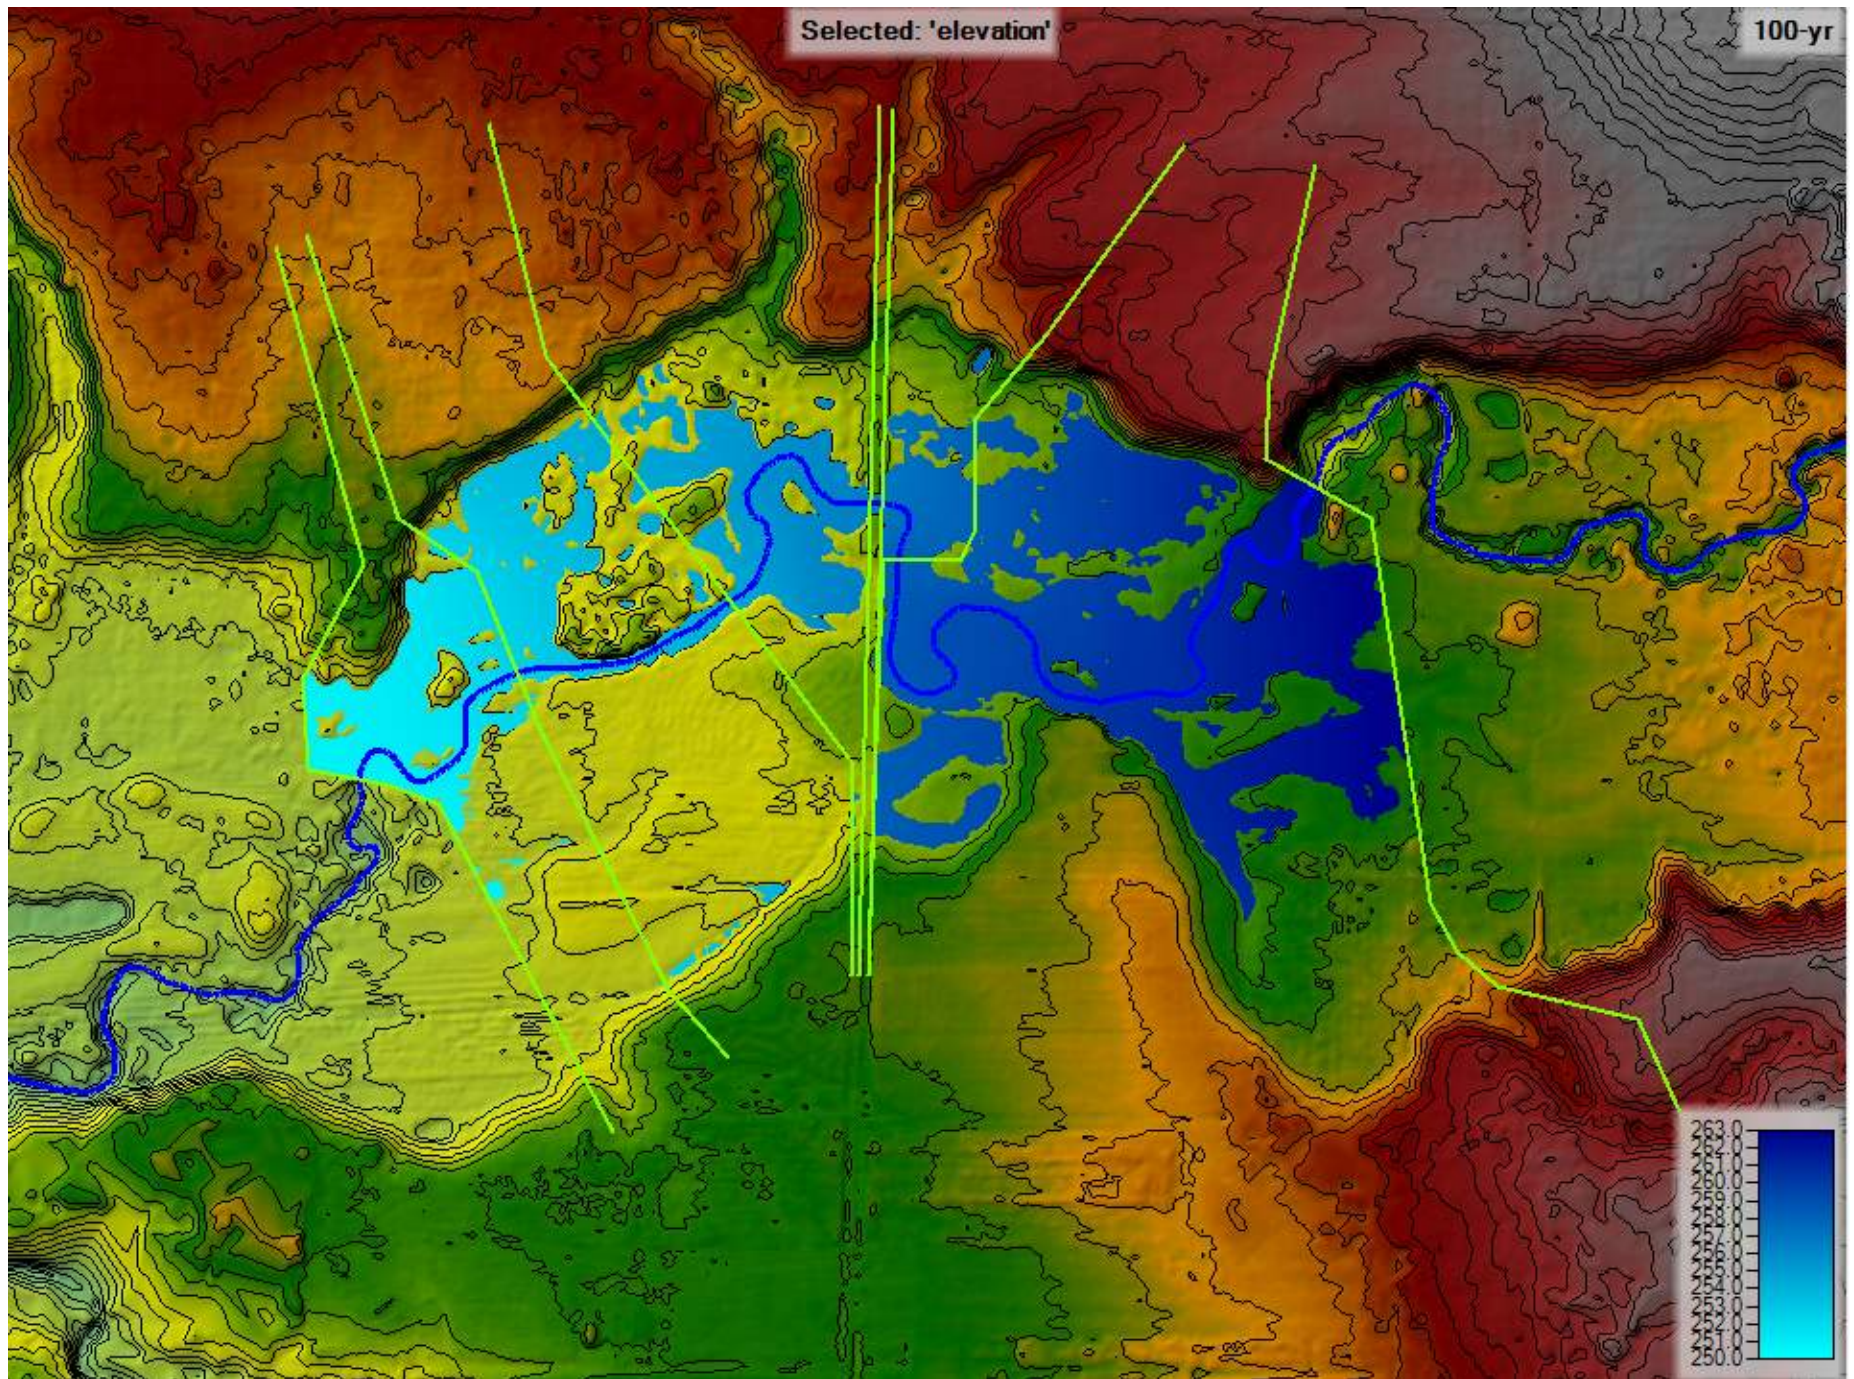
100-YEAR FLOOD MAP PROVIDED FOR CONTEXT ONLY AND IS NOT INTENDED TO REPLACE FEMA FIRM
